## Floodplain response 14 years after invasive removal in Canyon de Chelly National Monument, AZ

Lindsay Reynolds February 3, 2020 Riparian Ecologist, National Operations Center Bureau of Land Management, lreynolds@blm.gov

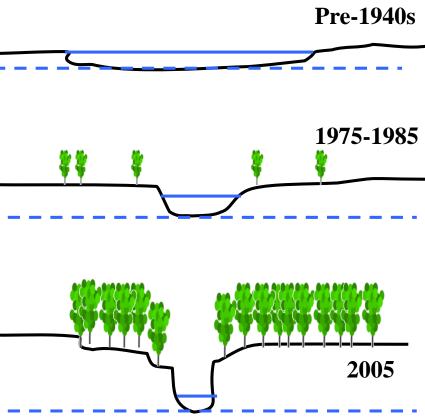
# Floodplain changes 1930s-2005

\*Native cottonwood, exotic tamarisk and Russian olive riparian forest

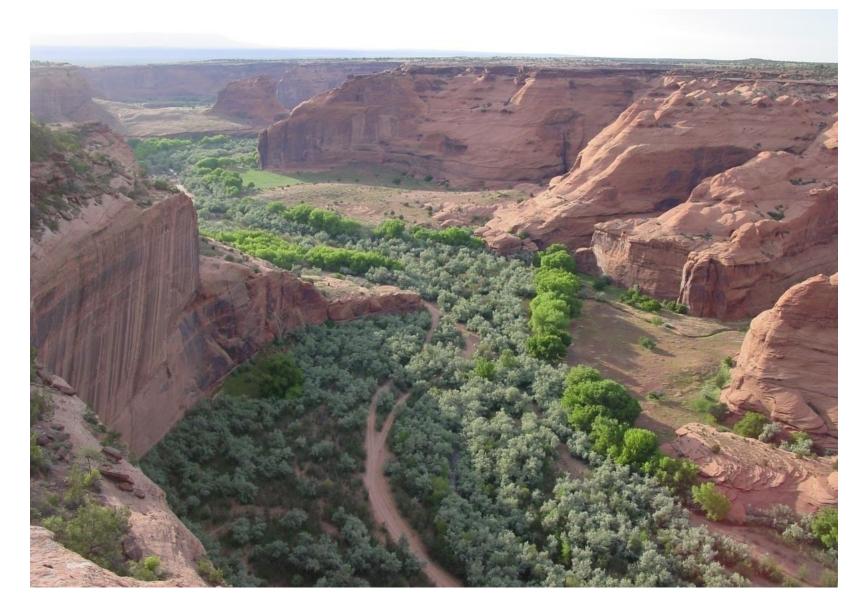
#### **Study Sites**

NUCKINO NORMOS Chinle Wash 12 Chinle CANYON de CHELLY 34 5 6 Exotic plant removal sites: 1. Navajo Fortress 2. Standing Cow 3. Lower White House 4. Upper White House 5. Sliding Rock 6. Spider Rock

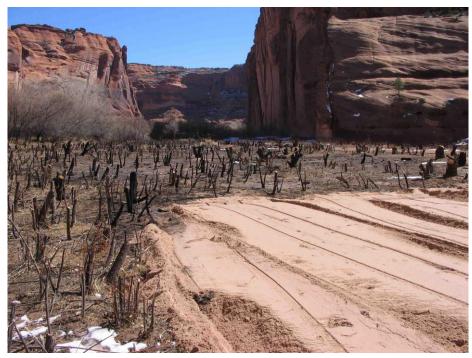
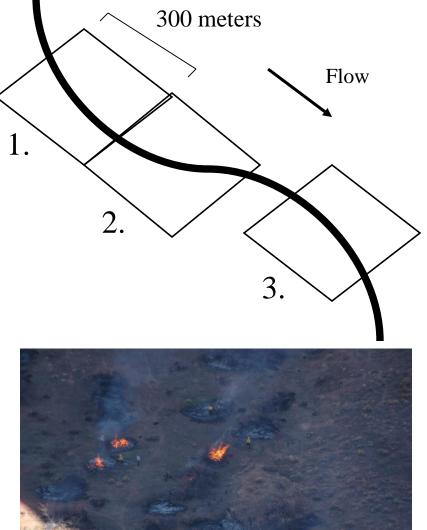
#### **Removal Sites**

- 1. Control
- 2. Above-ground removal w/ herbicide
- 3. Whole plant removal

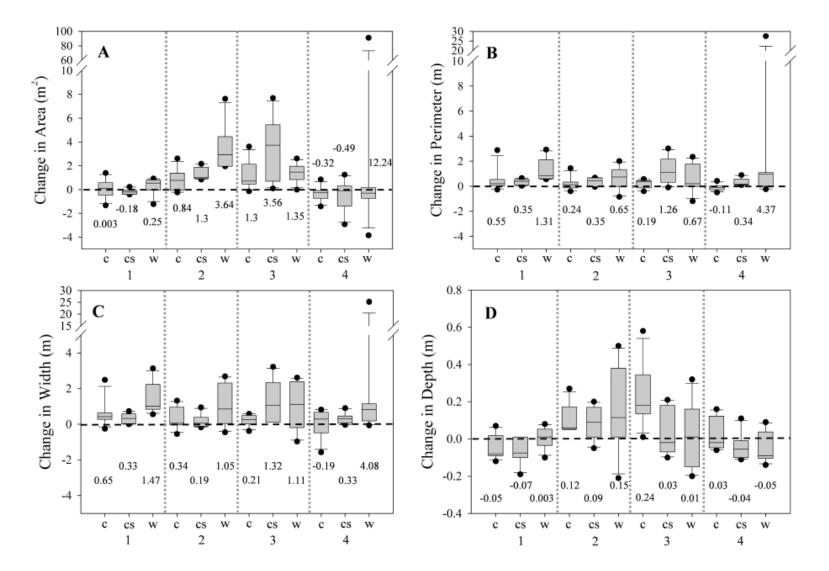
#### **Channel form pre-post removal 2007**

Jaeger, K. L., and E.E. Wohl. 2011. *Channel response in a semiarid stream to removal of tamarisk and Russian olive*, Water Resources Research, 47 (2). W02536, doi: 10.1029/2009WR008741

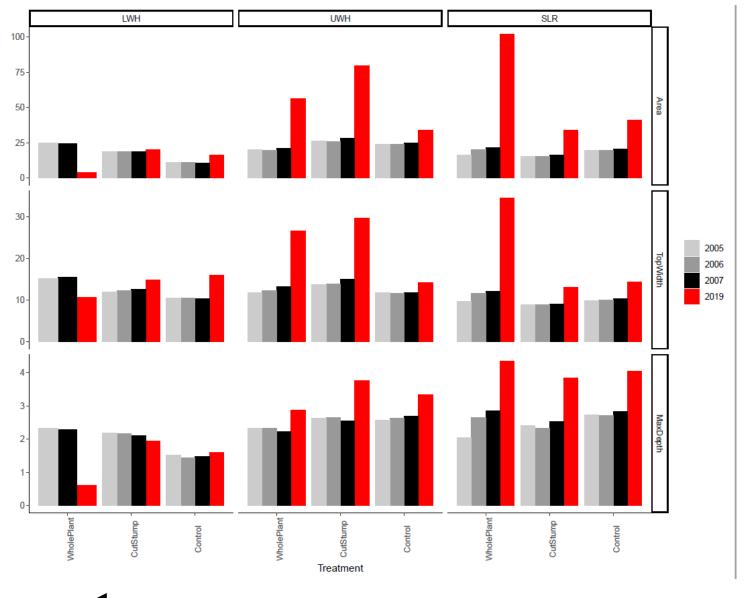
#### Channel form 2005-2019

Downstream

Upstream

- Tamarisk and Russian olive invasion was driven by:
  - wet years, large floods -1980s
  - channel narrowing, channel incision which caused which?
- After invasive plant removal:
  - Cohesive banks with clay and prior entrenchment facilitate further channel enlargement (including incision) and does not promote lateral movement: persistent entrenchment

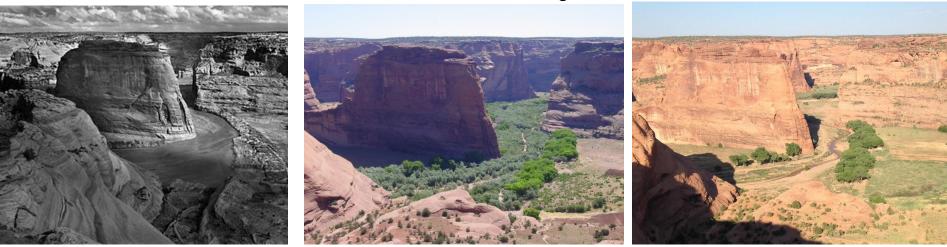
## **Summary**

1942 Ansel Adams

2005

2015

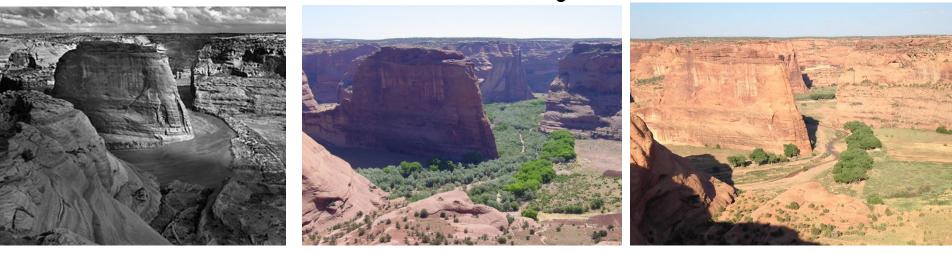
## Summary

1942 Ansel Adams

2005

2015

- Where bank sediments are dominated by sand, widening and channel migration is happening, with sufficient flow
- Vegetation in removal sites is dominated by exotic grasses and forbs, return of native plant communities is limited.
- Seeding and grazing exclosure are facilitating native grass persistence
