# Assessment of Geomorphic Impacts of Vegetation Removal on the Colorado River

**Gigi Richard, Ph.D.**  
Director  
**FOUR CORNERS WATER CENTER**  
at FORT LEWIS COLLEGE

**COLORADO MESA UNIVERSITY**  
RUTH POWELL HUTCHINS WATER CENTER

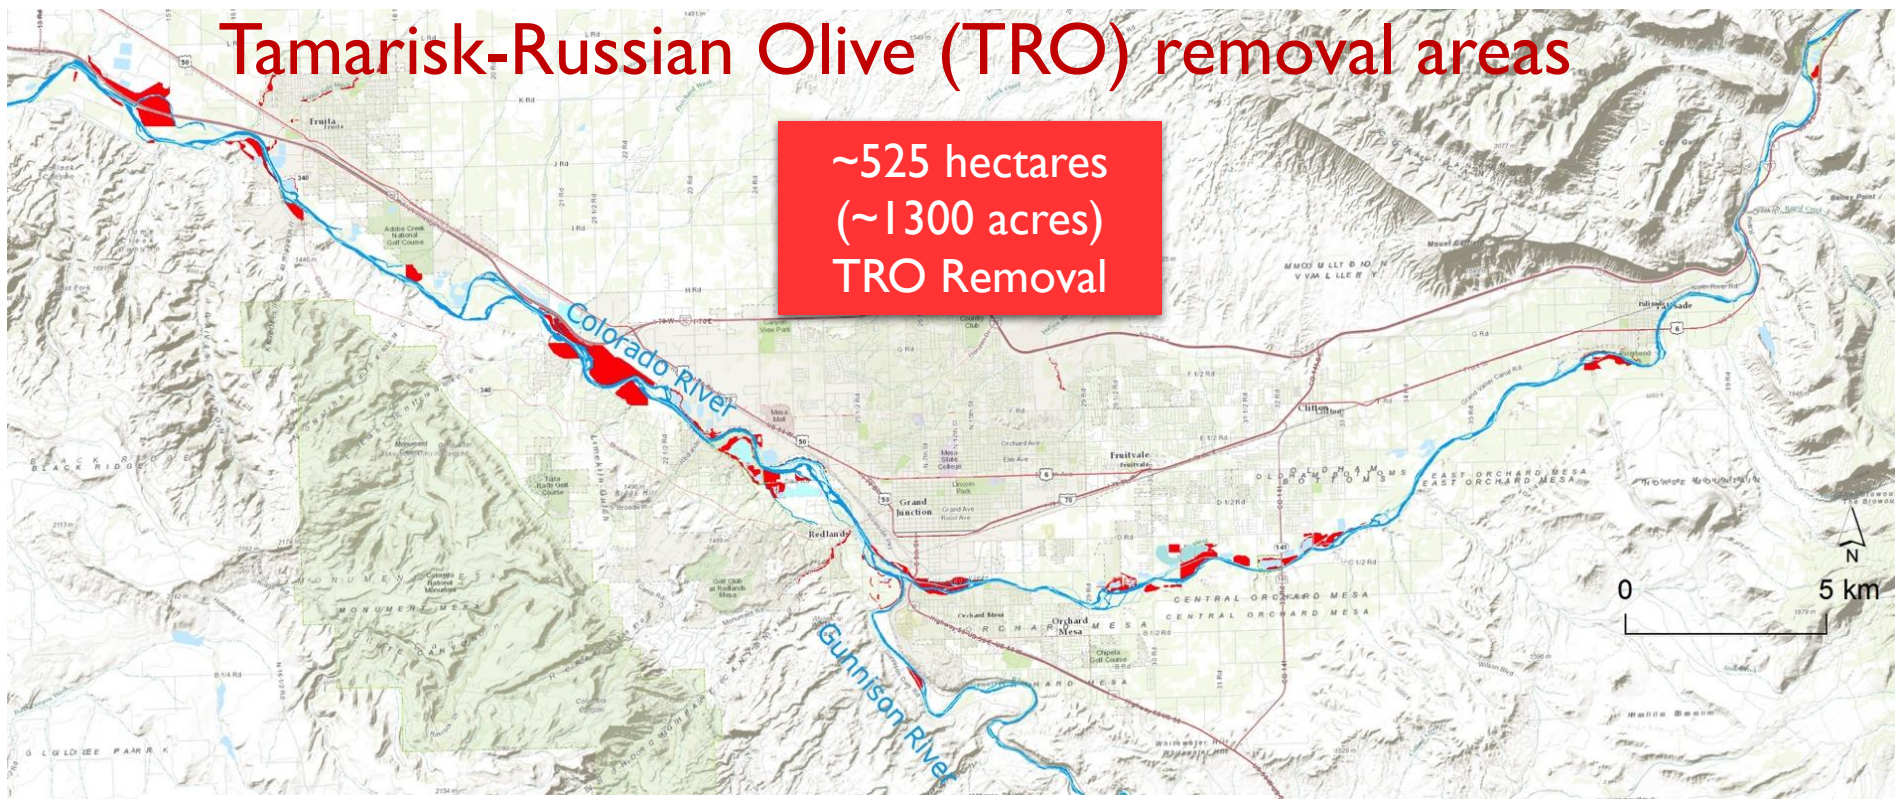
# Tamarisk-Russian Olive (TRO) removal areas

~525 hectares  
(~1300 acres)  
TRO Removal

- Colorado & Gunnison Rivers
- Removal areas through 2015 (Tamarisk Coalition, 2015)

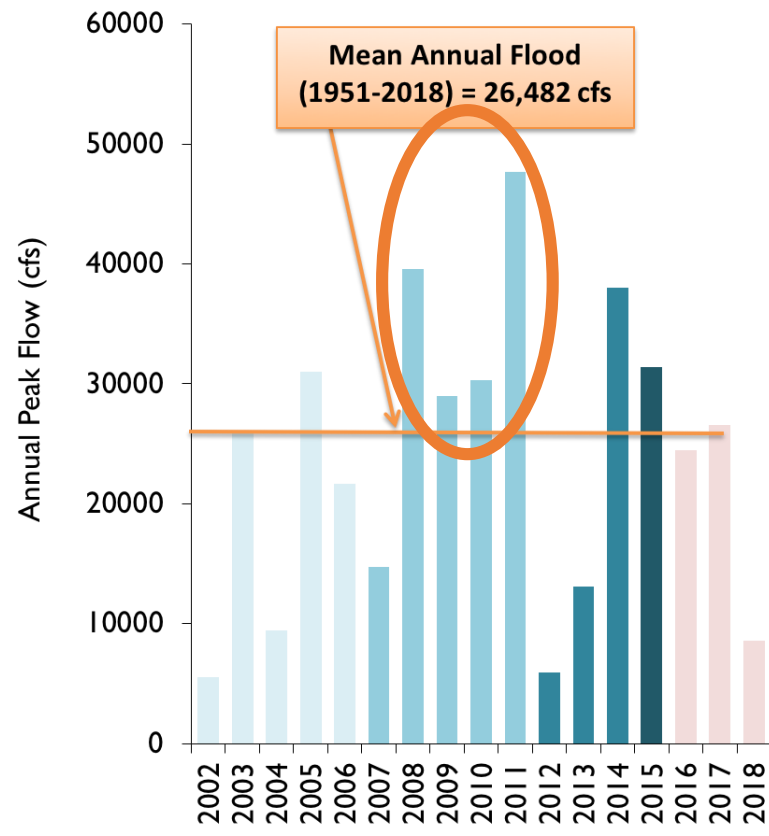
Colorado River Near CO-UT State Line

# Annual Peak Flow

Four years of peak flow above the mean annual flood between 2007 and 2012

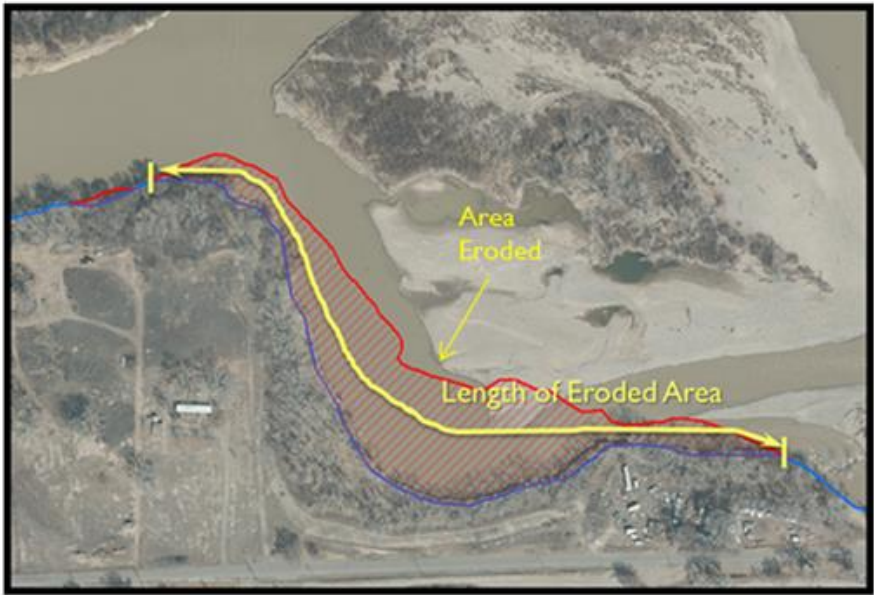
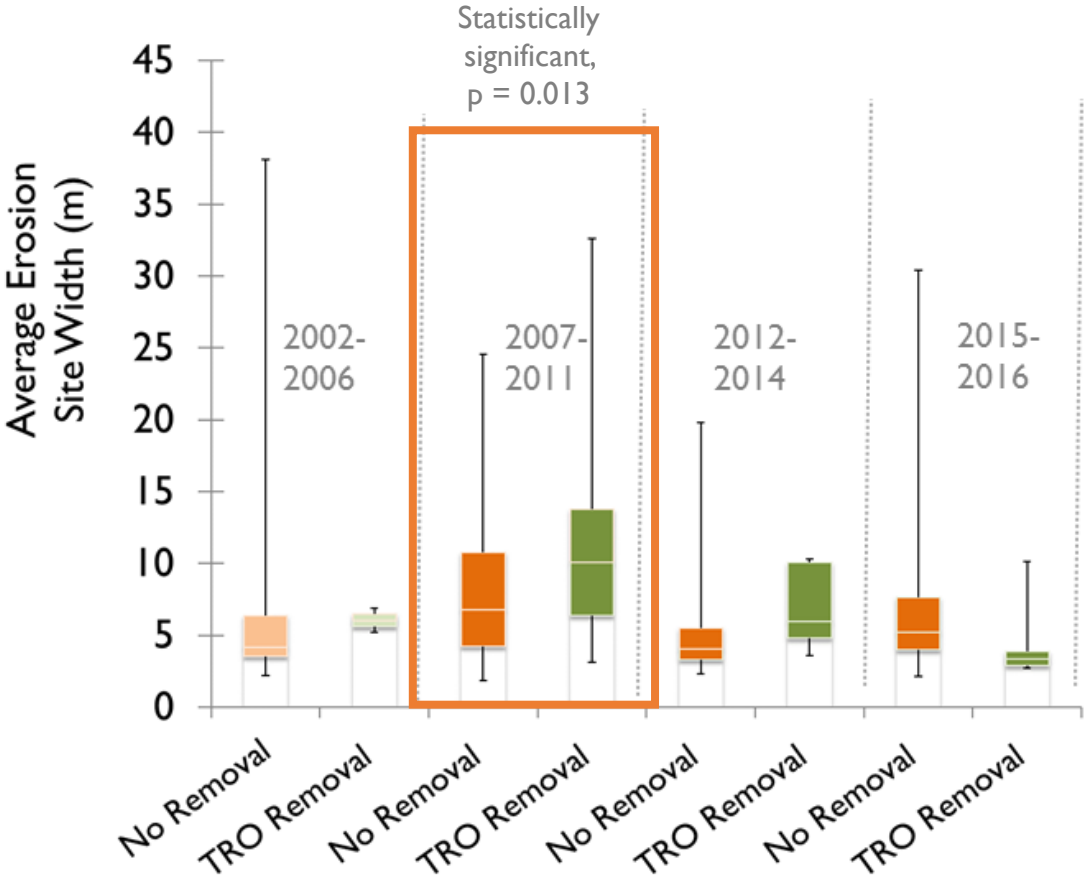
$$\text{Avg. Width of Eroded Area} = \frac{\text{Area Eroded}}{\text{Length of Eroded Area}}$$

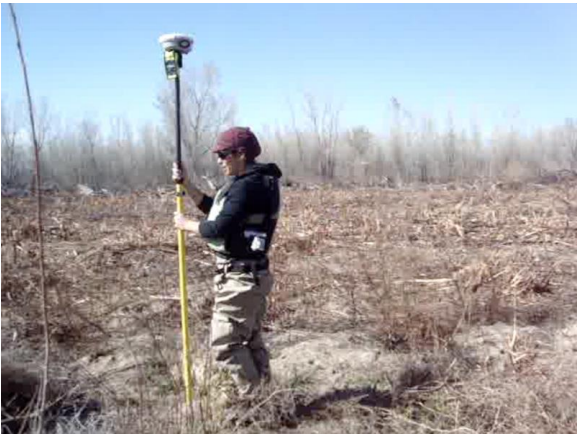
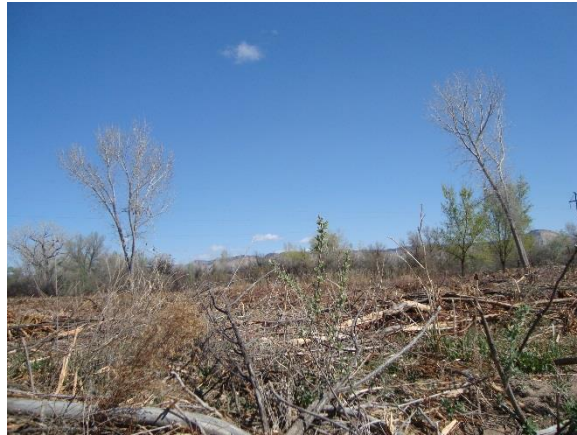
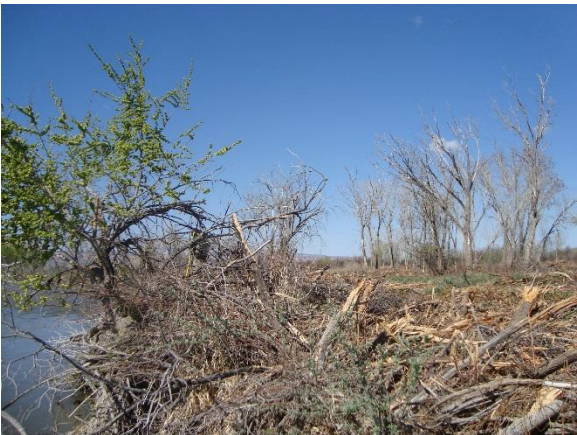
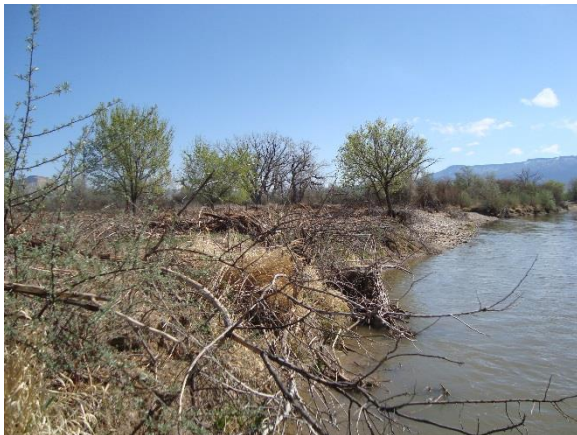
TRO Removal by mastication, Jan 2015

Photos taken 3 April 2015

Colorado River Island

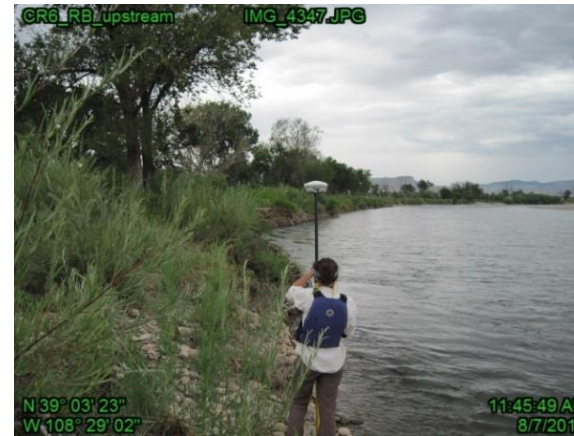
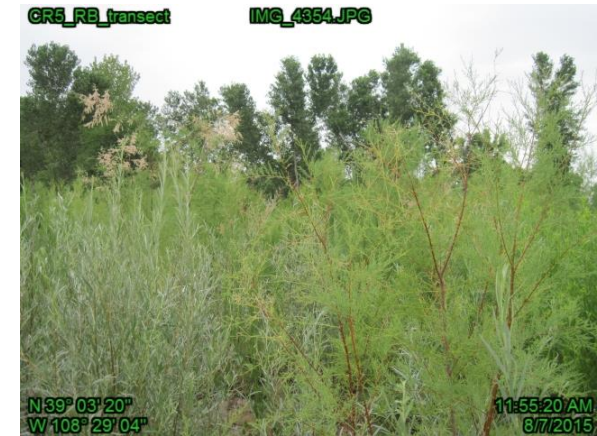
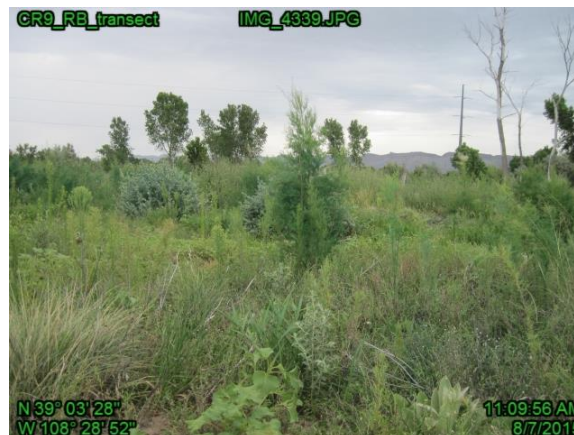
Colorado River Island, August 2015

Rapid post-removal reveg

- Secondary weeds
- Tamarisk re-sprout
- Native vegetation

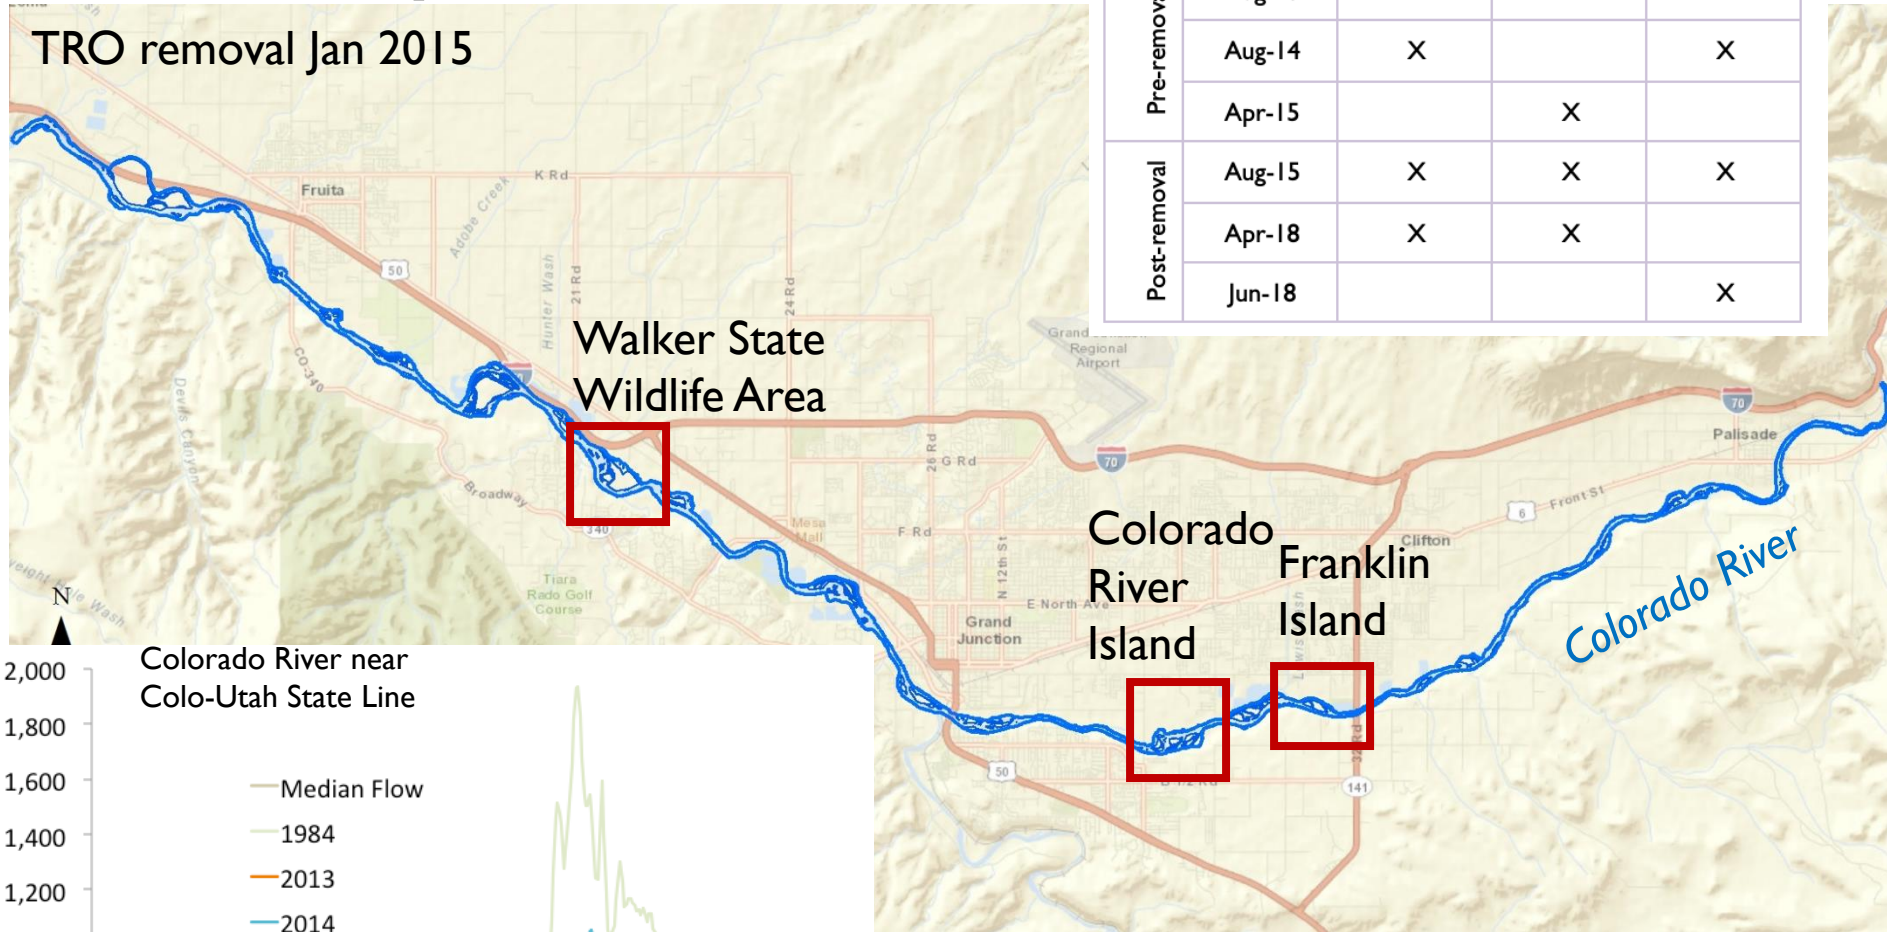
# Field study sites

Month of Survey	Franklin Island	Colorado River Island	Walker SWA
Pre-removal	Aug-13	X		X
	Aug-14	X		X
	Apr-15		X	
Post-removal	Aug-15	X	X	X
	Apr-18	X	X	
	Jun-18			X

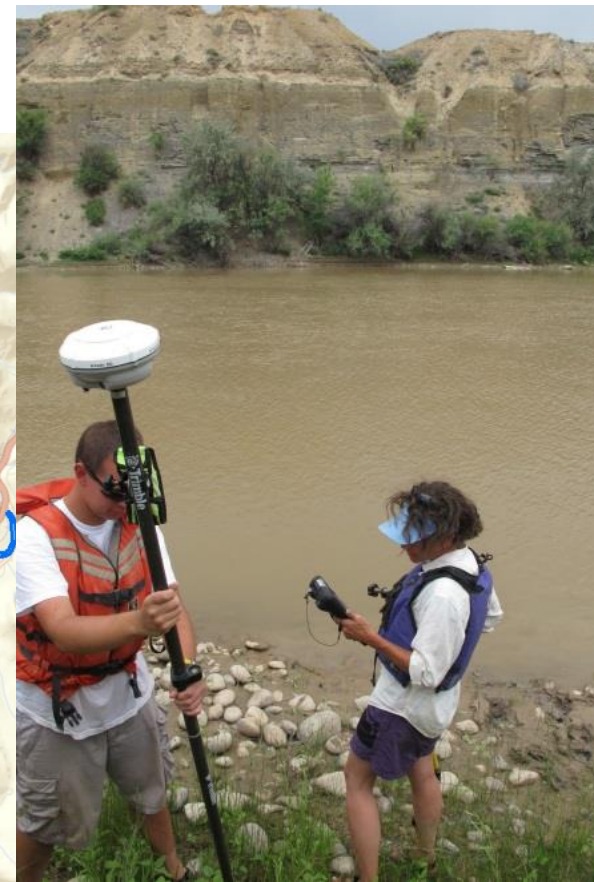
Trimble Survey-grade GPS w/ Real-Time Virtual Reference Network (RTVRN)

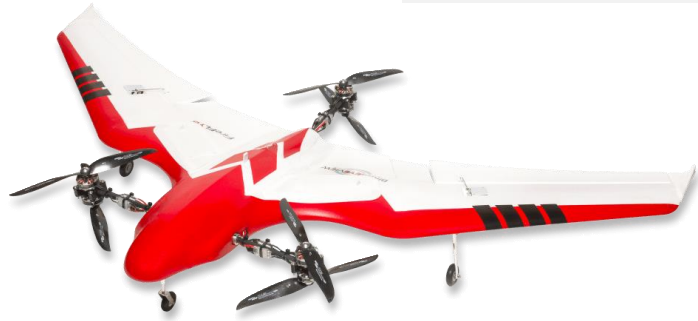
Remote sensing for assessment of secondary invasive weed growth

2017 - three study sites flown  
Firefly Pro 6 w/ Multispectral camera – RGB, red edge, near infrared, 7cm resolution

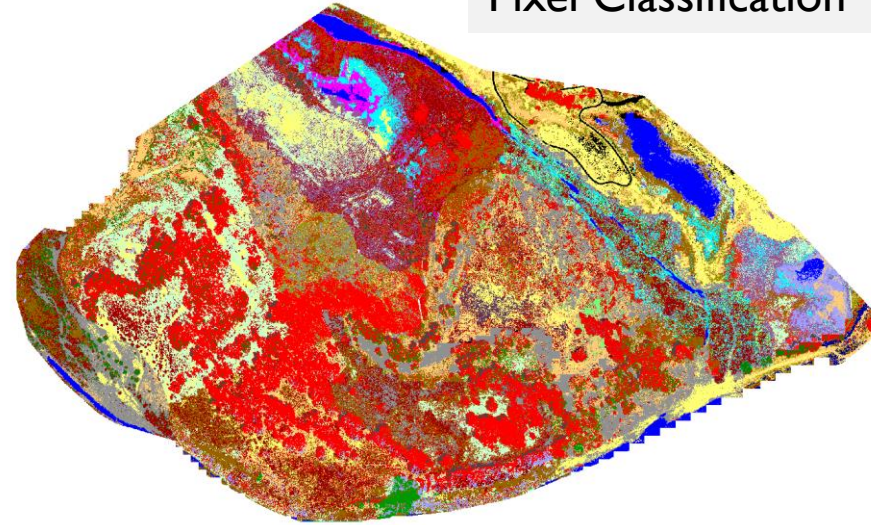
## Pixel Classification

Tamarisk	Dark Red
Russian Olive	Light Blue
Kochia	Purple
Cottonwood	Red
Elm	Green
Coyote Willow	Brown
Reed Canary	Light Green
Common Rush	Cyan
Rabbitbrush	Yellow
Sedge	Magenta
Water	Blue
Shadow	Grey
Litter	Light Grey
Concrete	Black
Herbaceous	Orange
Bare Ground	Yellow

Walker State Wildlife Area - 50 hectare

Individual Species	CW	EL	WL	TM	RO	RB	SD	RD	RS	KC
Cottonwood ( <i>Populus spp.</i> )	22	1	0	2	3	3	0	2	1	2
Elm ( <i>Ulmus pumila</i> )	2	36	0	0	2	0	0	0	0	0
Willow ( <i>Salix exigua</i> )	1	1	41	2	1	0	0	4	1	1
Tamarisk ( <i>Tamarix spp.</i> )	1	0	18	33	1	1	0	2	0	0
Russian olive ( <i>Elaeagnus angustifolia</i> )	0	0	0	1	22	0	0	0	1	0
Rabbitbrush ( <i>Ericameria nauseosa</i> )								0	0	2
Sedge ( <i>Carex spp.</i> )								0	2	0
Reed Canary Grass ( <i>Phalaris arundinacea</i> )								19	0	3
Rush ( <i>Juncus spp.</i> )								1	21	0
Kochia ( <i>Kochia scoparia</i> )								2	0	17
<b>Total</b>	26	38	60	40	30	30	33	30	26	25
<b>Producer's Accuracy (%)</b>	85	94	68	83	73	87	97	63	81	68
<b>Relative Commission Error (%)</b>	15	6	32	17	27	13	3	37	19	32

Willow were mistakenly identified as tamarisk 30% of the time
