Attachment To Improve Tamarisk Removal

Keith Windell
Project Leader, MTDC

7E72E79—Attachment To Improve Tamarisk Removal

December 2009

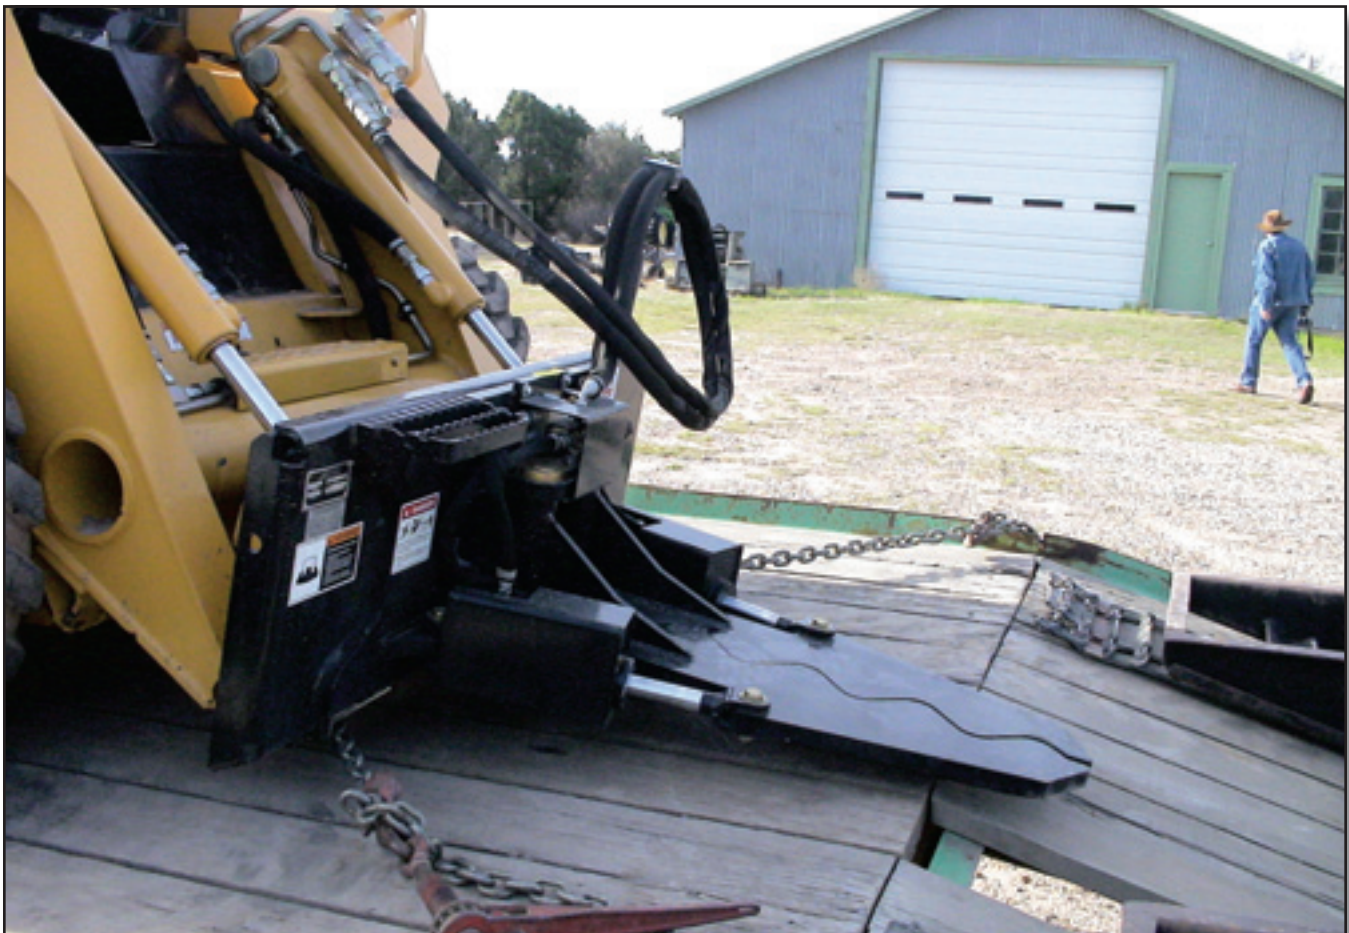
Figure 1—The Star Hill JAWZ attachment was used to pull tamarisk plants from the ground.

whether the JAWZ (figure 1) attachment could perform the task.

Some of the clumps were larger around than the JAWZ could open (34 inches maximum). In these cases, the JAWZ grabbed a portion of the tamarisk stems at or slightly below the ground line.

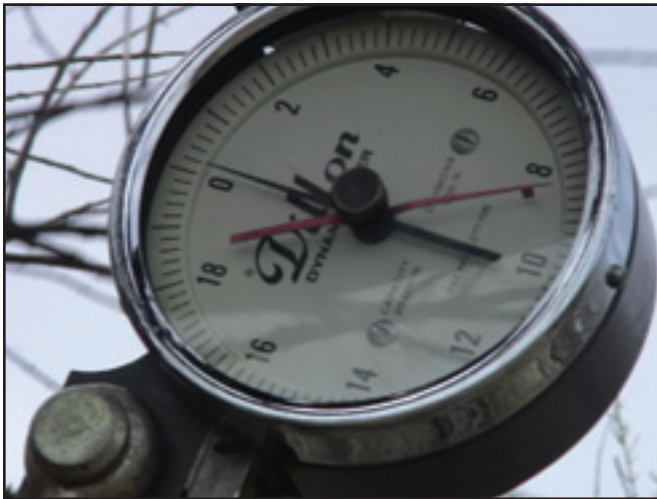
Figure 2—A Dillon 20,000-pound dynamometer used to determine how much force was needed to pull tamarisk.

To determine how much force was required to pull the tamarisk, a Dillon dynamometer (figure 2, serial No. AP505) was placed between a chain wrapped around the base of the tamarisk clump and a large, surplus military forklift designed for rough terrain (figures 3a and 3b).

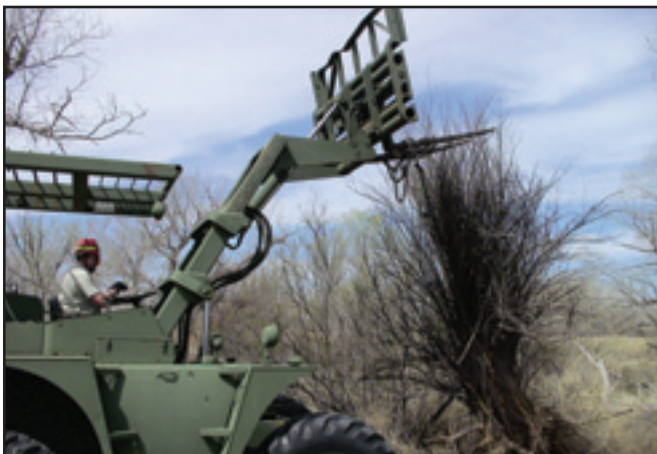
Figure 3a—A surplus military forklift designed for rough terrain was used to pull out tamarisk.

After the soil dried out later that summer, the forklift (which can pull with 12,000 pounds of force) could not pull out the tamarisk. Pull tamarisk in the spring when soils are moist!

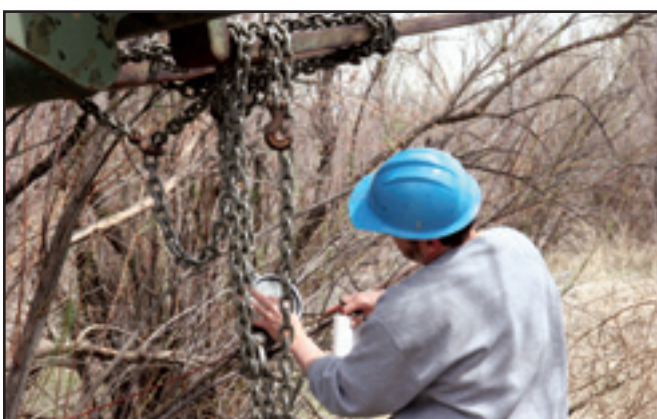
Figure 3b—Collecting pull data.

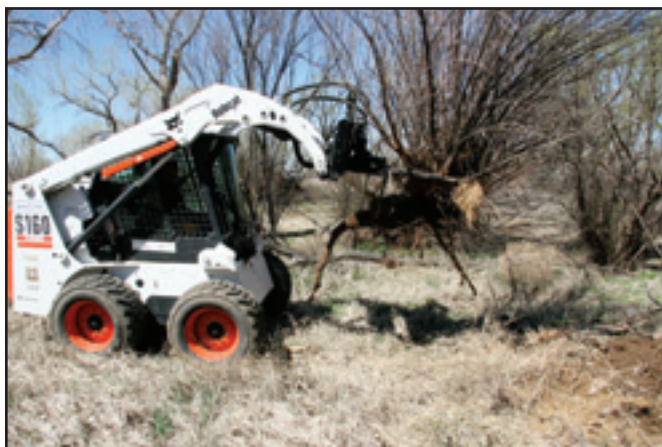
Figure 4—The Bobcat S160 skid steer loader.

The JAWZ attachment was tested on two different wheeled skid steer loaders: the Cimarron National Grassland's Bobcat S160 rubber-tired skid steer (figure 4) and a John Deere 260 skid steer (figure 5) borrowed from the Kiowa and Rita Blanca National Grasslands.

Tamarisk bundles were easier to pull out when they were rocked from side to side. The Bobcat S160 rubber-tired skid steer, which was lighter and had better flotation than the John Deere 260 skid steer, was less likely to get stuck in the sandy soils. The Bobcat S160 has an operating capacity of 1,600 pounds, a boom breakout force of 3,000 pounds, and a tipping load of 3,200 pounds. It has 56 net horsepower and an operating weight of 5,752 pounds. The Bobcat S160 had a more difficult time pulling tamarisk than the John Deere 260.

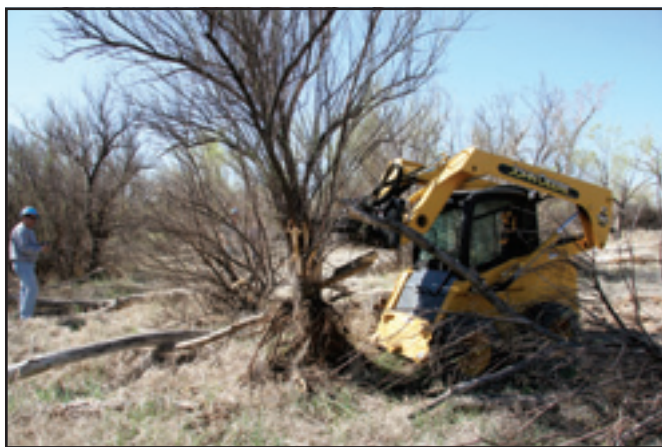
Figure 5—Tamarisk pulled up by the John Deere 260 skid steer loader. Note the size of the tamarisk's root.

The John Deere 260 has an operating capacity of 2,400 pounds, a boom breakout force of 4,800 pounds, and a tipping load of 5,000 pounds. It has 69 net horsepower and an operating weight of 8,250 pounds.

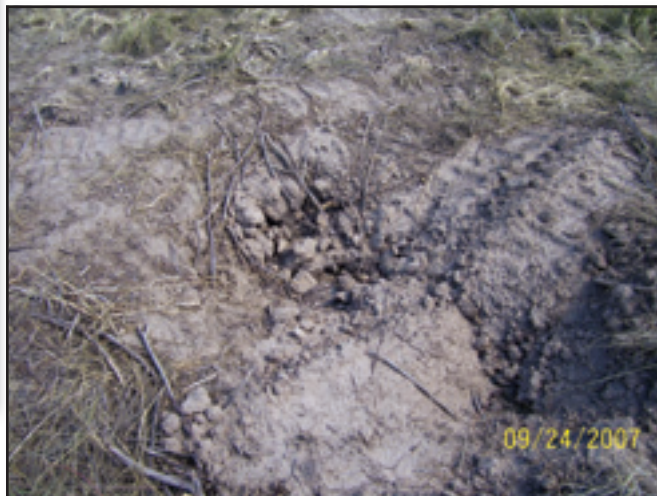
Figure 6—The hole left after a tamarisk has been pulled from sandy soil at the Cimarron National Grassland.

Holes were left after the tamarisk was pulled (figure 6). The Cimarron National Grassland employees felt that these holes would probably fill in naturally.

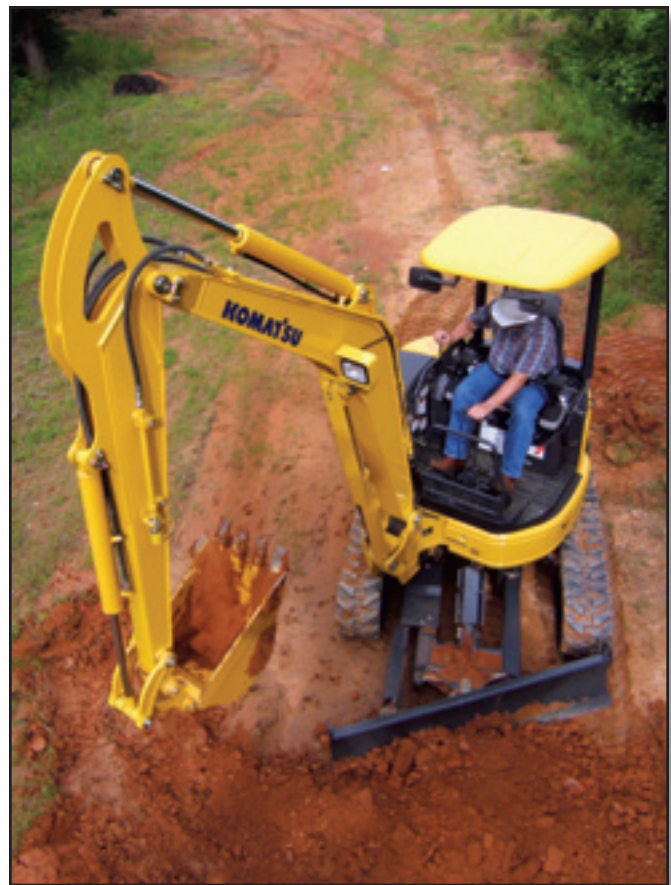
Figure 7—A Komatsu compact excavator. (Photo courtesy of Komatsu America).

Starhill located a manufacturer, Attach-All, that makes an adapter plate that will allow any skid-steer attachment to be mounted on a Komatsu PC50MR excavator (39.4 horsepower, operating weight 11,110 pounds).

The PC50MR compact excavator can apply force of 5,120 pounds at ground level (10 feet in front with standard arm length and blade down) or 2,740 pounds at ground level (10 feet to the side with standard arm length and blade down).

compromise considering equipment size, pulling capability, and general rental availability (figure 7).

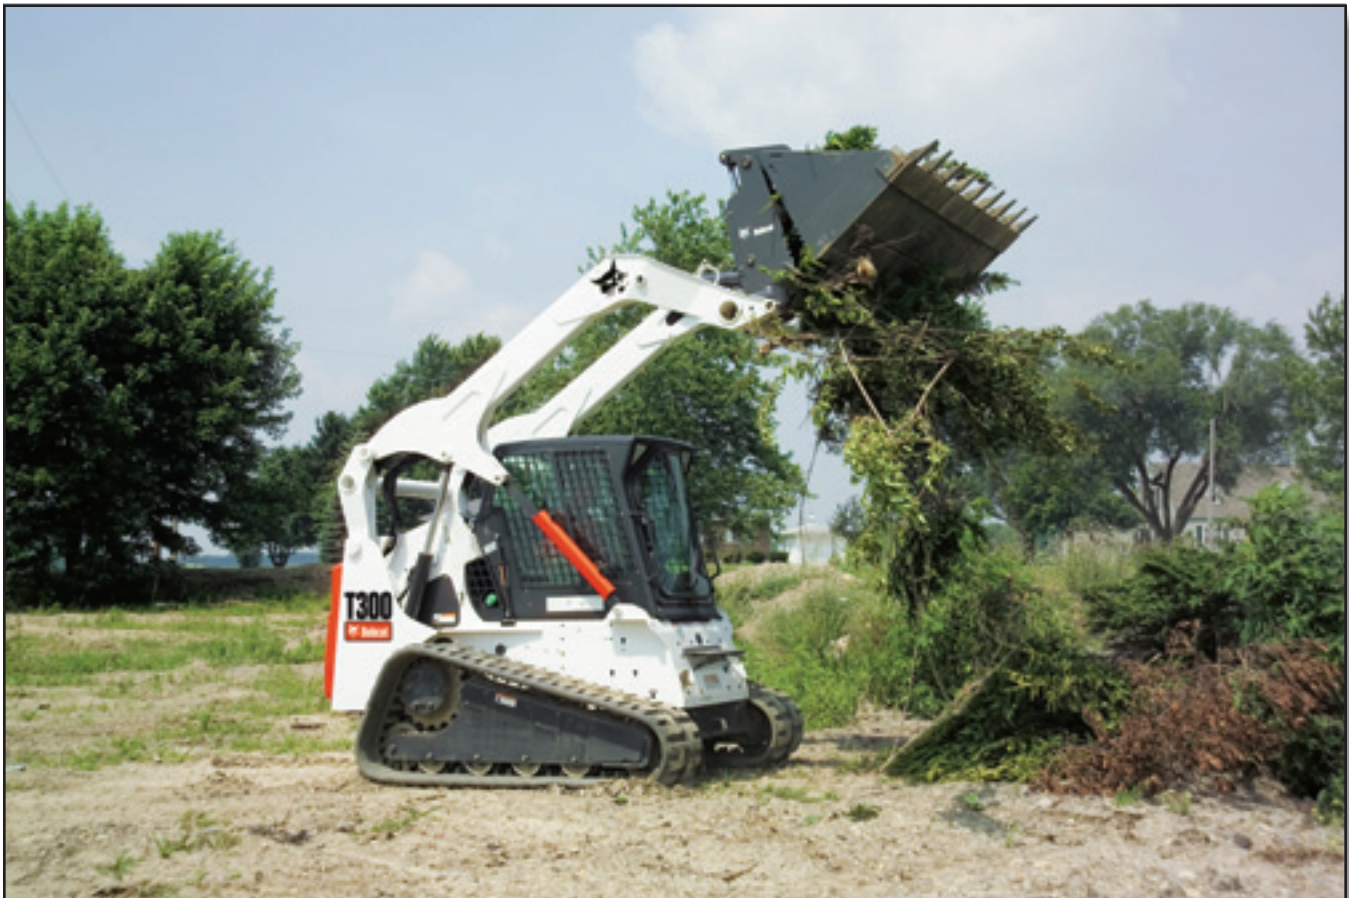
Figure 8—T300 Bobcat Compact Track Loader (Photo courtesy of Bobcat Co.). No photos with the JAWZ mounted on the T300 were available.

A Bobcat T300 compact tracked loader (figure 8) was rented to replace the PC50MR compact excavator. The T300 has rubber tracks for improved maneuverability and flotation. The T300 compact tracked loader has 81 horsepower, a boom breakout force of 6,700 pounds, and a rated lifting capacity of 3,000 pounds.

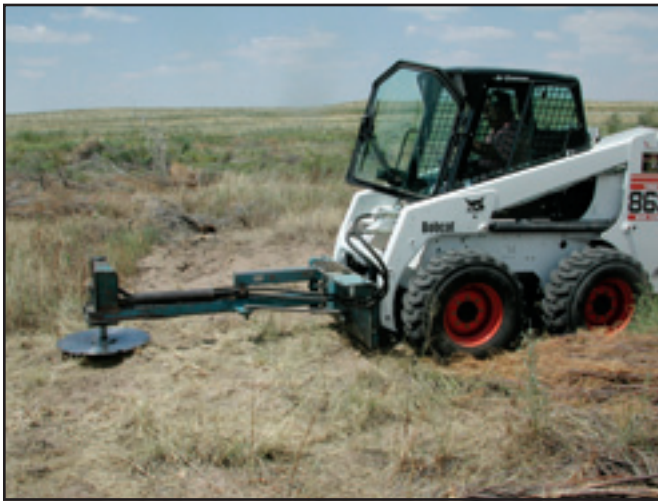
Figure 9a—A Bobcat brush saw mounted on a skid steer loader.

One eradication method now used on the Cimarron National Grassland involves cutting tamarisk. Figures 9a through 9d show how the Cimarron National Grassland cuts tamarisk with a rigid Bobcat brush saw mounted flush with the ground on a skid steer.

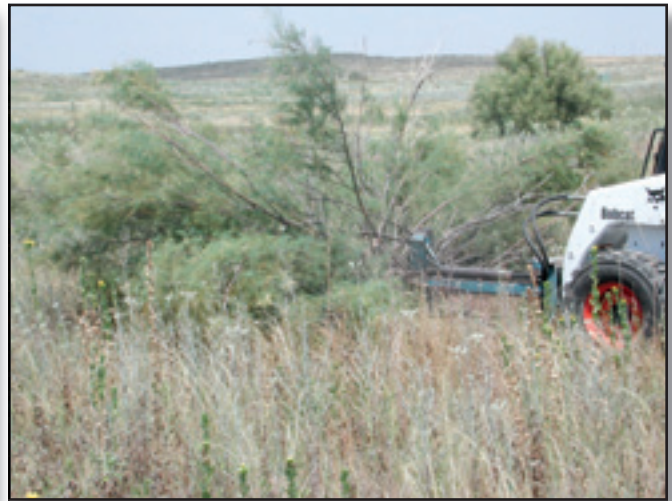
Figure 9c—The Bobcat brush saw being used to cut tamarisk.

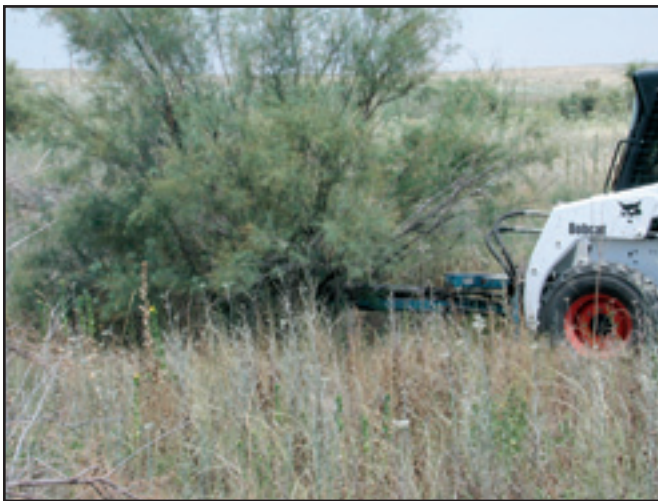
Figure 9b—The skid steer loader equipped with a Bobcat brush saw approaches a tamarisk plant.

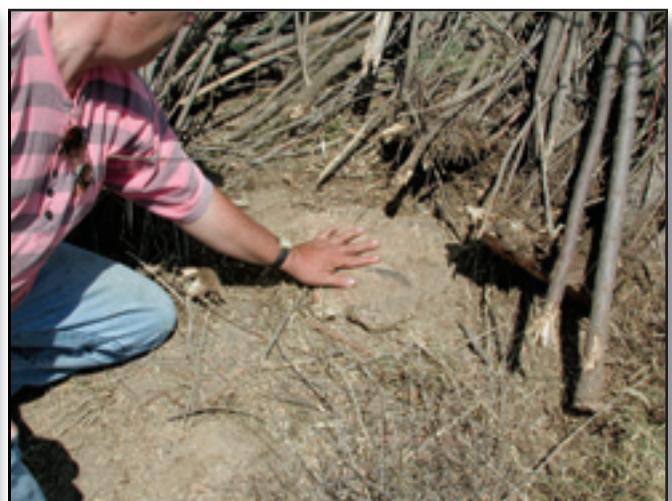
Figure 9d—A tamarisk stump left after the plant was cut by a brush saw mounted on a skid steer loader.

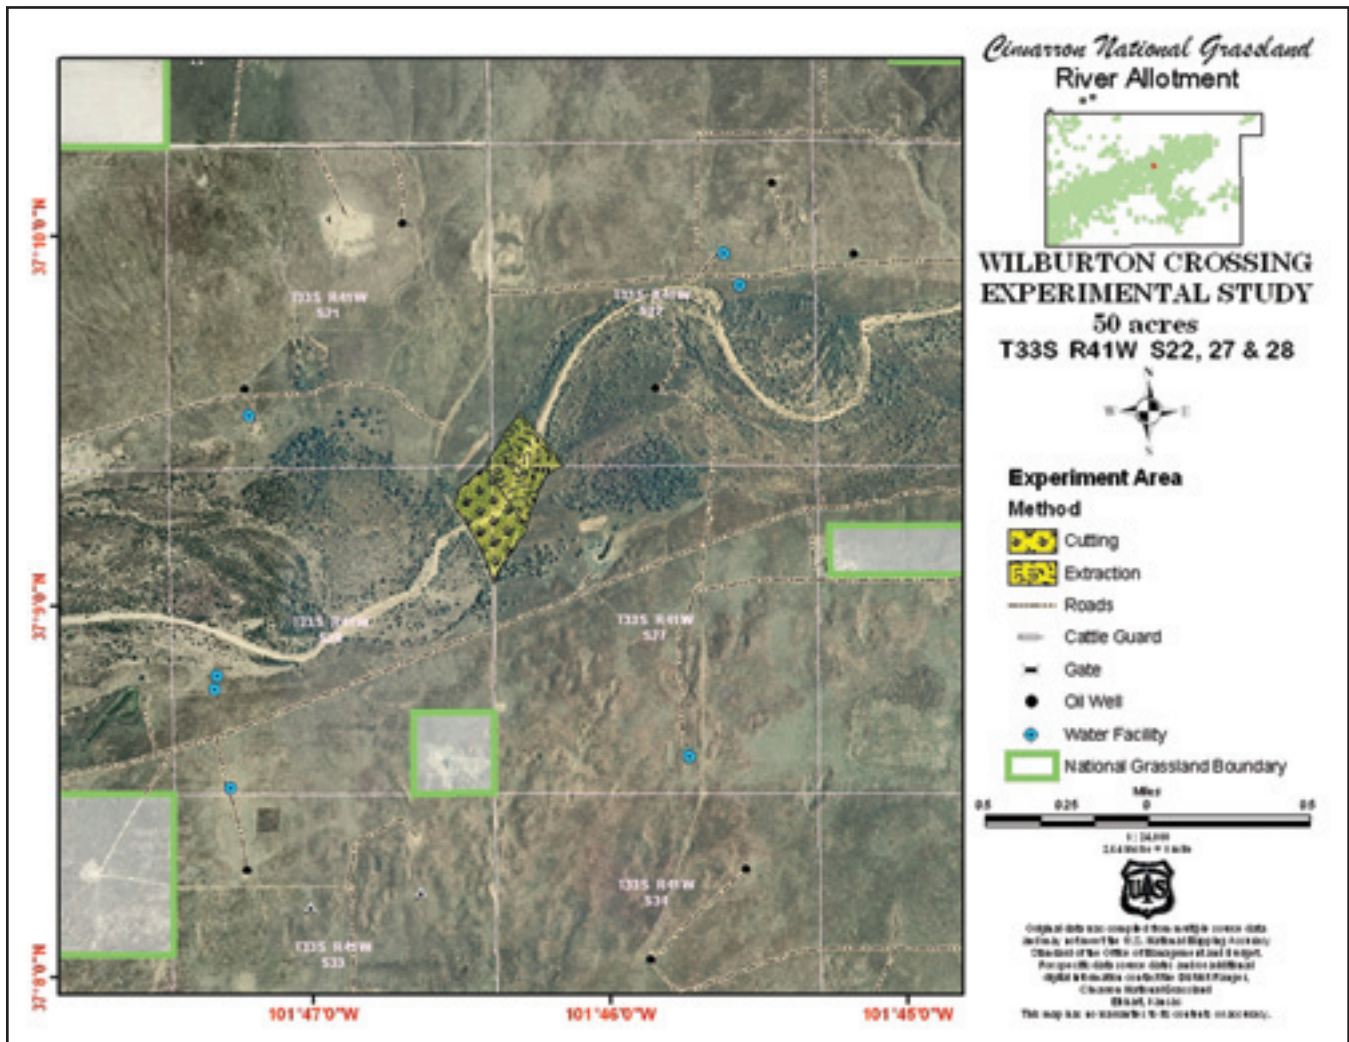
Figure 10—The study site at the Cimarron National Grassland was divided into a cutting plot and an extraction (or pulling) plot.

The study site (divided into two study plots) was east of the Cimarron River crossing on Morton County Road 16 (figure 10). Both study plots ran north and south across the river. Cimarron National Grassland employees flagged the plots with surveyor's tape. The tamarisk infestation was heavier

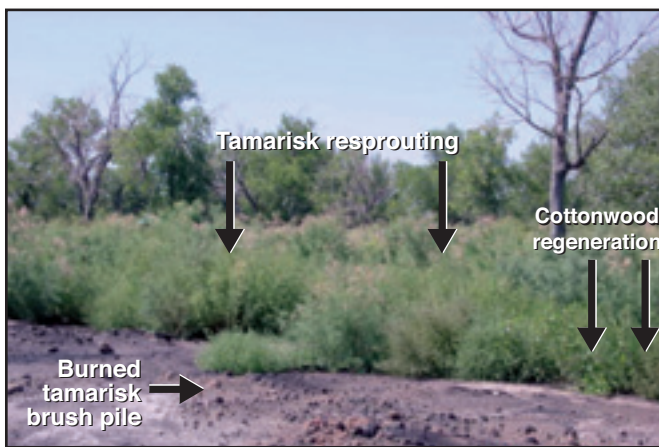
Figure 15—An overview of the study site where tamarisk trees were cut (September 4, 2008). The bare ground is where piled tamarisk was burned.

Tamarisk resprouted abundantly from stumps when it was cut with a brush saw. The height of the tamarisk sprouts ranged from 3 feet to about 6 feet (figure 15). There were few sprouts in the pulling plot where tamarisk was extracted with the JAWZ attachment. The height of the tamarisk sprouts there ranged from 1 foot to about 5 feet (figure 16).

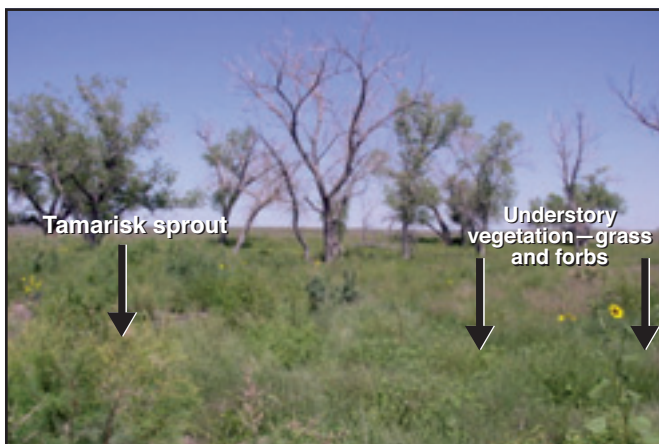
Figure 16—An overview of the study site where tamarisk trees were pulled (September 4, 2008).

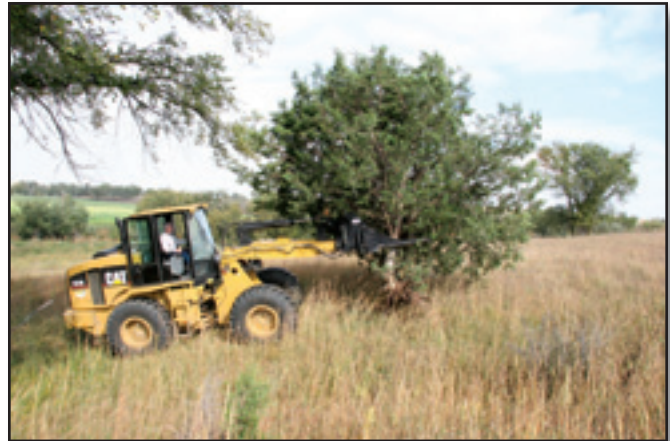
Figure 17a—Star Hill Super JAWZ on a Caterpillar 924 removing a tree (Photo courtesy of Starhill Solutions, Inc.).

The Super JAWZ could pull large clumps of tamarisk from drier soils, but doing so would risk snapping the tamarisk off at the ground line. If that happens, additional sprouting is likely. Rubber-tired machines will not be able to maneuver in sandy river bottom soils as well as machines mounted on tracks.

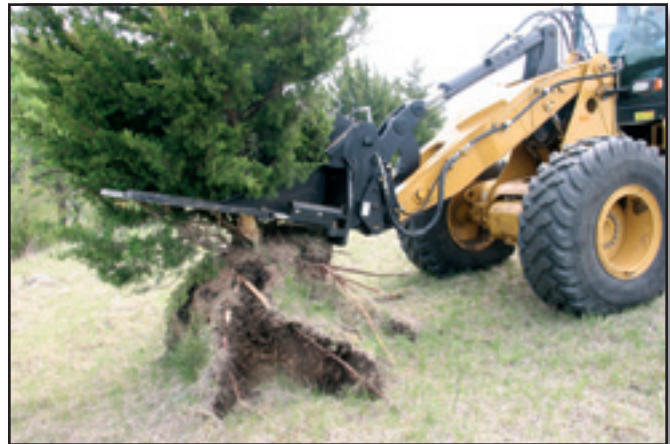
Figure 17b—Star Hill Super JAWZ with adapter for Caterpillar 924 (Photo courtesy of Starhill Solutions, Inc.).
