Channel Morphologic Changes Associated with Invasive Vegetation Removal

Celeste Wieting¹, Sara Rathburn², Lindsay Reynolds³, Jonathan Friedman⁴, Derek Schook⁵

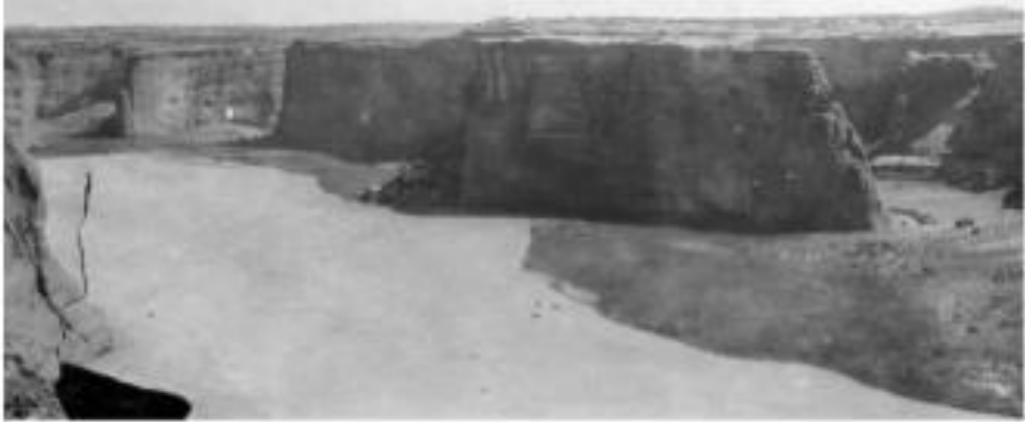
1924 C.H. Dane

a) A shift in the geomorphic nature.

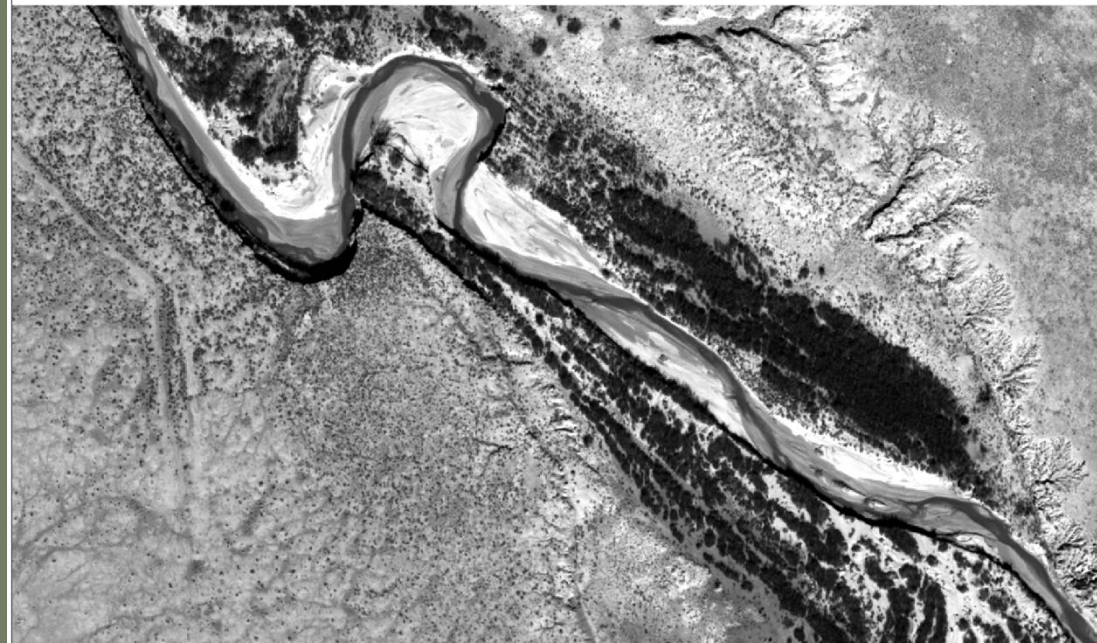
Nov. 2006
satellite image
(DigitalGlobe)

Aerial images of channel widening within the sprayed reach at Rio Puerco

Average
channel width
= 35.7 m

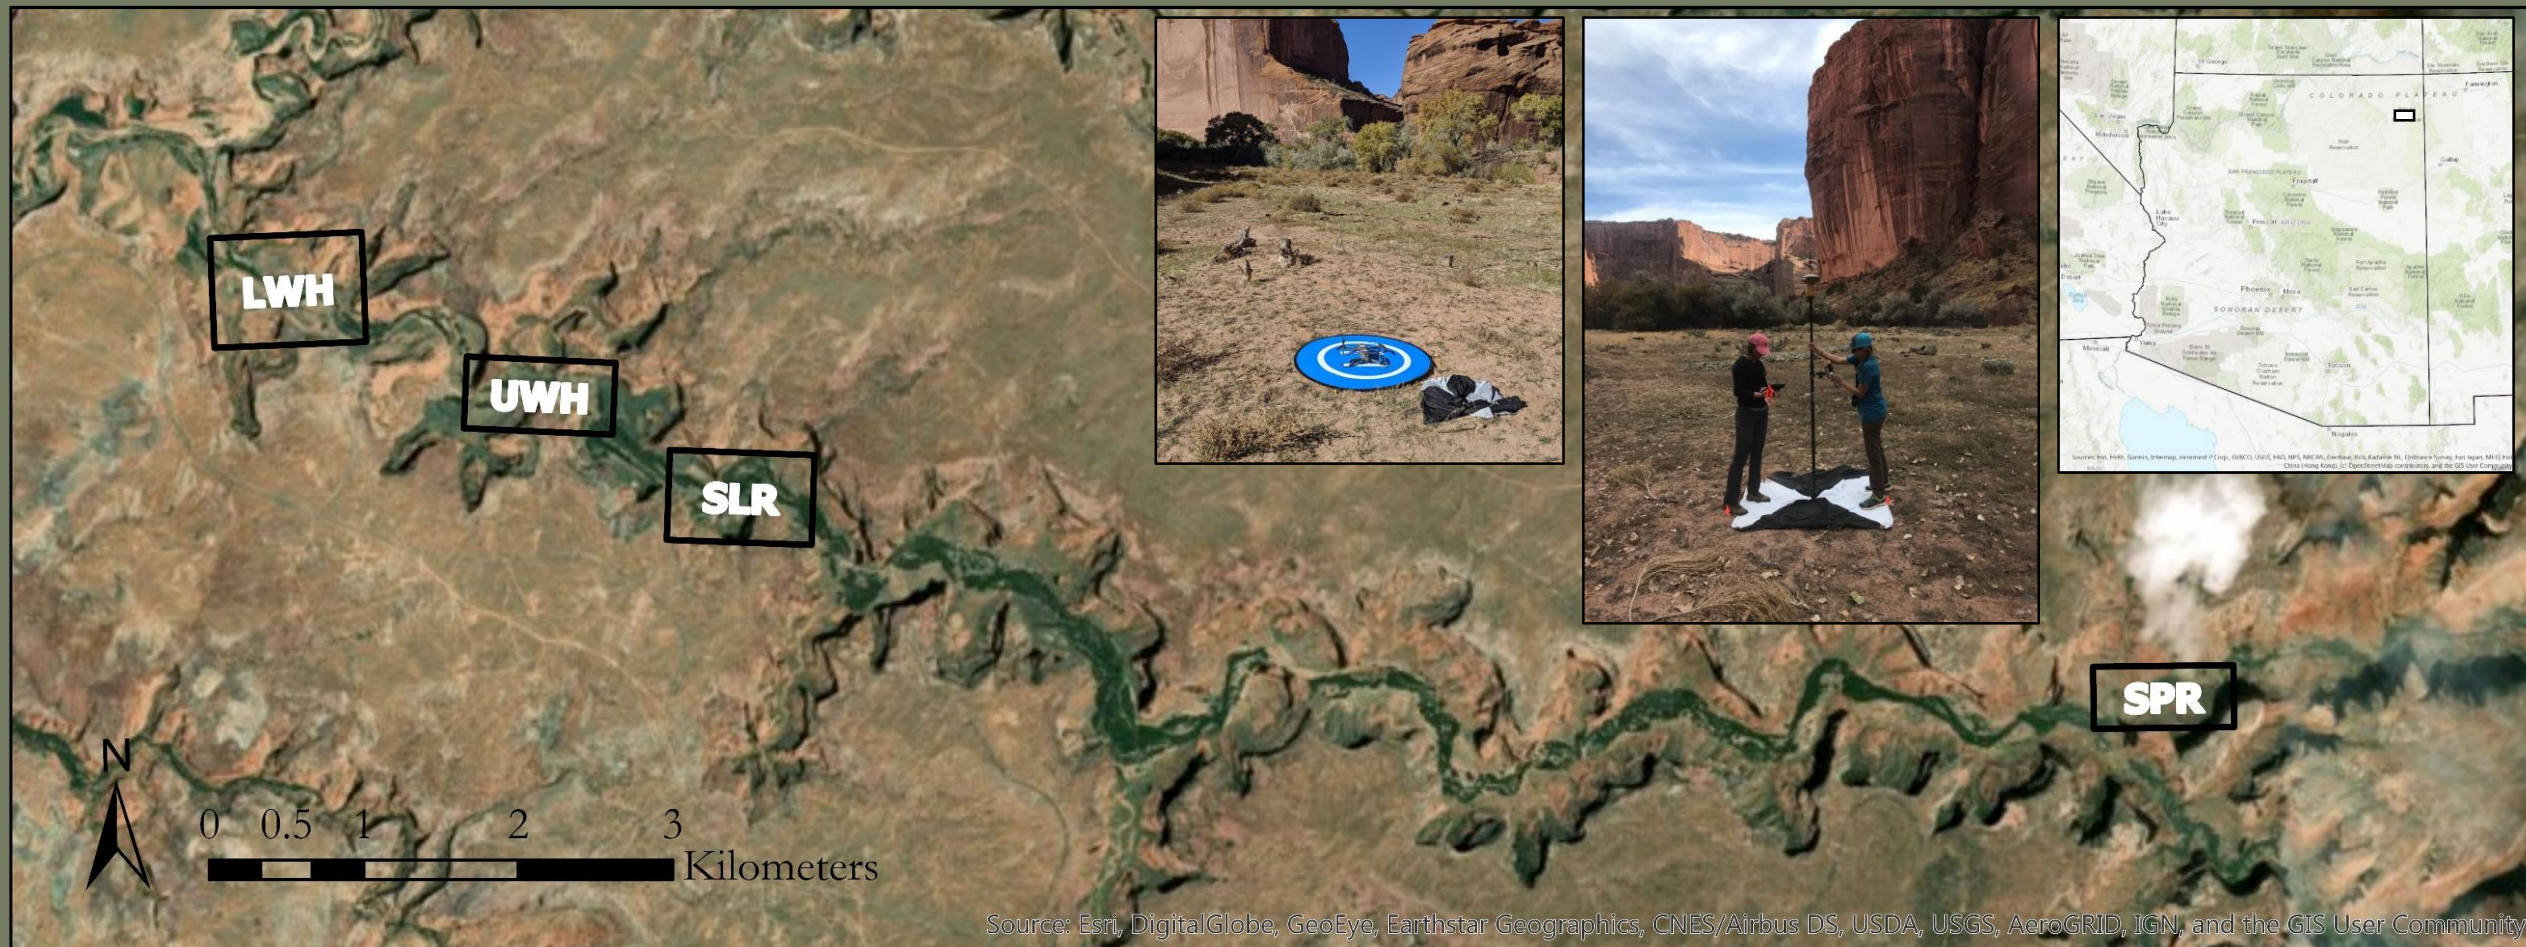
CACH XS and UAS Survey Sites

Whole plant removal, cut-stump, and control areas at each site.
