**Colorado River Section 206
Aquatic Ecosystem Restoration
Mesa County, Colorado**

Appendix B: Engineering Report

October 2012

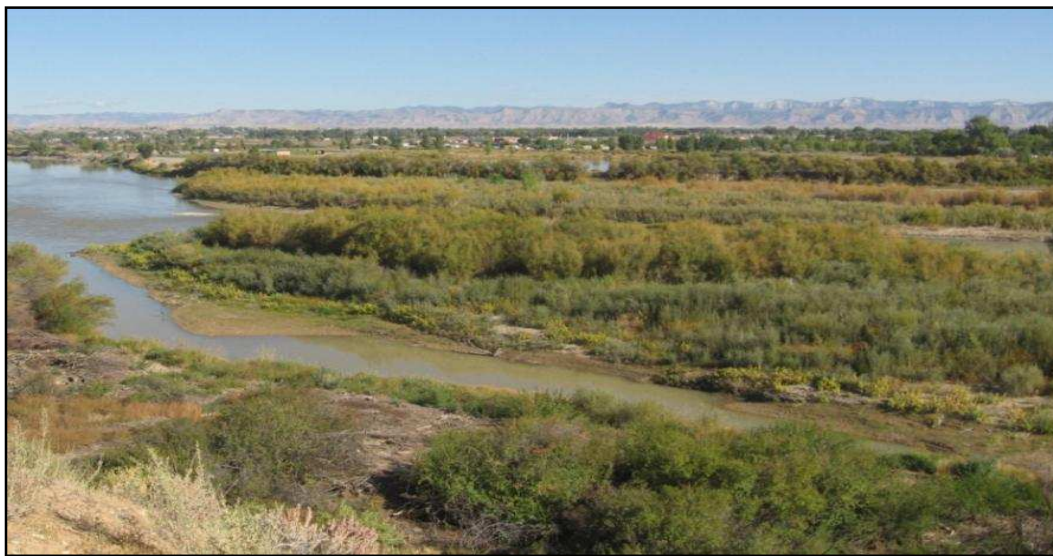
Figure 2.2 Tamarisk on the Colorado River overlooking Segment 6, illustrating an infested floodplain.

Figure 2.2 illustrates tamarisk along the Upper Colorado River while Figure 2.3 provides the mapped tamarisk infestations within the Colorado River Basin based on all available mapping and inventory data.

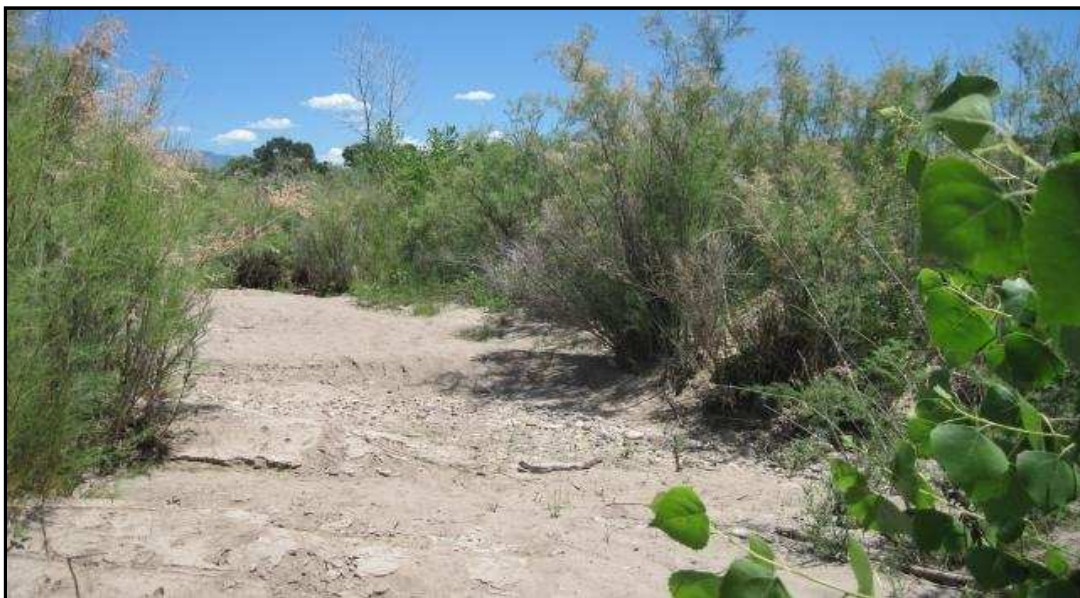
Figure 2.8 Accretion from colonizing Tamarisk on a bar, Colorado River Segment 17.

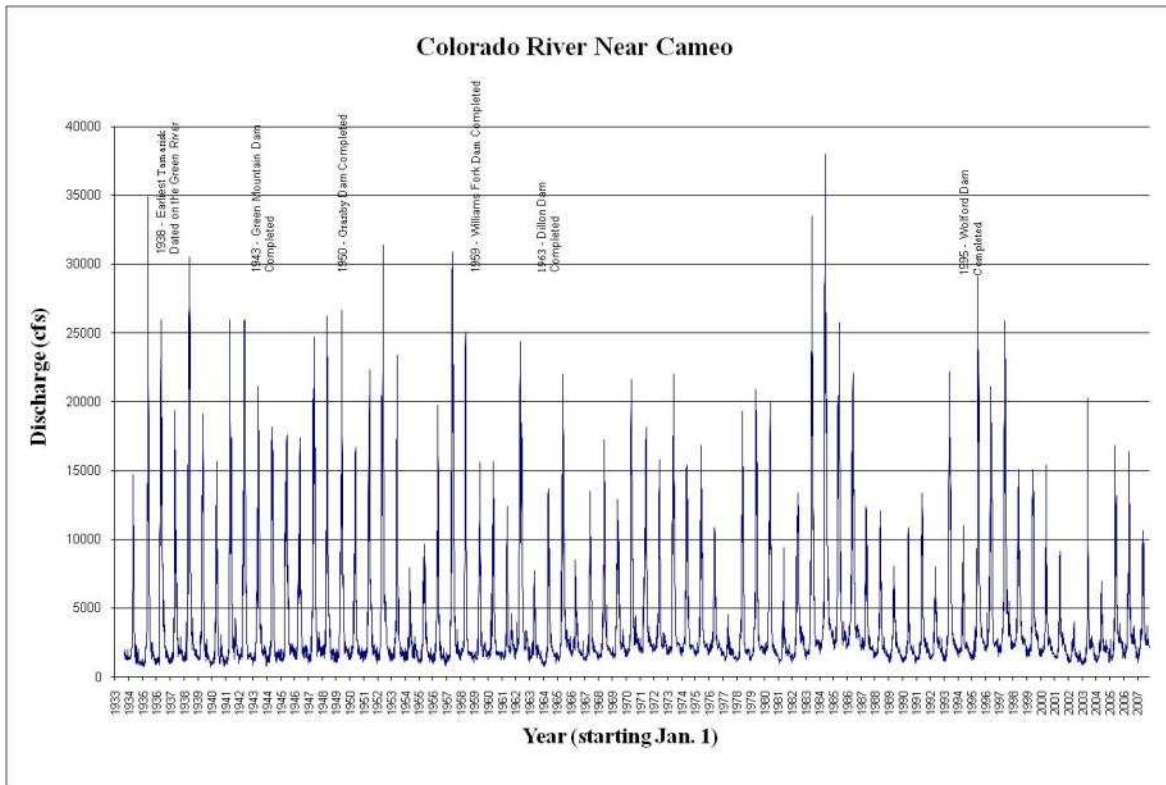
Figure 2.16 Colorado River near Cameo.

Figures 2.16 and 2.17 present the daily discharge data from two U.S. Geologic Survey (USGS) gages representing the project area. Figure 2.16, Colorado River near Cameo, presents flows in the Colorado River above the Gunnison River confluence for the period from 1933 to 2007 (74 years). Figure 2.17, Colorado River near State Line, presents flows of the Colorado River near the Colorado-Utah state line for the period from 1951 to 2007 (56 years). Figure 2.16 also includes a time line denoting the construction of various upstream dams that potentially affect the reach hydrology.

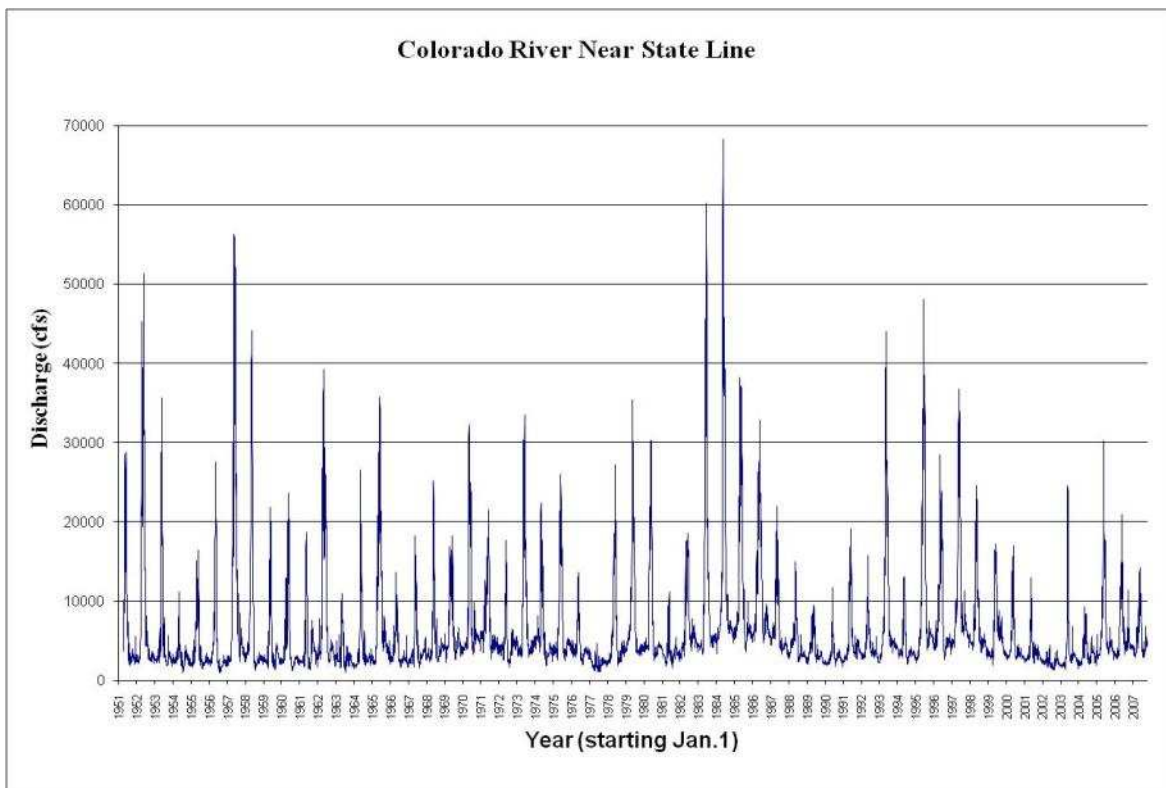
Figure 2.17 Colorado River near State Line.

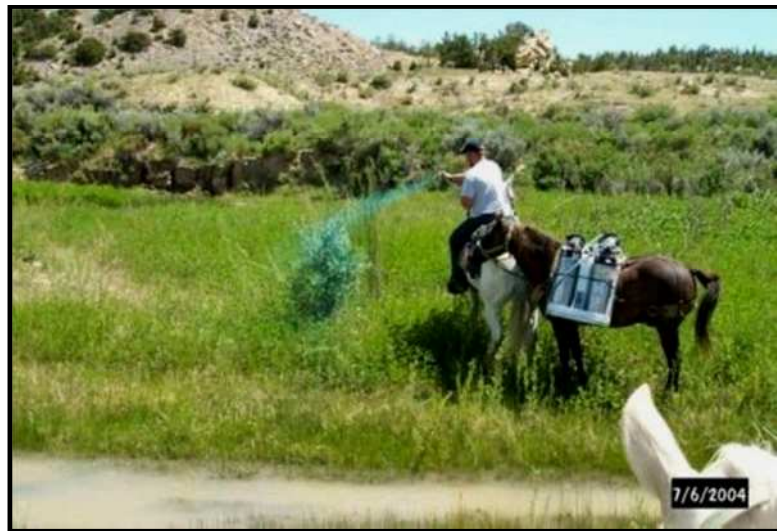
Figure 3.1 Horseback herbicide spray application. Wyoming 2004.

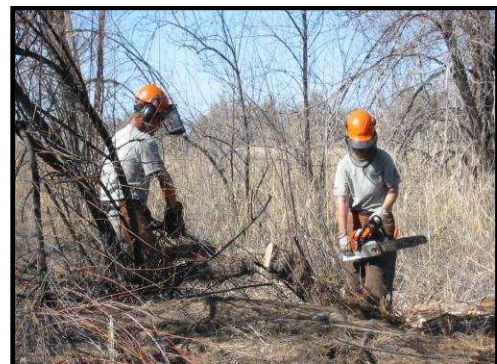
Figure 3.2 Chainsaw removal of tamarisk in Colorado with proper safety equipment.

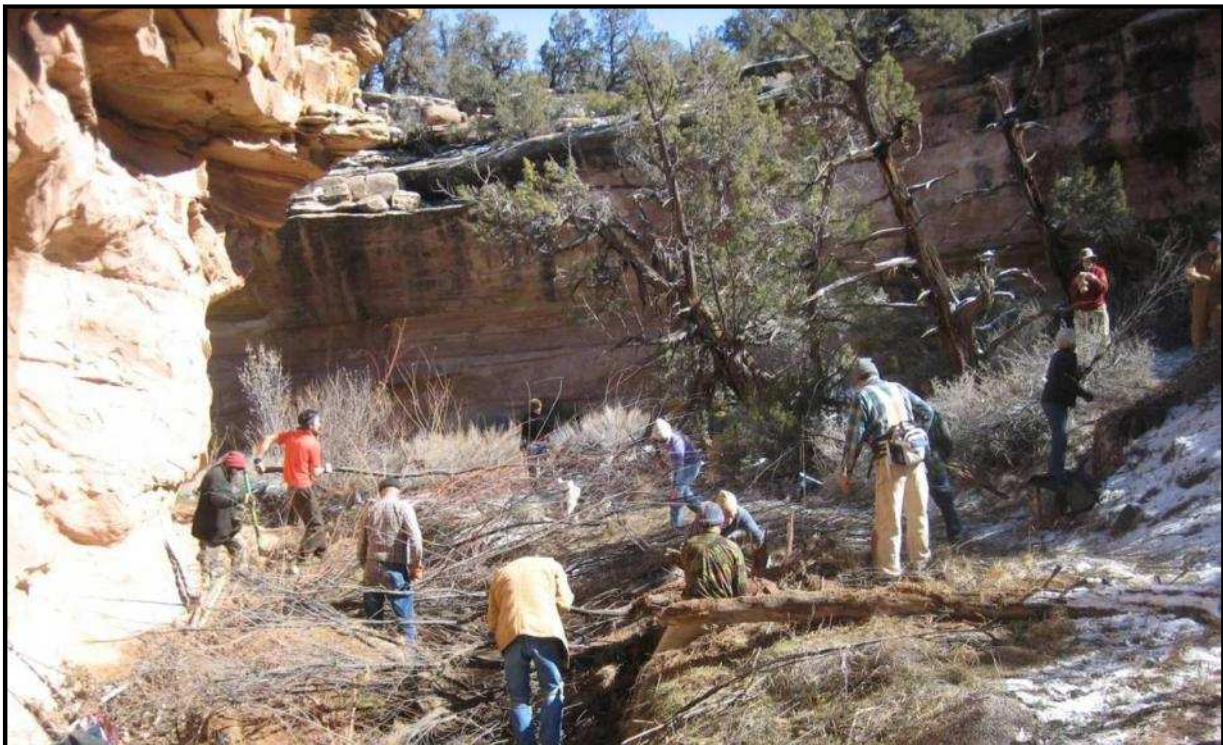
Figure 3.3 McInnis Canyons Volunteer Project western Colorado using the cut-stump removal technique near Grand Junction, 2007.

Applicability: Hand-clearing tamarisk and Russian olive is appropriate for canyons, washes, irrigation ditches, and along steep riverbanks, which have a high level of access difficulty. For moderate levels of access difficulty, hand removal will be appropriate for some areas of a work site, such as steep slopes. For volunteer projects, hand control measures using handsaws and loppers to reduce liability issues is an appropriate approach (Figure 3.3).

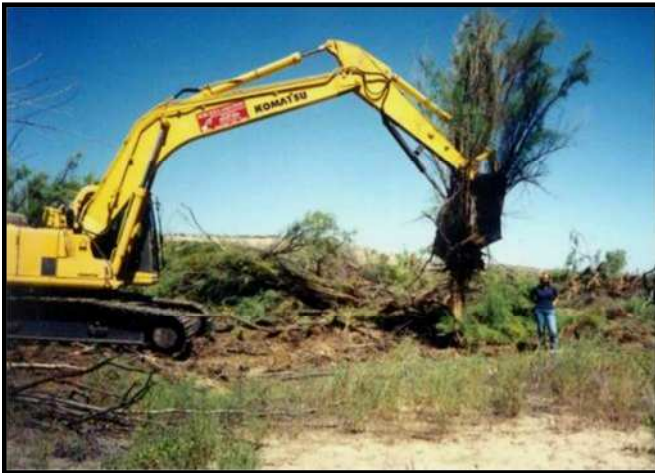
Figure 3.4 Root crown extraction using tracked excavator.

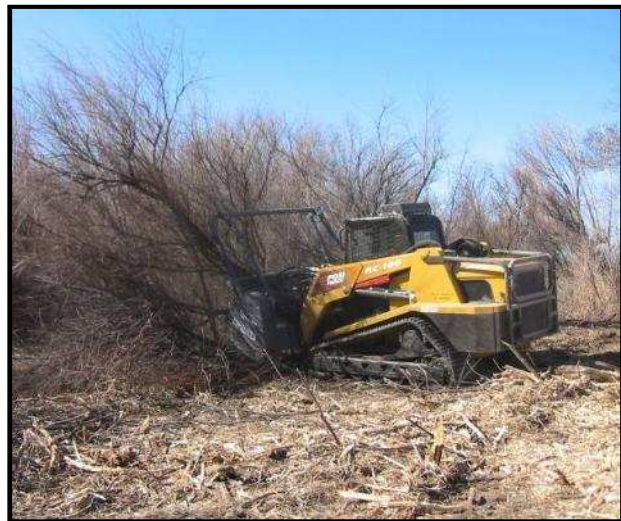
Figure 3.6 Mechanical mulching equipment.

When using a skid-steer mounted mulcher, the trees are typically mulched in a six-foot wide path at a rate of 0.25 to 1.5 acres per hour depending on density, terrain, and equipment. The resulting mulched materials can reduce soil disturbance, and provide a good seed bed for native plant recruitment if the mulched material recruitment if the mulched materials are not too thick while discouraging establishment of secondary weeds. The carrier equipment can run on track or rubber tire systems and typically range from 100 to 225 horsepower. Larger diameter trees (greater than 12 inches) occasionally require 500 horsepower equipment. Tracked mulching equipment provides a lighter footprint pressure than those with wheels and thus causes less soil disturbance.

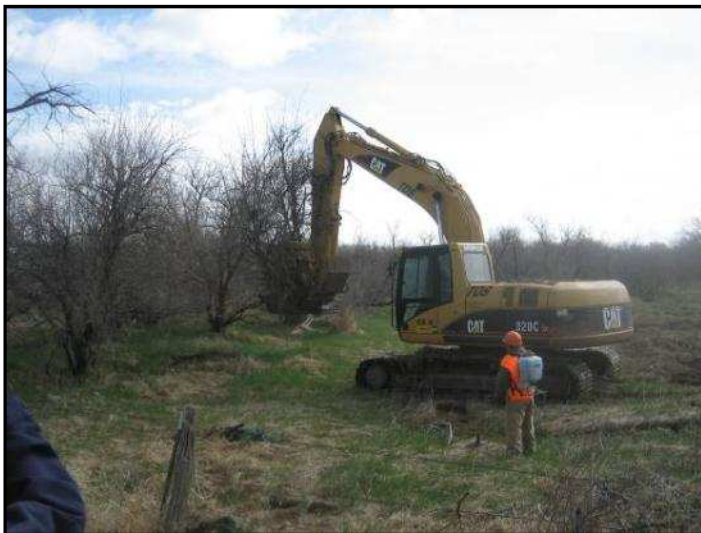
Figure 3.7 Grab and cut-stump equipment.

Grab and cut-stump – Equipment developed for the forest products industry combines a grabbing or holding device that attaches to a tree while a shear or circular saw blade cuts the tree near ground level (see Figure 3.7). Herbicide is then applied to the cut stump. This equipment is commonly called a “feller buncher” and is produced by several manufacturers as a tracked or rubber tired vehicle and can be equipped with a self-leveling capability to work in rough terrain. Recent work in Nebraska has shown this equipment’s usefulness in clearing ditches and step stream banks where other mechanical equipment could not gain access (Beyer 2007). As with

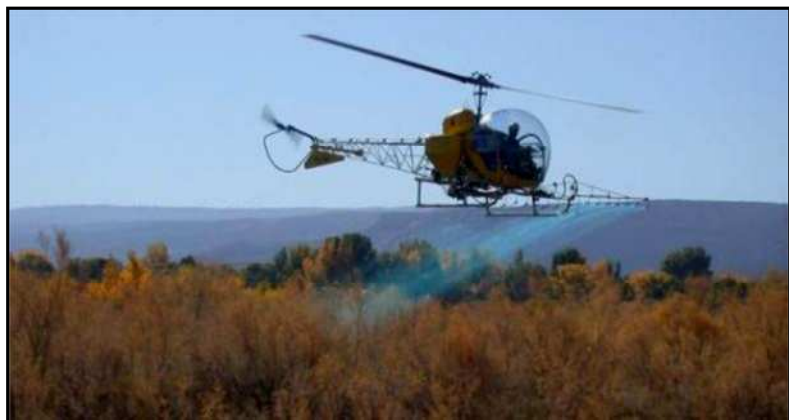
Figure 3.8 Aerial herbicide application technique being demonstrated with dyed water at 2003 Tamarisk Symposium, Grand Junction, Colorado.

Aerial herbicide application (see Figure 3.8) now uses precision agricultural spraying techniques controlled by GPS coordinates and specific flight plans to ensure that herbicide is only delivered to desired locations. Additionally, nozzle design improvements minimize herbicide drift. Herbicide can be delivered by helicopter or fixed wing aircraft. The herbicide typically used is imazapyr (Arsenal®) which has been approved for use near water (sold under the Habitat® label) in some southwestern states.

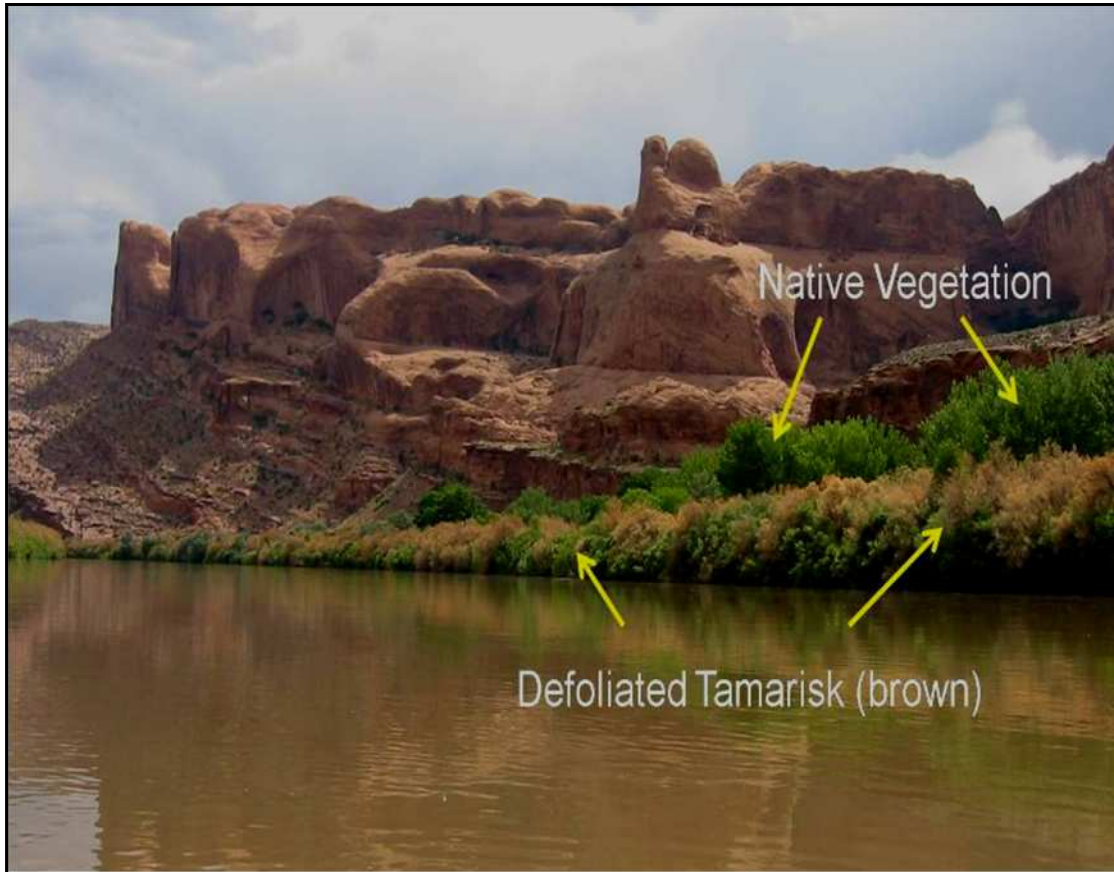
Figure 3.11 Tamarisk defoliated (brown) by tamarisk leaf beetle and non-damaged native vegetation (green), Colorado River in Canyonlands National Park, Utah 2008.

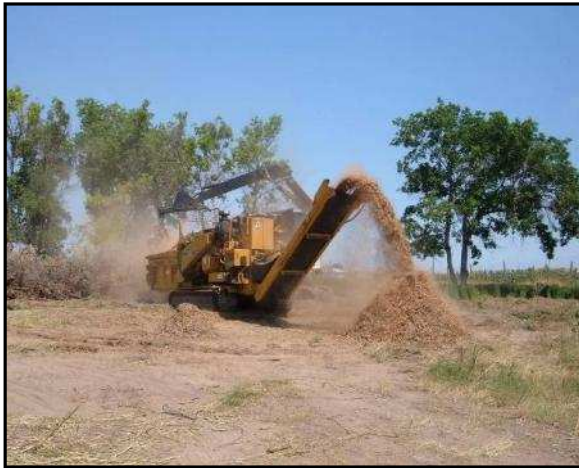
Figure 3.13 Large mulching equipment.

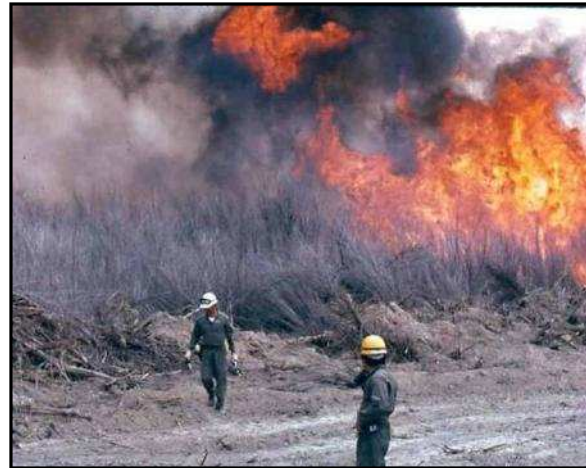
Figure 3.14 Controlled fire for dead tamarisk.

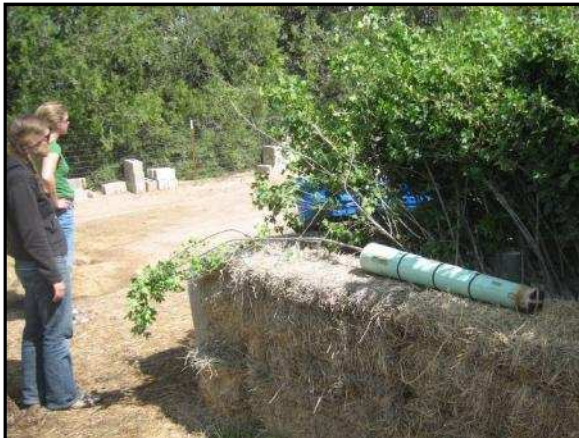
Figure 3.17 Example of long-stem plant in container.

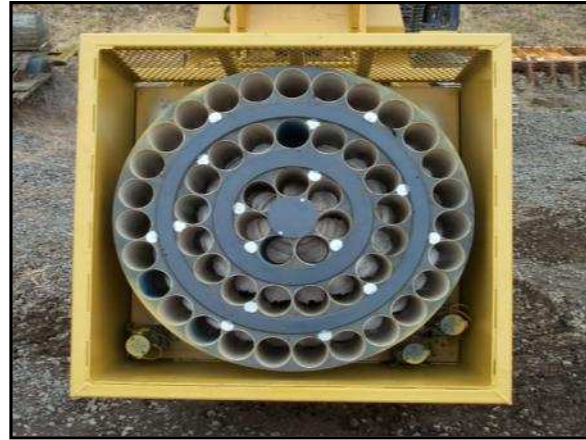
Figure 3.20 Plant container portion of Rotary Stinger.
