Restoration and Monitoring Plan for Native Fish and Riparian Vegetation on the San Rafael River, Utah

15 July 2013

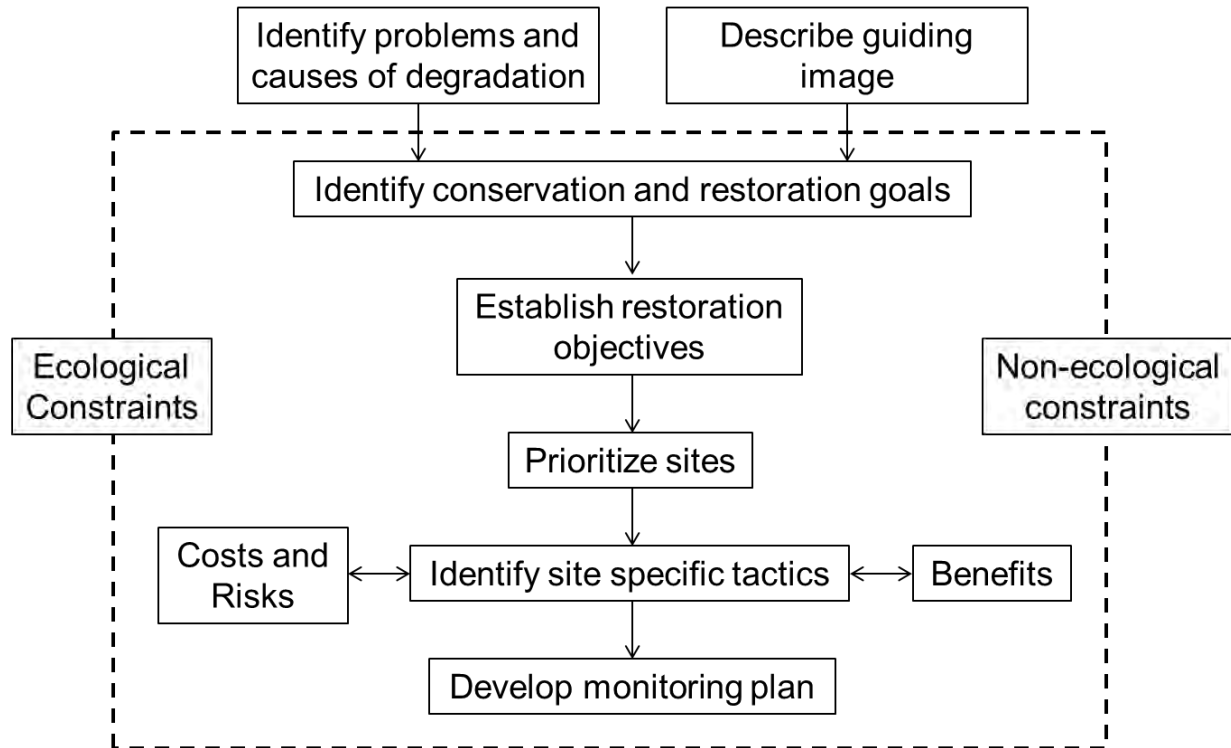
Figure 1. Diagram of the planning process that was followed in developing the San Rafael River restoration plan. Figure adapted from Figure 1 of Shafroth et al. (2008).

An important first step in the restoration planning process is to document the degraded state of the river and identify the causes of degradation (see Fig. 1). In this section of the restoration plan, the history of channel and floodplain geomorphic changes are summarized and

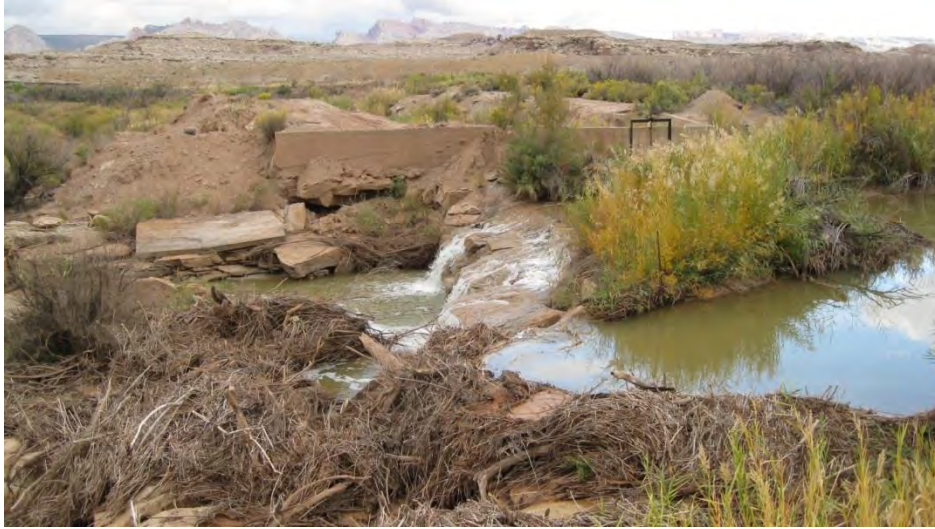
Figure 5. Picture of Hatt's Ranch diversion dam, which is a barrier to upstream fish movement. The dam is located on bedrock and was constructed in its current location in the early 1950s. Photo by B. Laub on October 12, 2012 at a flow of 18 cfs.

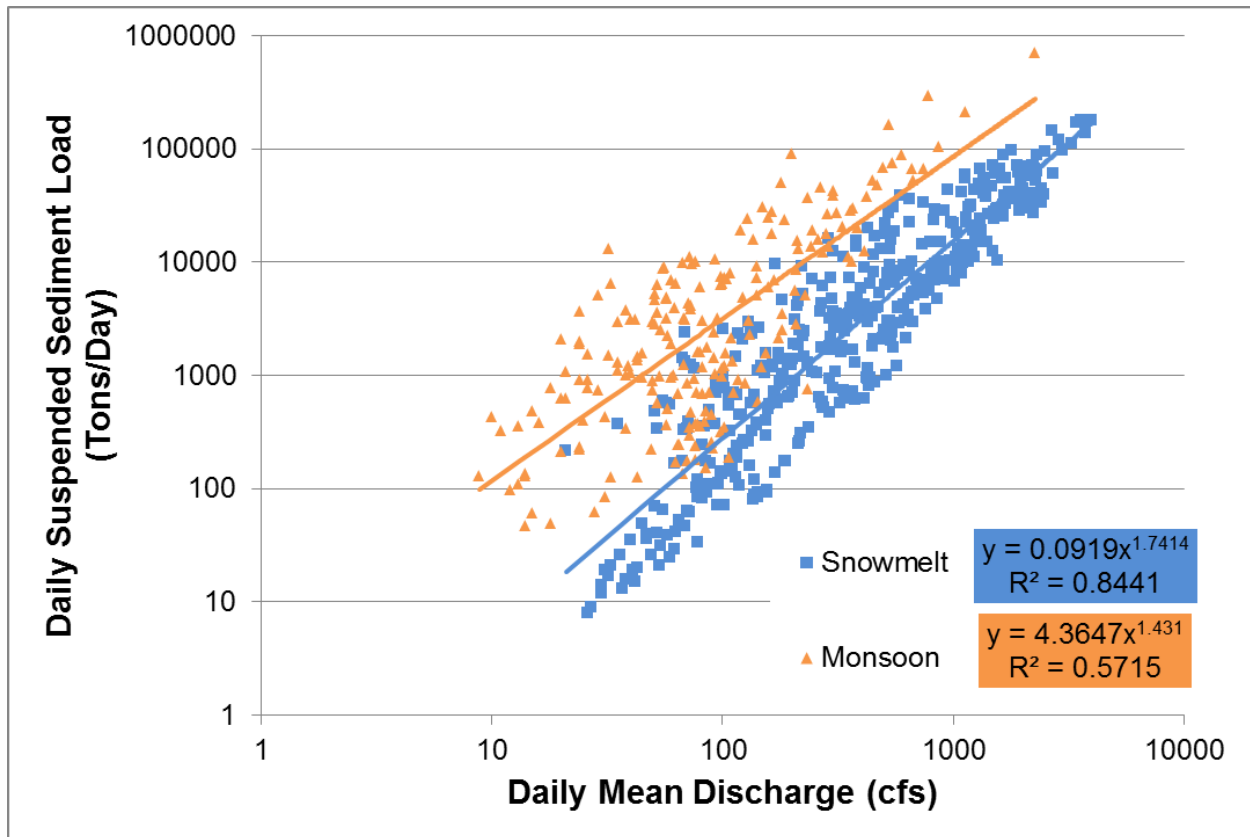
Figure 7. Suspended sediment rating curves measured in 1949 and 1951-1958. Flood types were distinguished on the combination of season and flood duration. In general, snowmelt floods occurred in spring and monsoon floods occurred in summer.

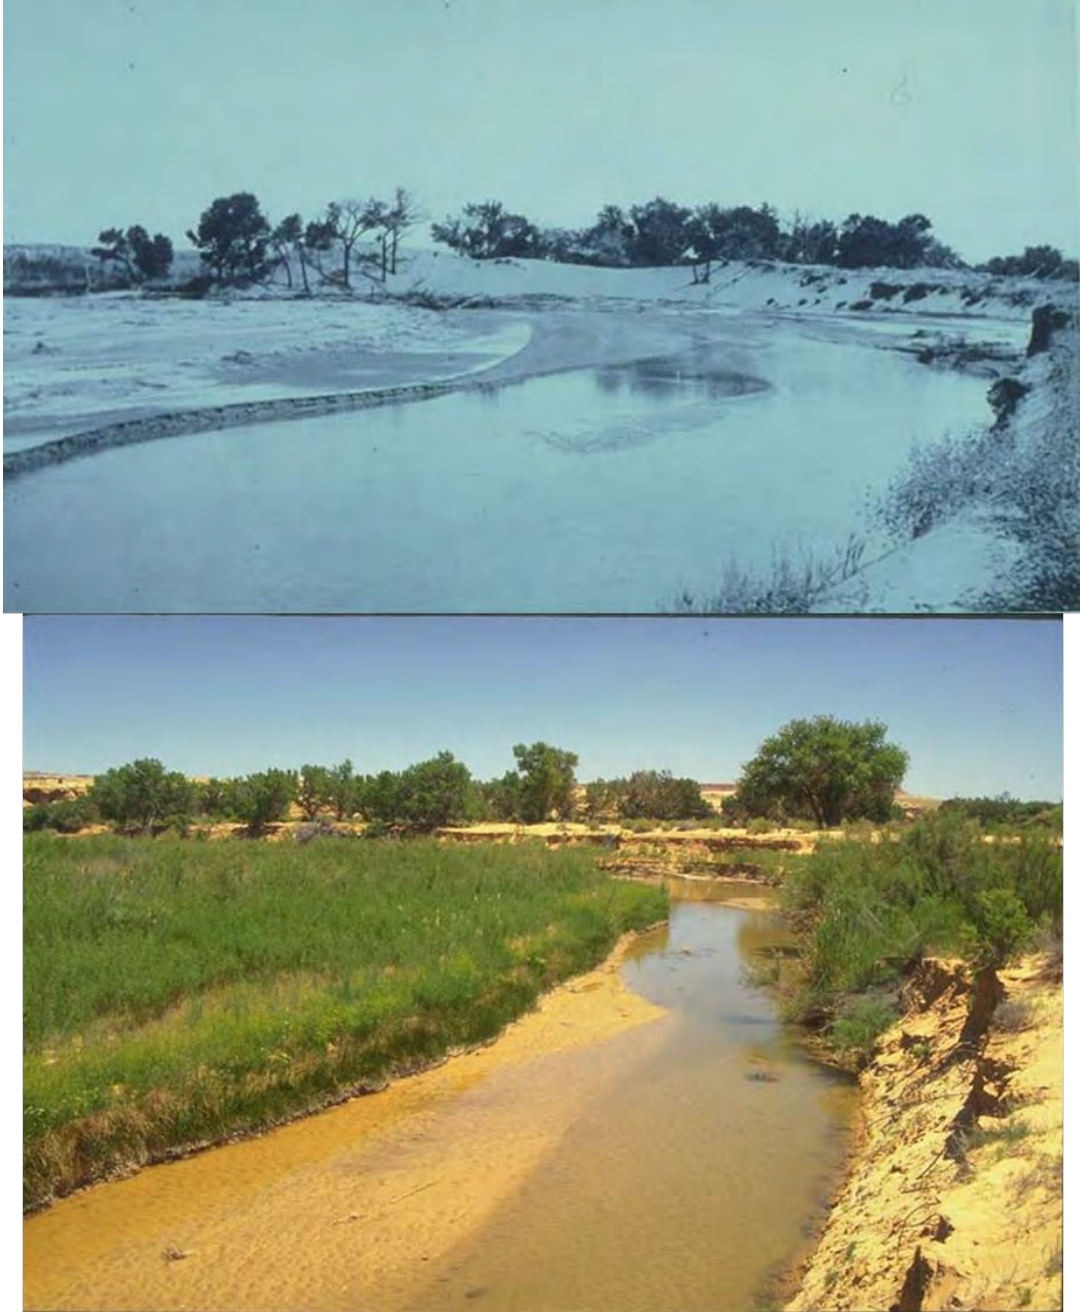
Figure 8. Pictures showing channel changes just upstream of Cottonwood Wash on the San Rafael River (photos are looking downstream toward Cottonwood Wash). The top photo shows the channel in 1917 (photo by W. B. Emery) and the bottom photo shows the channel in 1994 (photo by E. Hindley). Note the unvegetated bar on the left side of the 1917 picture and the wide active channel. In the bottom photo, vegetation has colonized the bar and the channel is confined within high vertical banks. The confinement into a narrow, deep channel is a result of sediment deposition and stabilization by vegetation within the former active channel and deposition on the floodplain which has caused vertical floodplain aggradation and the formation of riparian berms (see Fig. 10). The channel in this location was abandoned in 2011 as a result of a meander cutoff event (see Figs. 14 and 37).

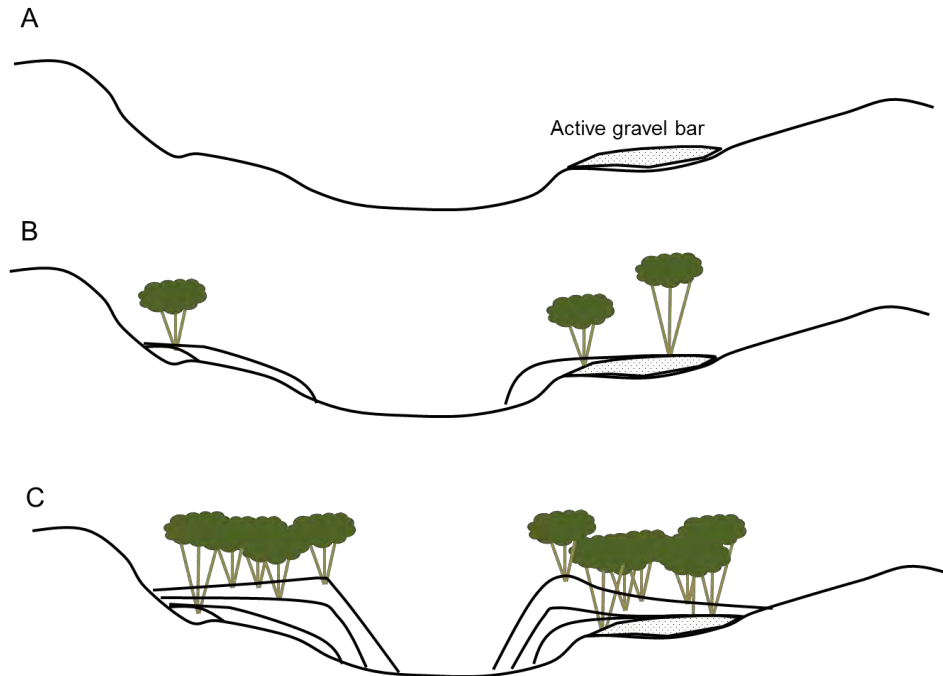
Figure 9. Generalized schematic of channel changes on the San Rafael River. In the top figure (A), the active channel is wide and maintains gravel bars free of vegetation. As spring flood flows decrease in magnitude, duration, and frequency, vegetation, including non-native tamarisk, is able to colonize gravel bars and floodplain deposits and the channel begins to narrow (B). Continued deposition due to monsoon floods further promotes floodplain accretion, formation of riparian berms, and channel confinement (C). Note that the channel elevation has remained the same and there is now an inset floodplain occupying the former active channel.

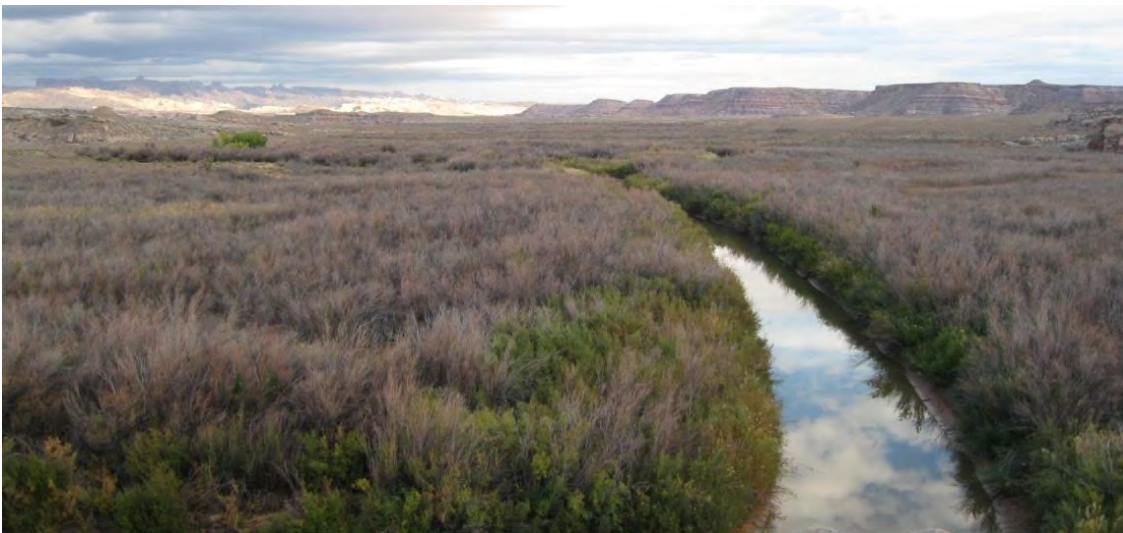
Figure 11. Picture looking upstream of Hatt’s Ranch diversion dam. Note the general lack of cottonwood and willow overstory cover and the abundant tamarisk, which has been defoliated by the tamarisk leaf beetle. Picture taken by B. Laub on October 12, 2012.

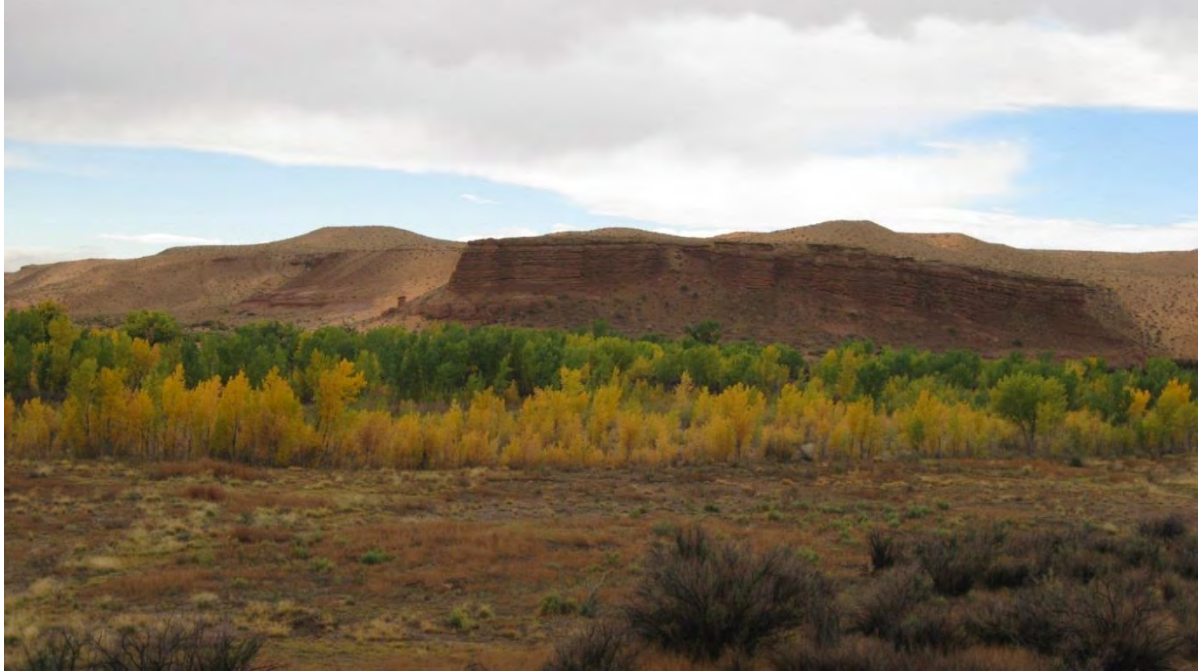
Figure 12. Picture taken at Frenchman's Ranch showing a stand of cottonwood trees of multiple age classes. The low abundance of tamarisk in this picture is due to a tamarisk removal effort carried out by Utah Division of Wildlife Resources (UDWR). Photo taken by B. Laub on October 12, 2012.

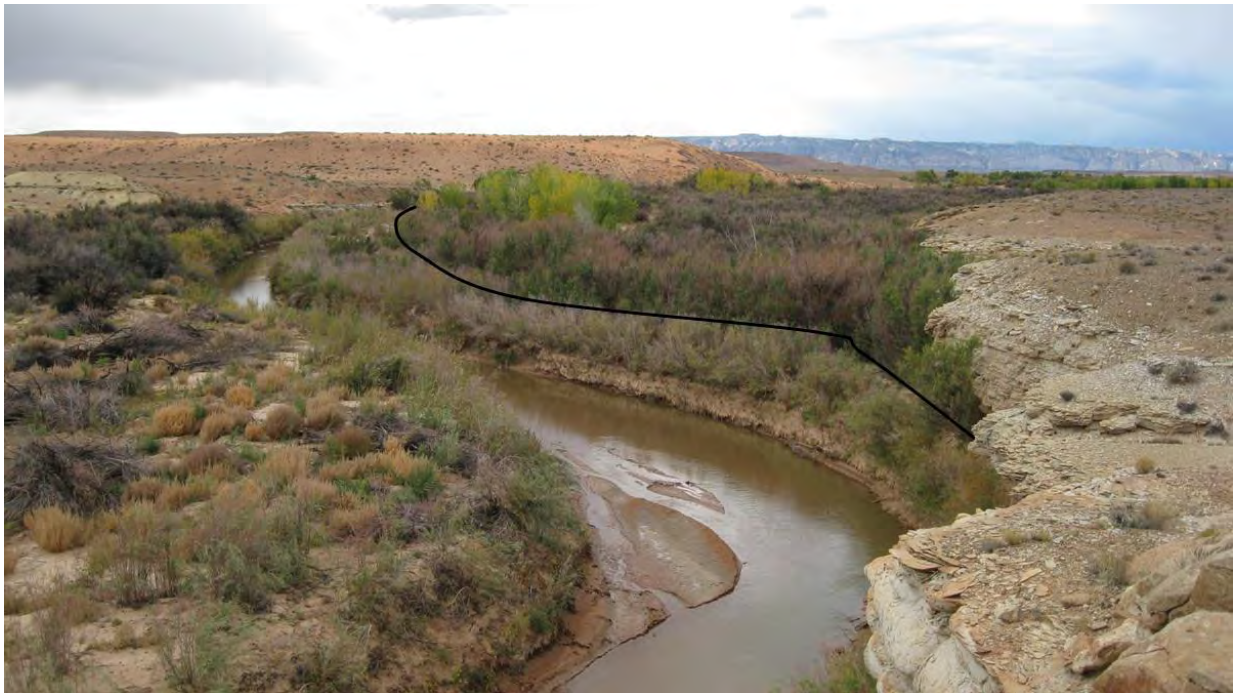
Figure 13. Picture looking upstream toward Dugout Wash. Note the band of willows and other vegetation along the riparian berm and the thick tamarisk stand that occupies much of the floodplain. Photo taken by B. Laub on October 12, 2012.

riparian seedlings (Engel-Wilson and Ohmart 1978, Di Tomaso 1998, Smeins 2003). Although no studies have formally determined whether the abundance of willow or cottonwood has declined along the San Rafael River from the early 1900s, replacement of native vegetation by tamarisk appears to have occurred in at least some places on the San Rafael River. In particular, the section between the San Rafael Reef and Hatt's Ranch dam contains very few cottonwood trees but thick tamarisk stands (Fig. 11). However, cottonwood stands with multiple age classes are found on other reaches of the river on the lower floodplain surface (Fortney 2013a; Fig. 12), indicating that tamarisk has not completely eliminated cottonwood recruitment. In addition, stands of willow and native phragmites are abundant along the riparian berms in many places throughout the lower San Rafael River, and tamarisk stands are generally set back from the channel edge and occupy much of the floodplain (Fig. 13).

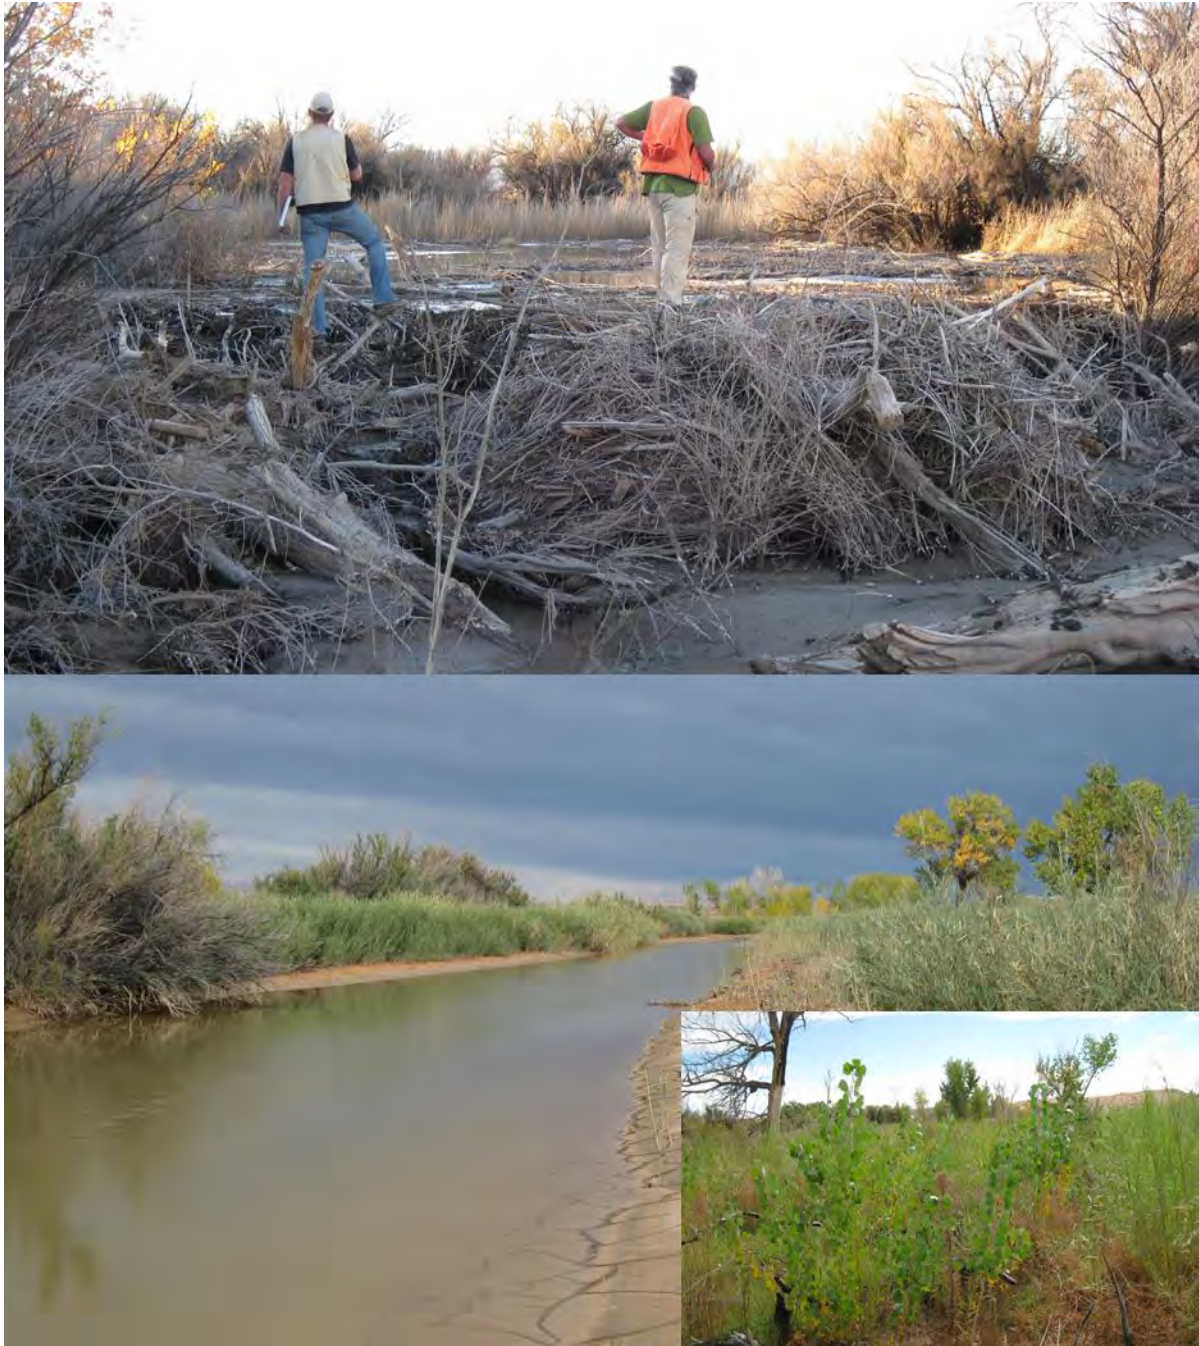
Figure 14. Impacts of a beaver dam on cottonwood recruitment. The top panel shows a beaver dam upstream of the confluence with Cottonwood Wash (note riparian ecologists for scale). Photo taken by B. Laub on November 7, 2012. The bottom panel is a picture of the channel upstream of the beaver dam, looking upstream, taken by B. Laub on October 12, 2012. As seen in the bottom panel, the dam backed up water in the channel and likely aided cottonwood recruitment in this area (shown in inset, taken by B. Laub on October 12, 2012).

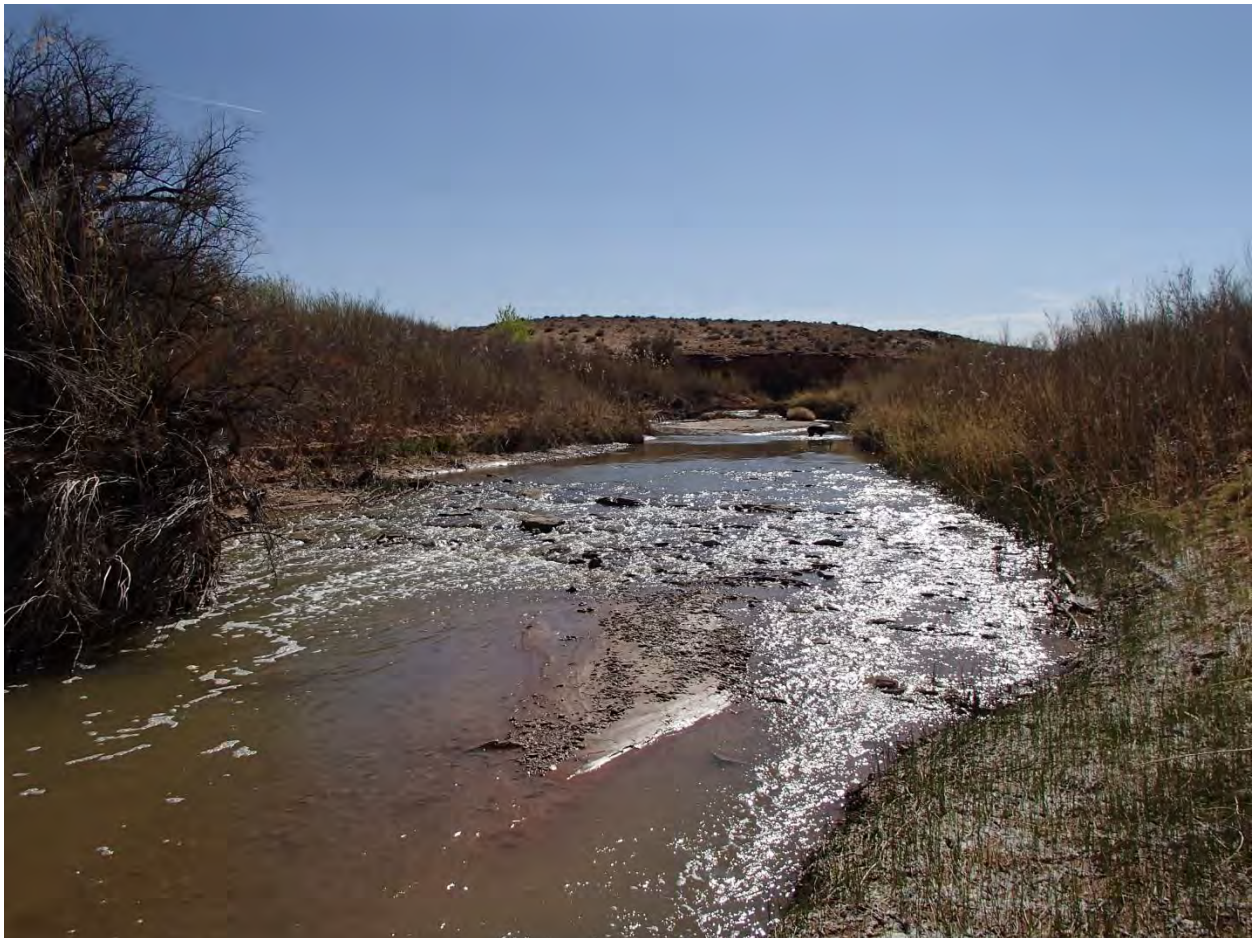
Figure 16. Picture looking upstream toward the confluence of Spring Canyon, showing the riffles and bars formed by the tributary junction. Photo taken by B. Laub on May 2, 2013.

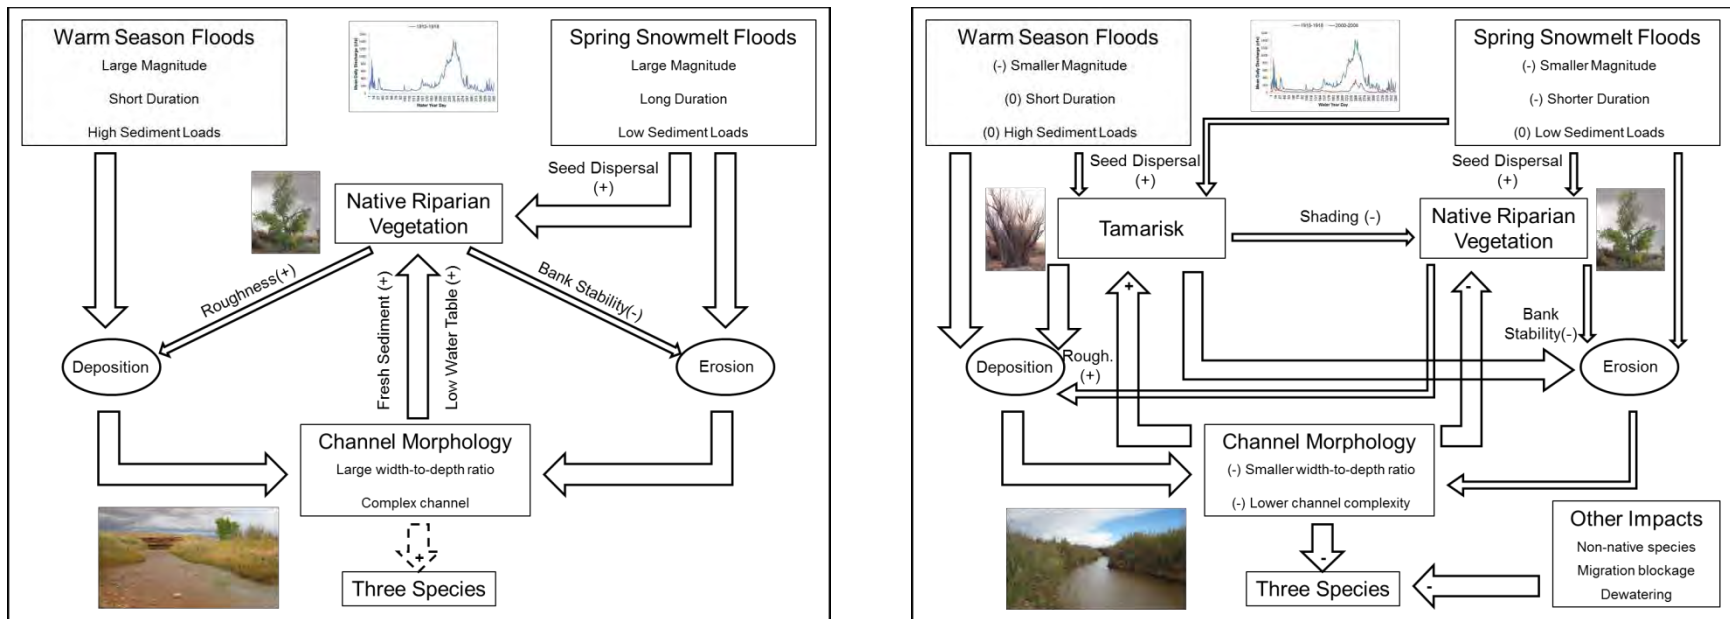
Figure 18. Conceptual model summarizing hydrological, channel, vegetation, and fish assemblage changes on the lower San Rafael over the last century. The left panel shows the state of the river in the early 20th century, prior to hydrological development within the watershed. The right panel shows the state of the river today. The right panel also gives the direction of change of hydrological and channel morphology properties as a result of water development: (+) indicates an increase, (-) a decrease, and (0) no significant change. State variables are shown in boxes and processes in circles. Arrows indicate direction of influence and arrow thickness gives relative strength of influence. Descriptions associated with arrows indicate the method of influence and whether the influence leads to an increase (+) or a decrease (-) in the state or process variable. The dashed arrow between channel morphology and three species in the left panel indicates that channel morphology (represented by the picture in the lower left corner of each panel) in the early 20th century is assumed to provide high quality habitat for the three species, but this has not been tested explicitly due to lack of data on fish populations from this time period.

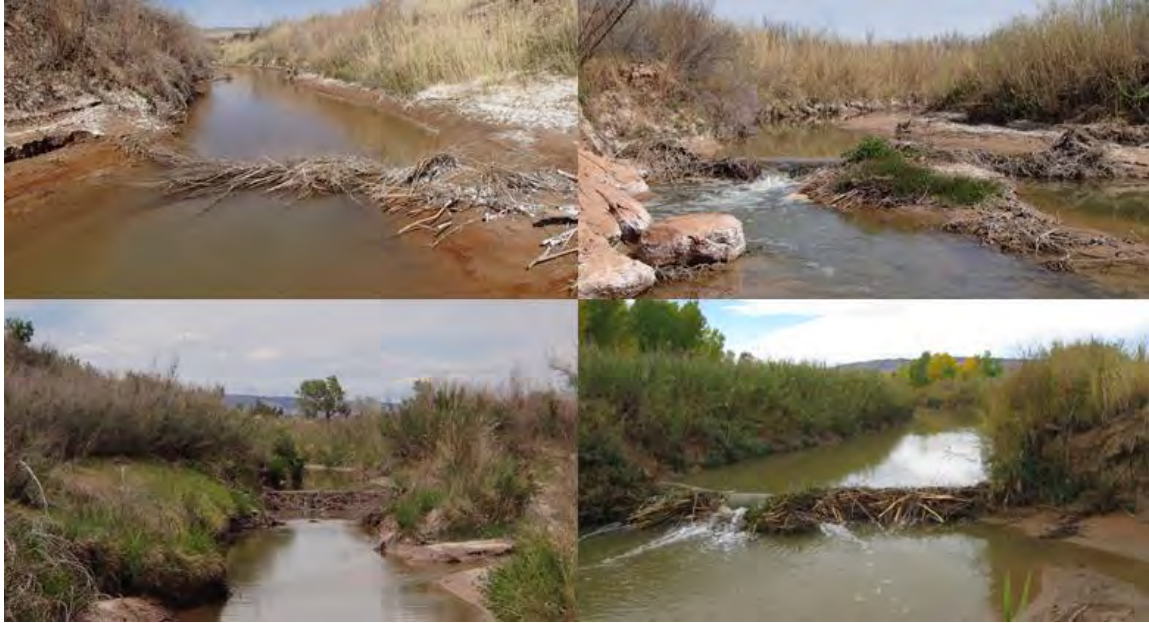
Figure 26. Pictures of four different active beaver dams observed on the San Rafael River in 2012 and 2013. Clockwise from top left locations are: reach 32, Tidwell Bottom, reach 47 (see Fig. 35), and just upstream of the Dugout Wash confluence. All pictures by B. Laub.

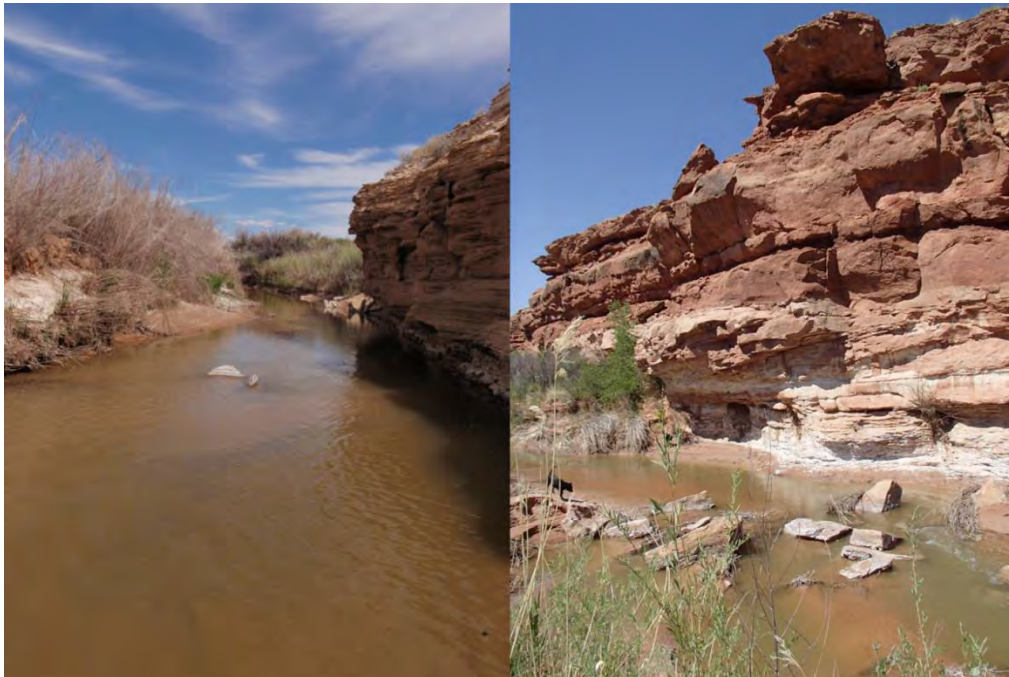
Figure 27. Pictures showing the intended effect of large substrate addition. Picture on the left shows a reach where the channel flows along the valley margin but there is a lack of large substrate in the channel and little channel complexity (Photo looking downstream below confluence of Dugout Wash, taken by Dave Dean on May 21, 2013). In the picture on the right, substrate has fallen from the cliff wall into the channel and is creating complex fish habitat (Photo looking upstream near Moonshine Wash, taken by B. Laub on May 22, 2013).

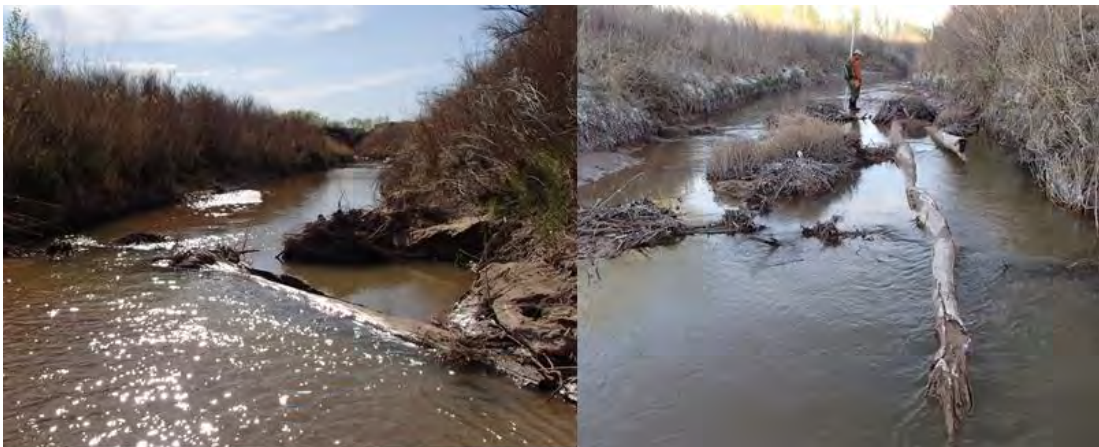
Figure 28. Pictures showing the intended effects of large wood additions to the channel. In both pictures, large logs and other wood accumulations in the channel create variations in flow and depth in an otherwise straight, generally uniform channel.

In addition to the channel changes exacerbated by tamarisk and other floodplain vegetation encroachment, alteration of native vegetation communities has likely impacted in-stream ecological processes and wildlife communities as well. Replacement of native vegetation, particularly large cottonwoods, by tamarisk may have negatively impacted habitat for native fish on the San Rafael River by reducing the amount of large wood and wood accumulations in the river. Analyses of aerial imagery and on-the ground observations have found that wood accumulations and large pieces of wood, primarily large cottonwood trees, increase channel complexity and provide important fish habitat including scour pools, backwaters, and overhead cover (Keller 2012 – attached as Appendix IV, see also Fig. 28).

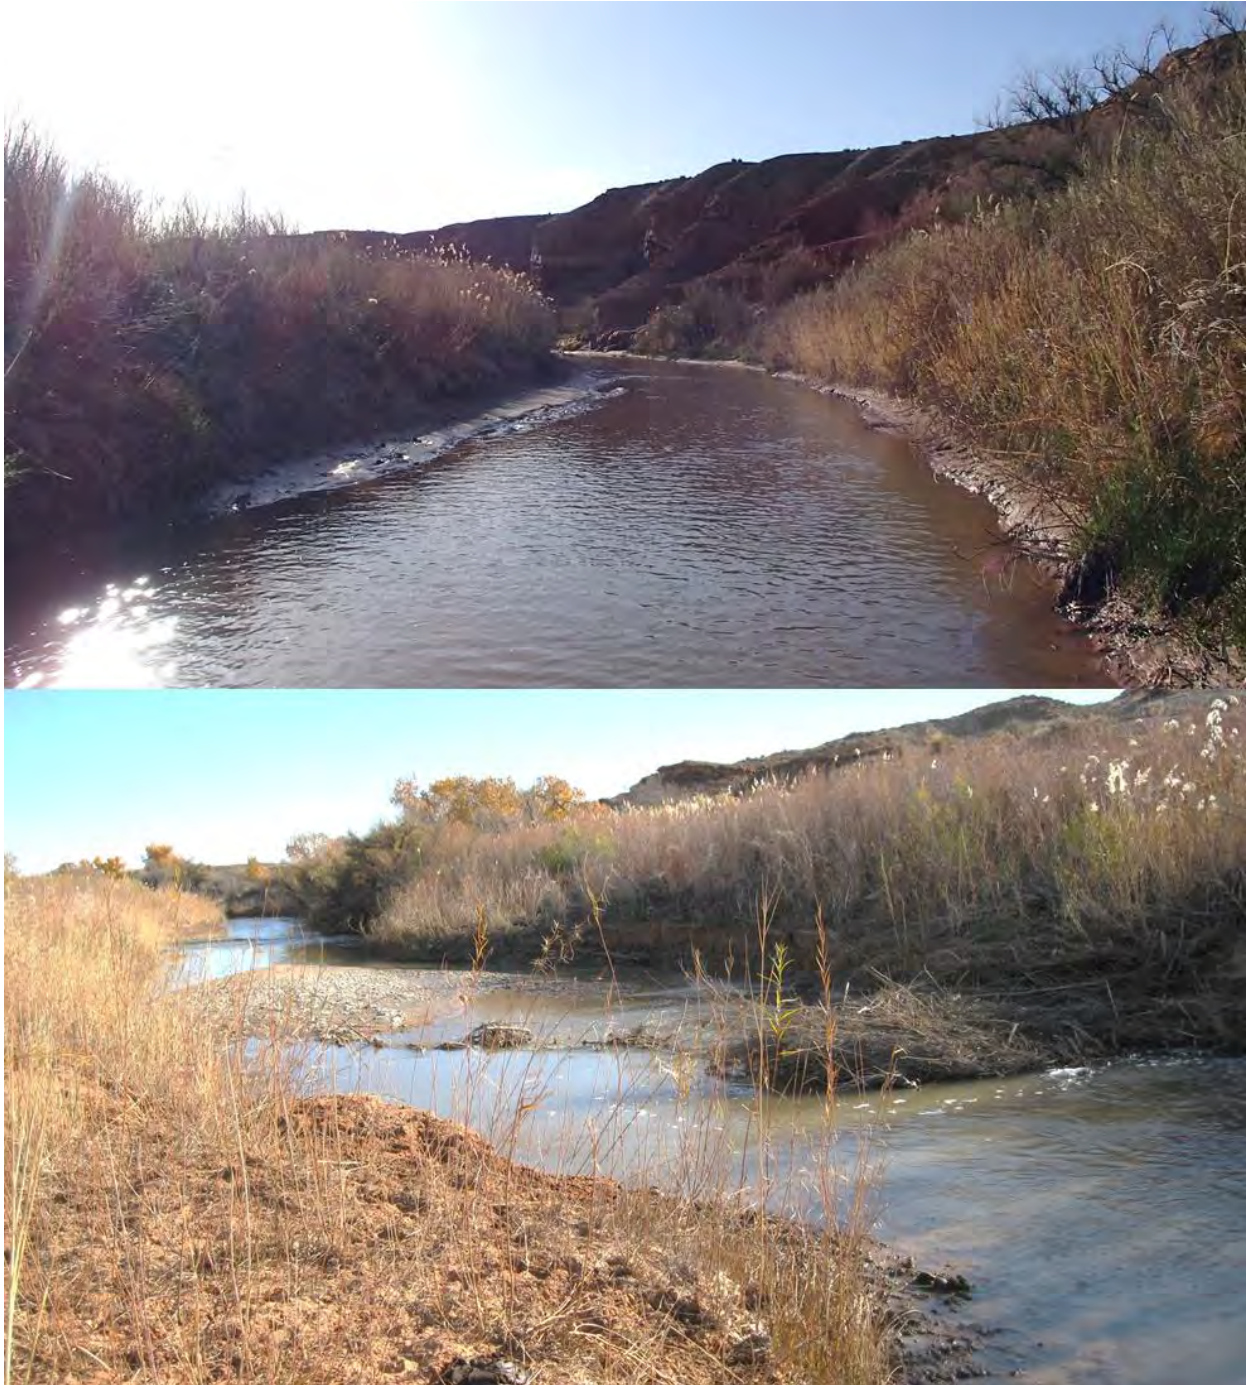
Figure 29. Pictures showing intended impact of gravel addition on channel morphology and fish habitat. The top picture shows the channel just upstream of the Spring Canyon confluence and is straight and confined with little channel complexity (View is upstream, taken by B. Laub on May 2, 2013). The bottom picture is downstream of Spring Canyon, which delivers gravel to the San Rafael River. The channel below the confluence has riffle-pool sequences, gravel bars, and a much-less confined channel (View is downstream, taken by B. Laub on November 7, 2012). Gravel addition is intended to mimic the impacts of this tributary input.

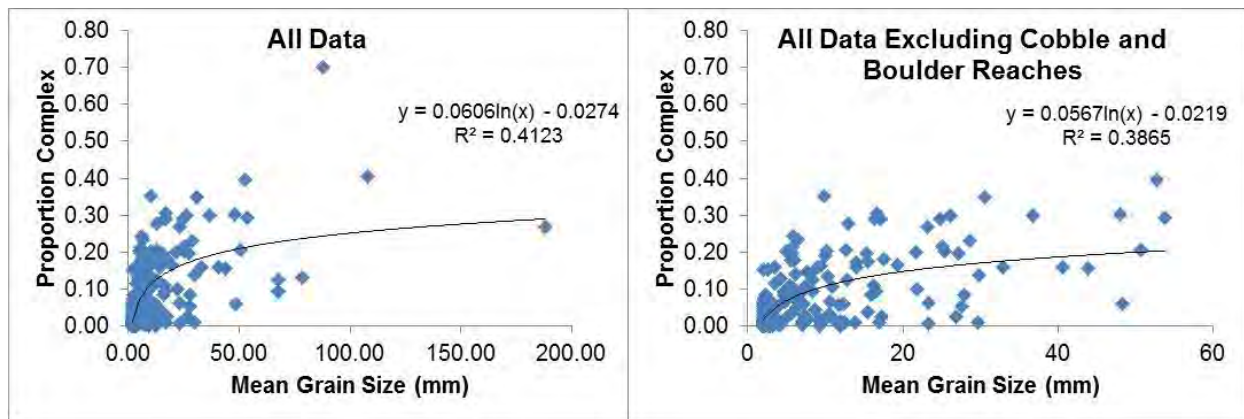
Figure 31. Relationship between mean grain size of a 300-m reach and proportion of the reach composed of complex fish habitat (pools, riffles, and backwaters). Left graph shows data for all reaches between Hatt’s Ranch dam and the Green River. Right graph excludes reaches containing cobble and boulder substrates.

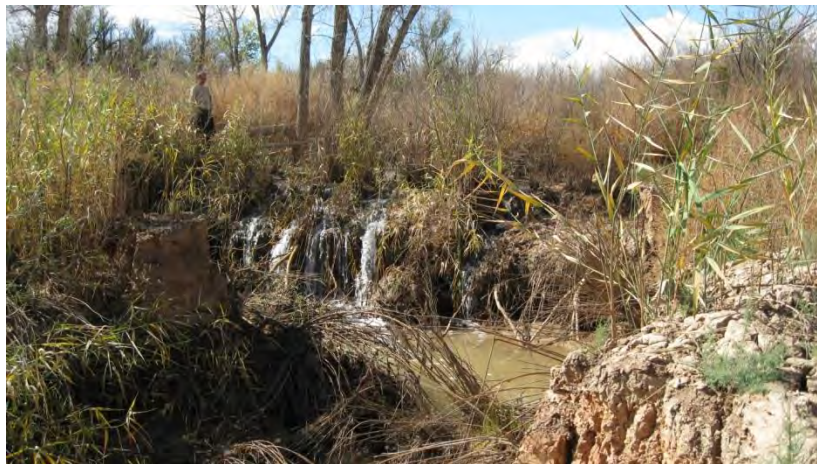
Figure 32. Photograph of a knick point on the San Rafael River in the vicinity of Cottonwood Wash. Photo taken by B. Laub on October 12, 2012.

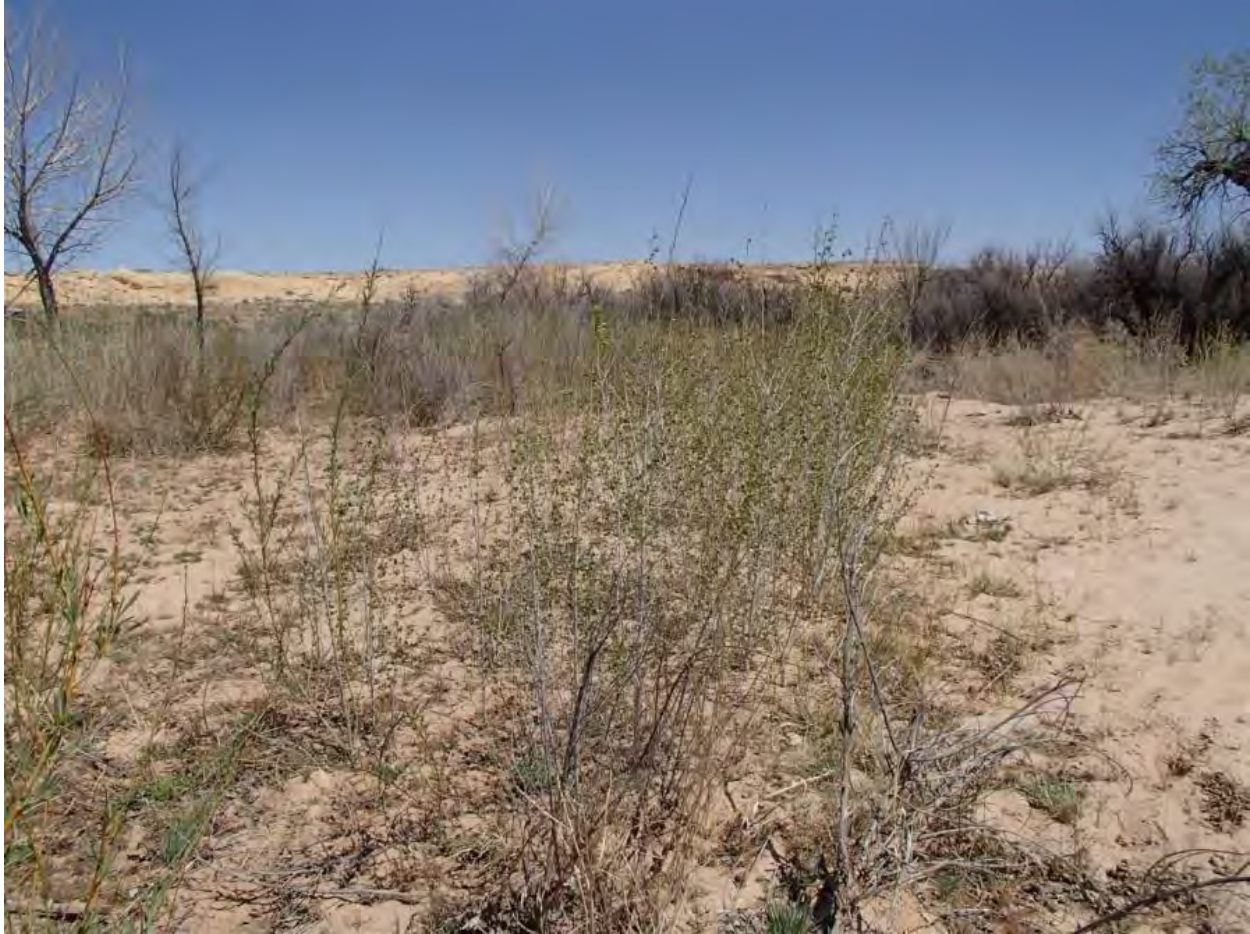
Figure 38. Photograph showing cottonwood recruitment in the Cottonwood Wash section. Photo taken by B. Laub on May 2, 2013.

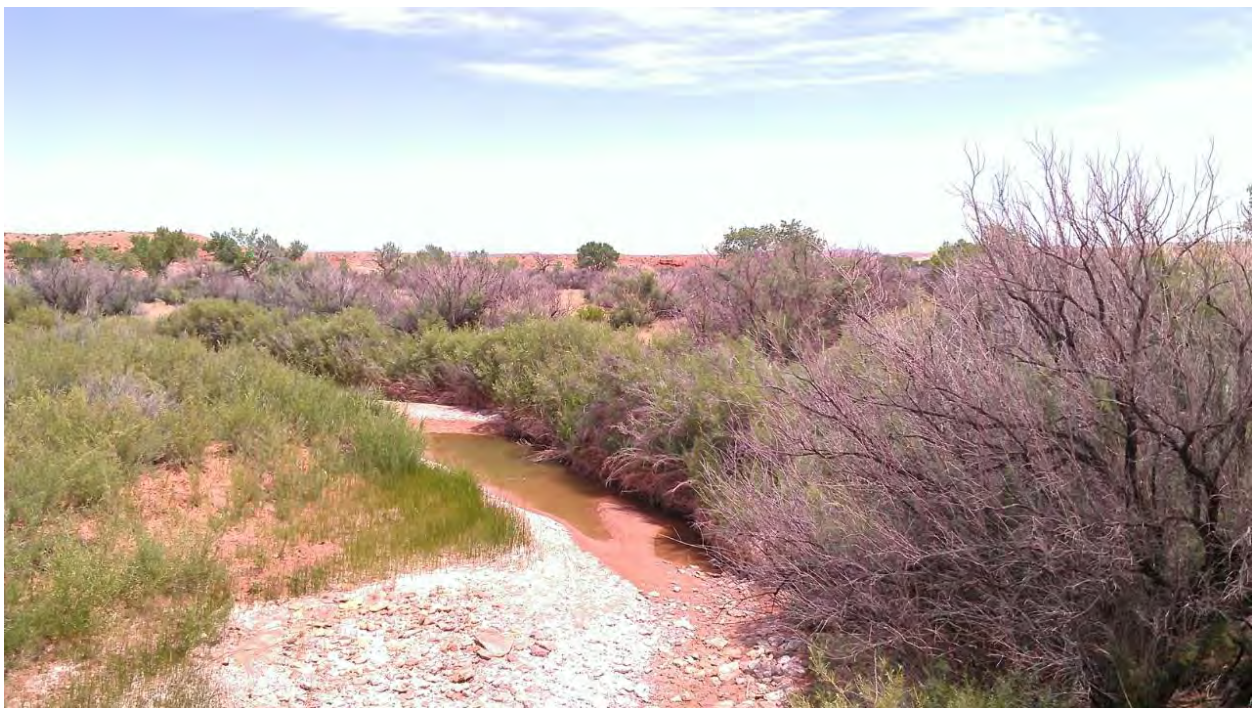
Figure 39. Picture of the San Rafael River looking downstream from the Lower San Rafael River Road bridge showing an isolated pool in an otherwise dry channel. Photo taken by B. Laub on June 23, 2013.

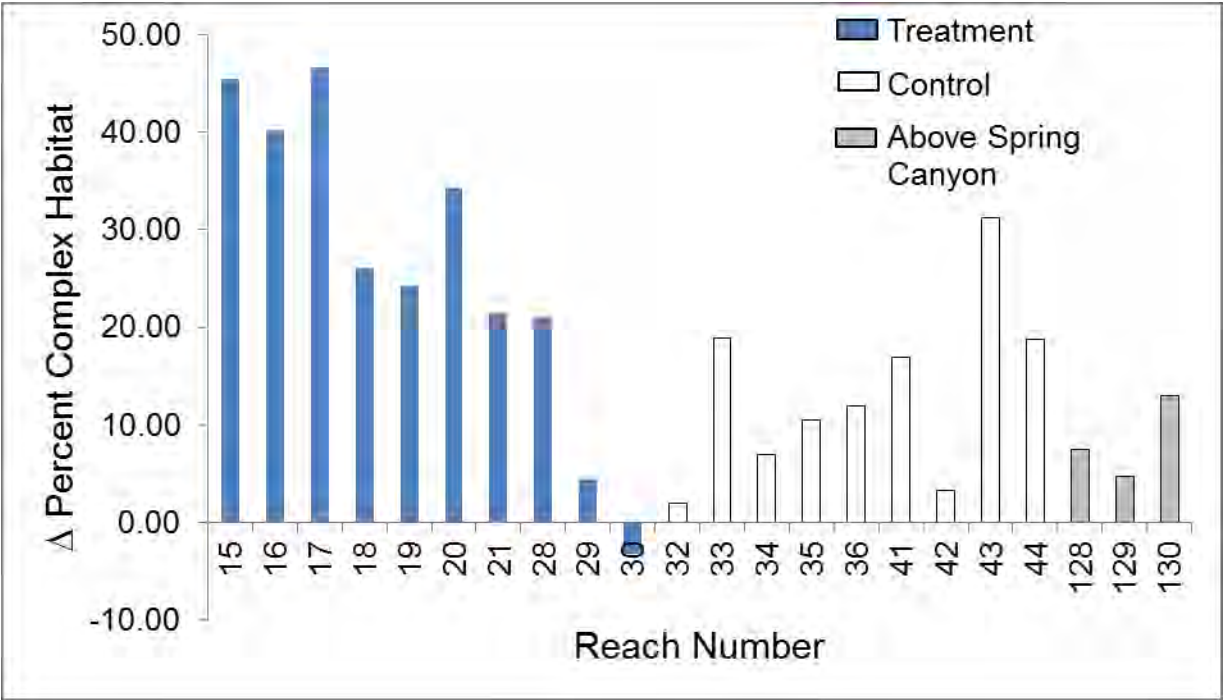
Figure 44. Difference in percent habitat complexity in 300-m reaches between 2010 and 2013 or 2012 (reach 15). Positive numbers indicate an increase in habitat complexity. The treatment and control reaches are located in the area where the UDWR removed tamarisk in 2009 below SH-24 (treatment) and the area below this removal area where tamarisk was not removed (control; see Keller 2012). Three reaches were also surveyed immediately upstream of the Spring Canyon confluence.

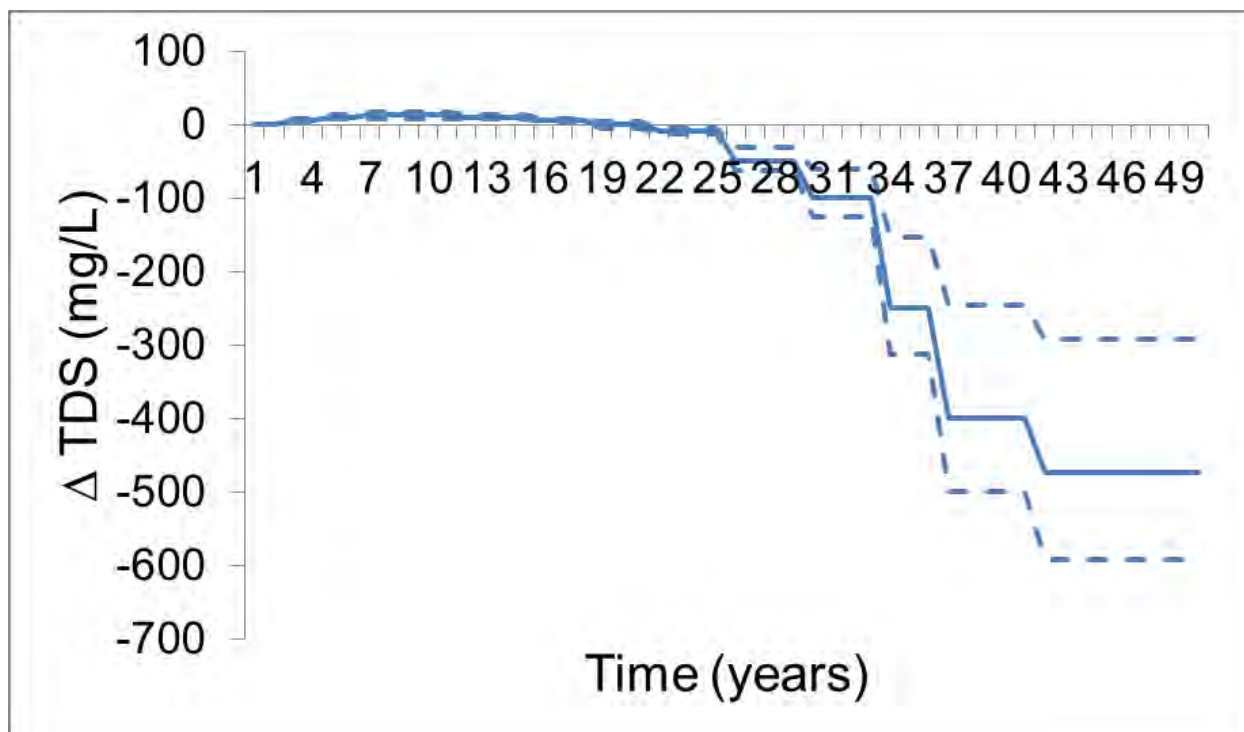
Figure 50. Predicted response of TDS to restoration actions over time. The graph displays the mean (solid line) and ranges (dashed lines) of the predicted difference between TDS concentrations upstream and downstream of the project reach. The predicted increase in the short-term is based on the proportion of the load that streambank erosion was estimated to contribute in the lower San Rafael River (MFG, Inc. 2004). The predicted decrease over the long term is based on applying the average proportional reduction of specific conductance reported in a river-floodplain and wetland restoration project in North Carolina (Richardson et al. 2011) to the mean TDS concentration of the San Rafael River at SH-24 for the period prior to restoration (MFG, Inc. 2004). Ranges for the short-term increase are based on the 95% confidence intervals for the mean TDS concentration in the lower San Rafael River as reported in MFG, Inc. (2004). Ranges over the long term are based on the mean and maximum differences in reaches seen in the study in North Carolina (Richardson et al. 2011). A difference of 0 is assumed prior to restoration.
