Restoration and Monitoring Plan for Native Fish and Riparian Vegetation on the San Rafael River, Utah

15 July 2013

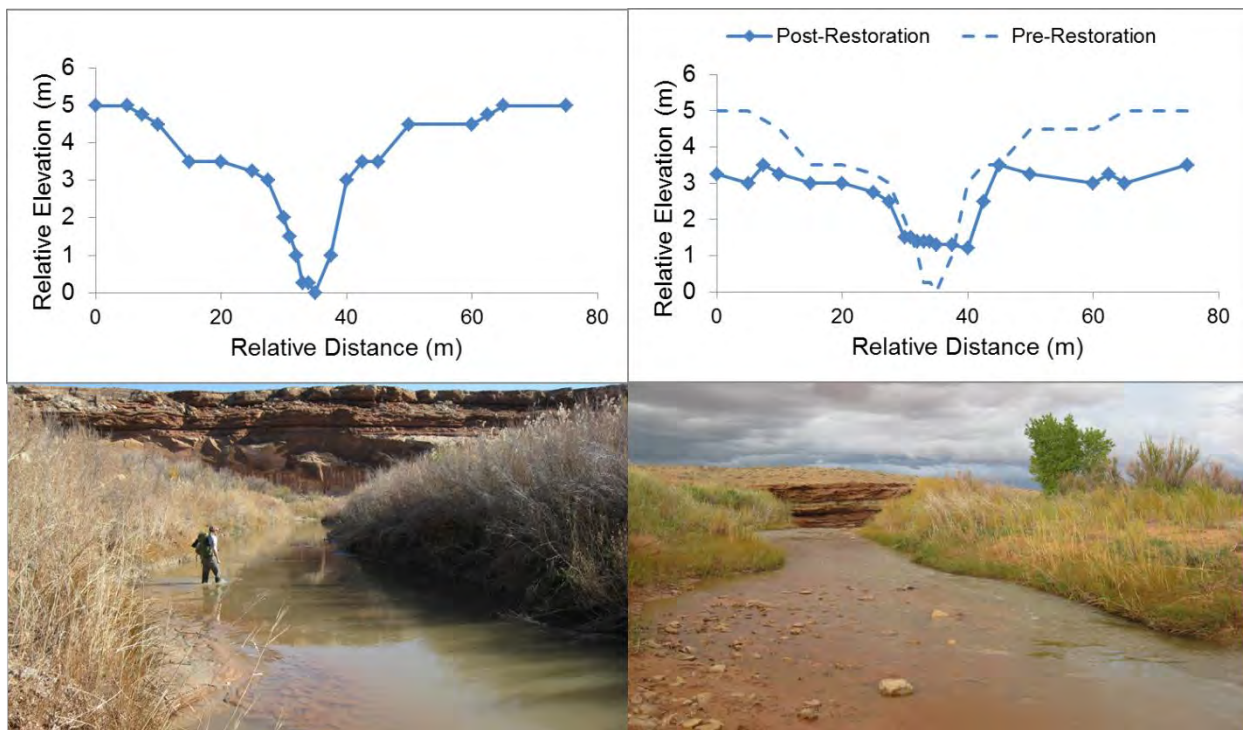
Figure 51. Predicted response of channel morphology to restoration actions and large spring snowmelt floods. The top row shows a representative cross-section before (left) and after (right) restoration actions and series of large spring snowmelt floods. The bottom row shows representative pictures of the predicted response with the left picture showing pre-restoration (photo looking downstream at about reach 158, taken by B. Laub on November 8, 2012) and the right picture post-restoration (photo looking downstream below Spring Canyon confluence, taken by B. Laub on October 12, 2012). Note the gentler-sloping channel banks, decreased entrenchment, and greater channel-floodplain connectivity predicted to occur as a result of restoration activities.

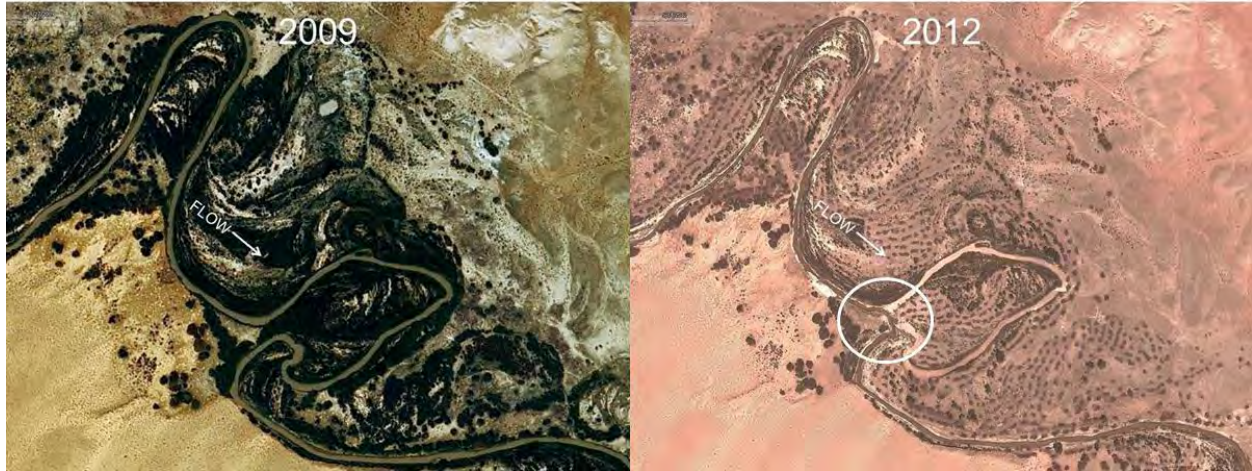
Figure 52. Aerial photographs of a reach of the San Rafael River taken in 2009 and 2012. Dots on the floodplain in the 2012 photo are piles of tamarisk that were removed by the UDWR in 2009-2010. In 2011 a large magnitude, long duration spring snowmelt flood occurred and caused a channel avulsion and meander cutoff event, seen in the circle on the 2012 photograph.

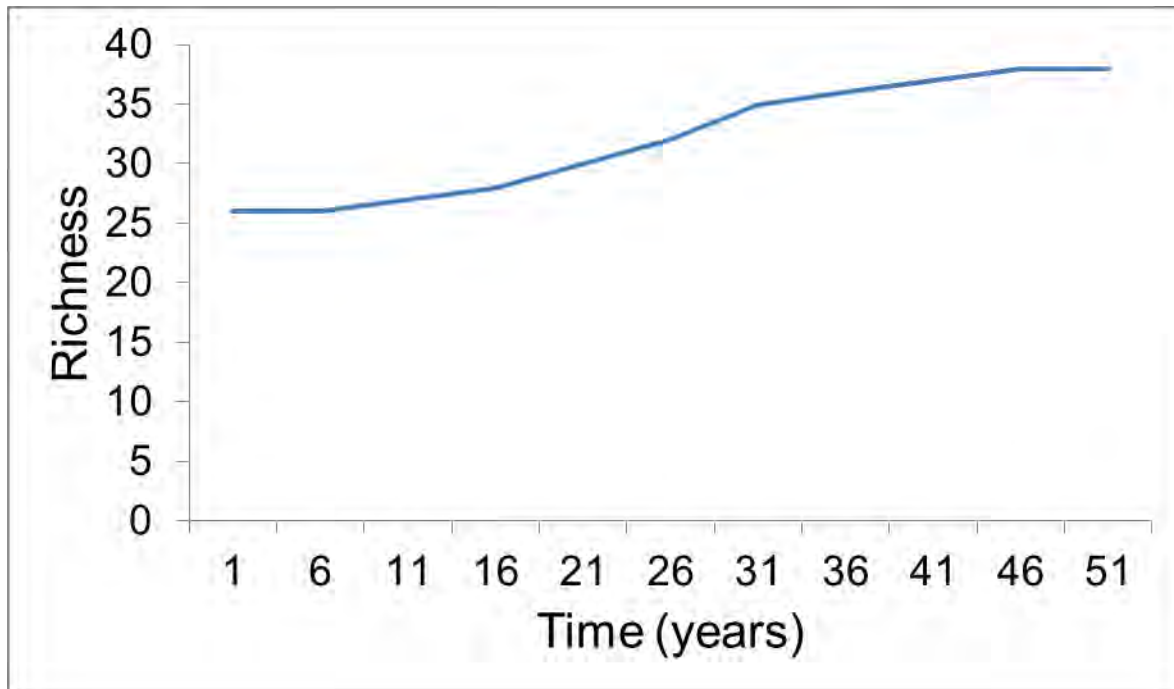
Figure 54. Predicted response of bird species richness to restoration actions over time. The graph displays the mean richness predicted in restored sites over time. The current richness is based on the average richness seen at Hatt’s Ranch over three sampling years by the UDWR, while the maximum predicted richness is predicted as the total number of species observed over the three year sampling program at Hatt’s Ranch (Wright 2012).
