# Case Studies of Riparian and Watershed Restoration in the Southwestern United States—Principles, Challenges, and Successes

By Barbara E. Ralston, and Daniel A. Sarr, editors

Open-File Report 2017–1091

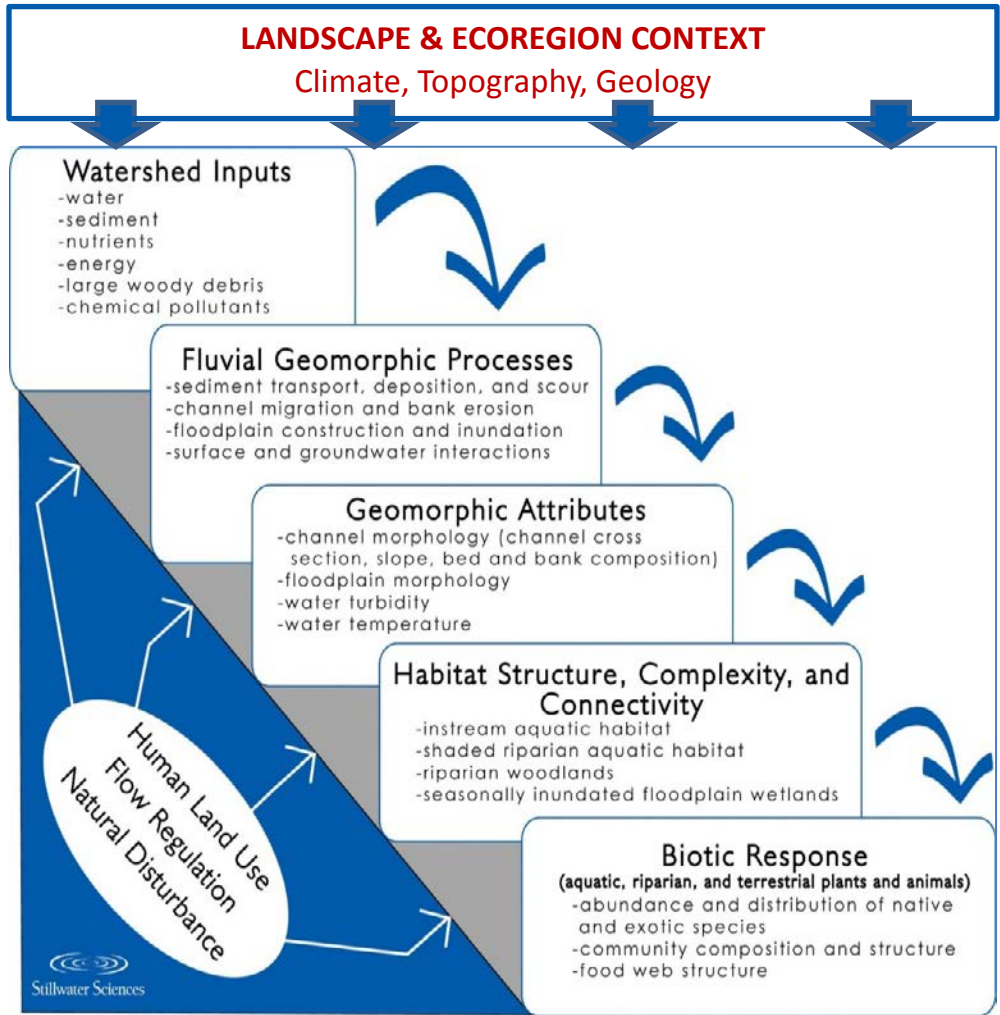
Figure 1. Ecosystem process linkages between climate and broad-scale context and biological features. Figure courtesy of Stillwater Sciences.

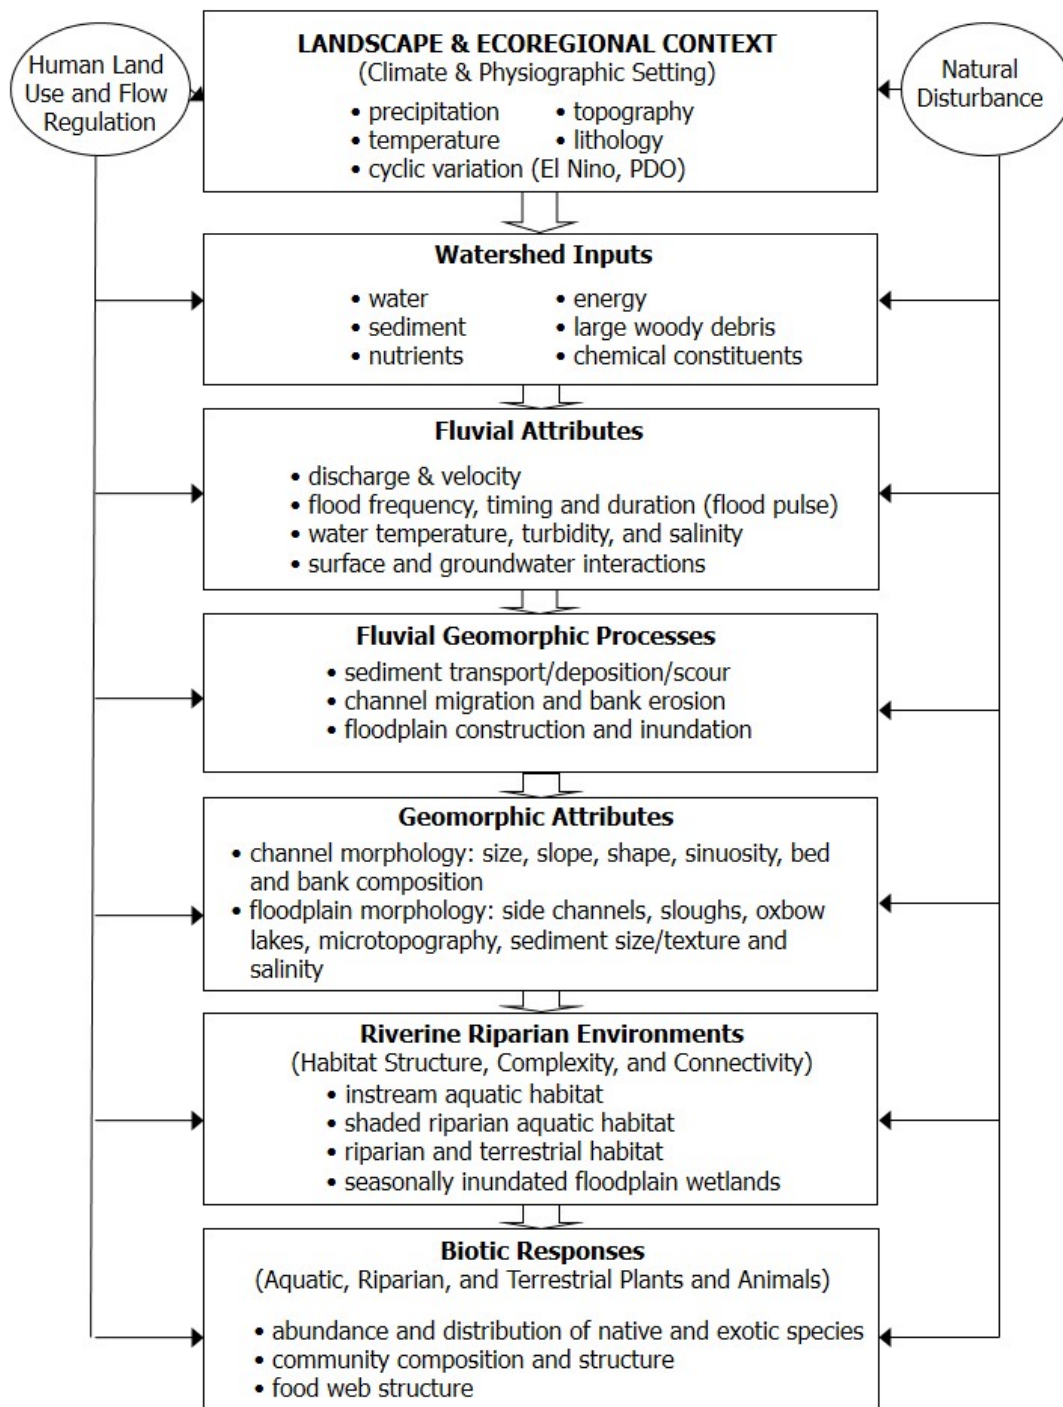
**Figure 1.** Conceptual physical and biological framework for alluvial river systems. Adapted and modified from Stillwater Sciences (2001) and Vaghti and Greco (2007). Pacific Decadal Oscillation is abbreviated as PDO in the Landscape and Ecoregional Context panel.

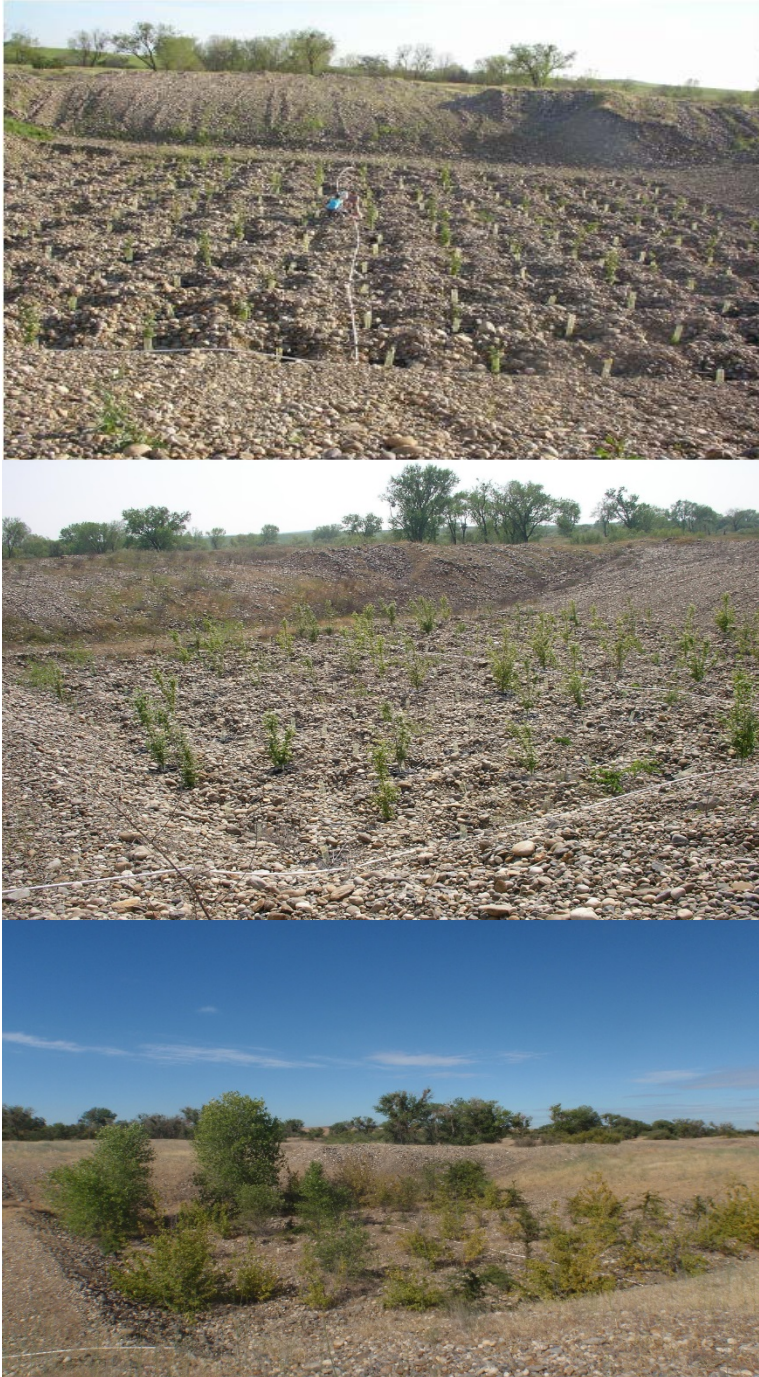
**Figure 2.** Time series of three photos from top to bottom of the floodplain dredger mining tailings revegetation experiment site on the lower Merced River, CA showing variation in plant survival and growth with species and irrigation and weed cover treatment within the 2-m depth to groundwater experimental block. Top: Year 1 (April 2004). Middle: Year 2 (April 2006). Bottom: Year 10 (June 2014)(photos, Stillwater Science).

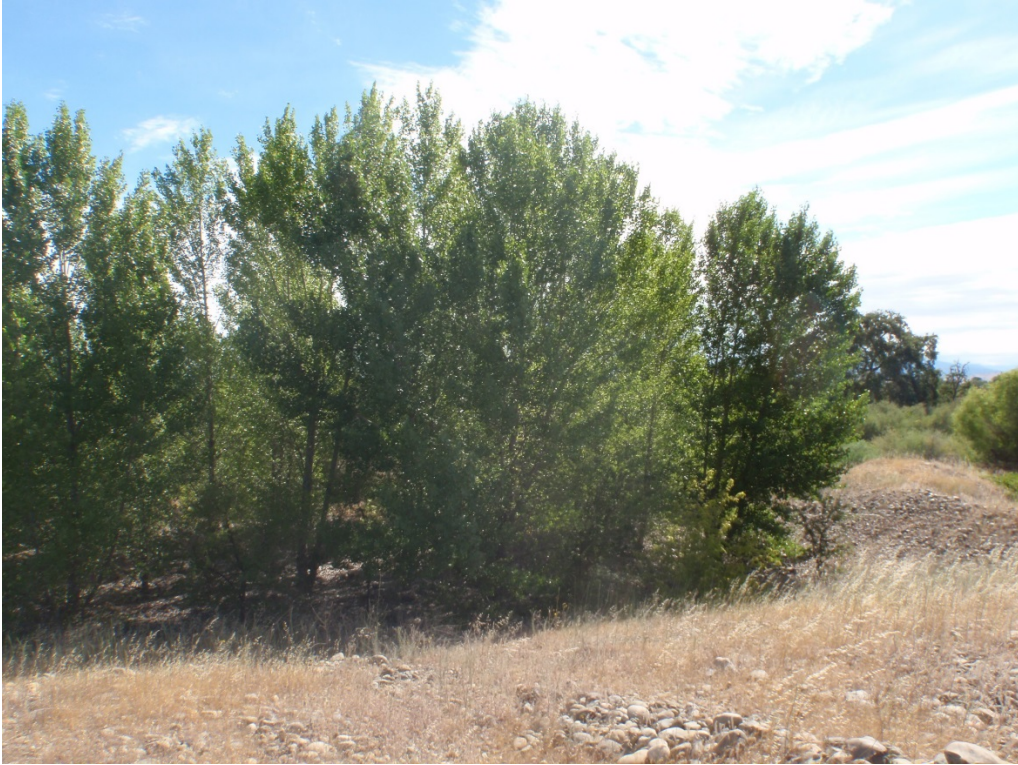
**Figure 3.** View of plants in the 1-m depth to groundwater experimental block in Year 10 (June 2014). Greater survival and growth were apparent in Year 10 in this block compared to the 2-m depth to groundwater block (See fig. 2, bottom photo)(photos, Stillwater Science).

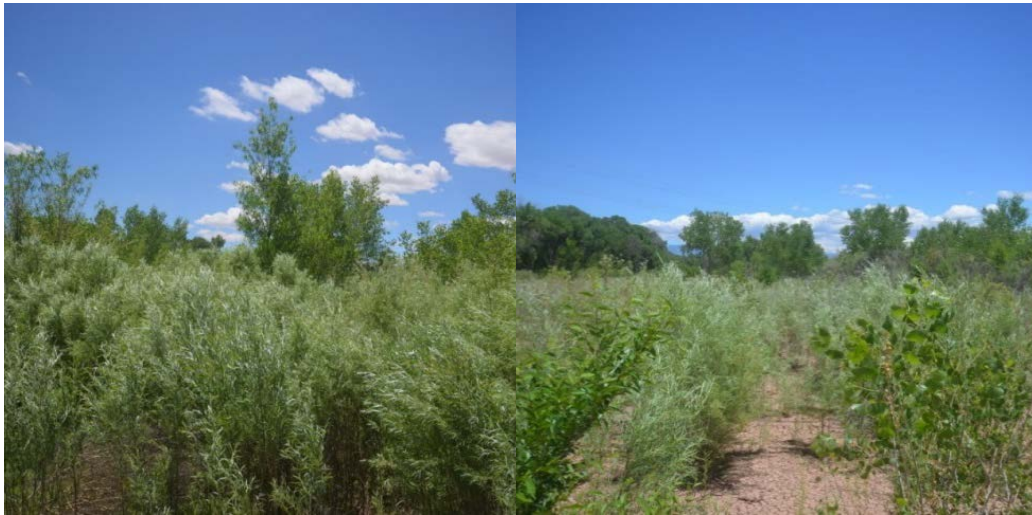
**Figure 1.** Variable coyote willow (*Salix exigua*) growth in constructed willow swales at the Middle Rio Grande site after three years of growth, with dense, high-quality habitat in some swales (left), and lesser growth and root-sprouts in others (right). Photos from June 12, 2015, M. Grabau, GeoSystems Analysis, Inc.

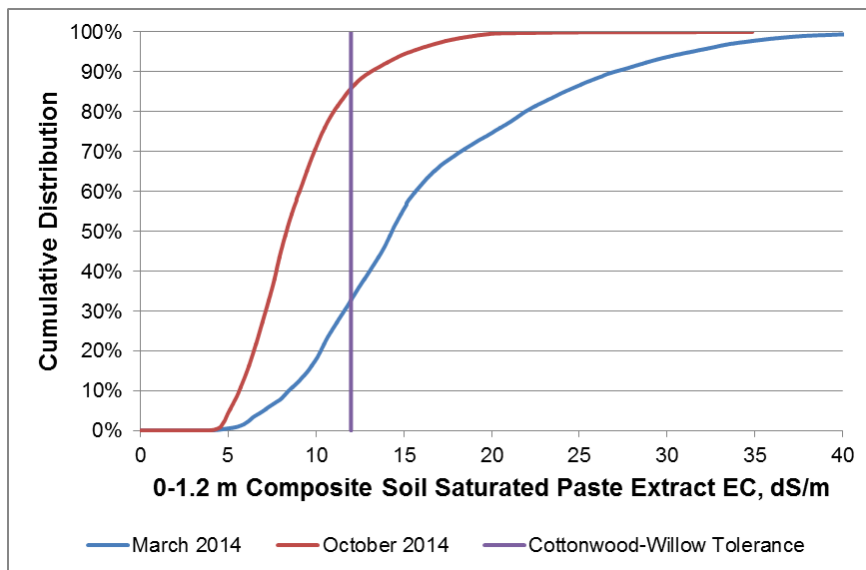
**Figure 2.** Cumulative distribution functions of estimated 0-1.2 m composite soil saturated paste extract electrical conductivity for 60 hectares along cleared meanders before (March 2014) and after (October 2014) the 2014 Minute 319 pulse and base flow deliveries.

Minute 319 environmental flows inundated cleared areas at Laguna Grande Restoration Area and at least temporarily increased groundwater levels between 50 cm and 2 m above baseline conditions. Additionally, large-scale soil salinity reductions were observed near reconnected meanders (fig. 2). Based on a generalized 12 dS/m soil salinity tolerance (i.e. with mortality of mature native trees occurring at higher electrical conductivity (EC) values, following GeoSystems Analysis, Inc. 2011), over 50 percent of the surveyed area became suitable for native trees. Cottonwood and/or willow established in approximately 70 percent (22 of 32) of established belt transects. Lack of establishment in some cleared areas was likely due to limited soil moisture, high salinity, and/or a lack of nearby seed sources. Outside of cleared areas, establishment was limited because flow rates did not provide widespread scour of existing vegetation. Assessment of Minute 319 flow effects on the Colorado Delta is ongoing by numerous organizations. Monitoring will continue in Laguna Grande to determine the longevity of soil salinity reductions and survival of seedlings.

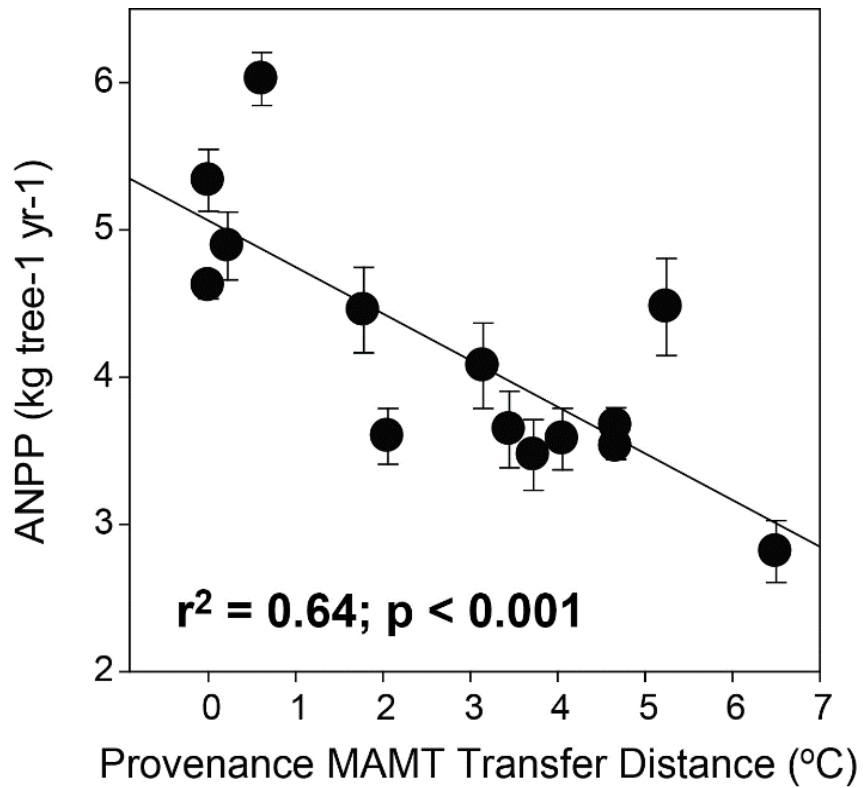
**Figure 3.** When grown at a low elevation common garden, different populations of Fremont cottonwood exhibit different productivities (ANPP) that are correlated with their mean annual maximum temperature (MAMT) transfer distances.

Trees were collected from 16 source populations of Fremont cottonwood and grown at a BOR riparian restoration site. We found that annual aboveground net primary productivity (ANPP, an important predictor of biodiversity), declined with increasing mean annual maximum transfer distance. A transfer distance of 6.5°C means that a high-elevation, cool-site population was transferred to the warmer, low-elevation experimental forest.

Three major findings are shown. 1) The slope of the regression line shows the sensitivity of cottonwood to a warmer climate. Foundation species characterized by high sensitivity are key candidates for conservation/restoration strategies, while less sensitive species might receive lower priority. 2) We can select source populations for a predicted level of climate change (for example, if temperature increases 4°C, the regression line shows the populations that are best adapted to a future, hotter environment). 3) The trait-based variation in a population response shows its potential to adapt to climate change (see vertical bars). If the predicted change in climate is less than the variation, then the population has the potential to adapt (evolve) to predicted changes. In combination, these findings provide a powerful tool to assist managers in the selection of genotypes and source populations that maximize biodiversity and survive climate change.

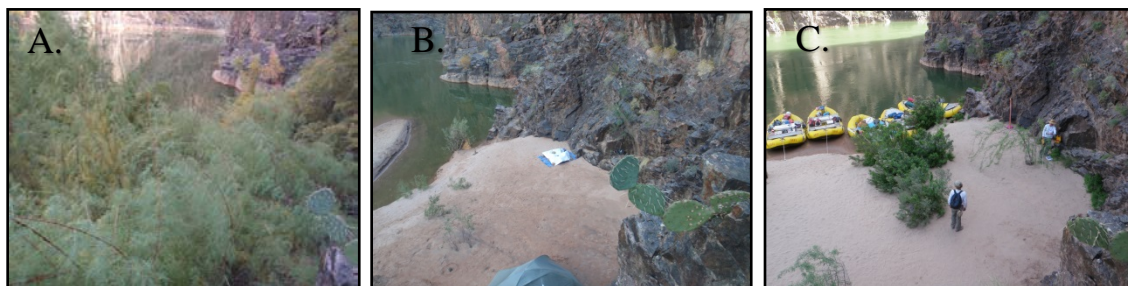
**Figure 1.** View of the most upriver portion of the site. A) October 2012; prior to tamarisk removal. The vegetation in the foreground is dominated by tamarisk. B) December 2012; after tamarisk removal and the High Flow Event. Note the native plants that were retained in the sandy area near the river. C) April 2015, 2.5 years post-removal. Note the rapid growth of retained native plants shown in photo b), including mesquite (*Prosopis glandulosa*) and seep willow (*Baccharis emoryi*) (photos M. McMaster, National Park Service).

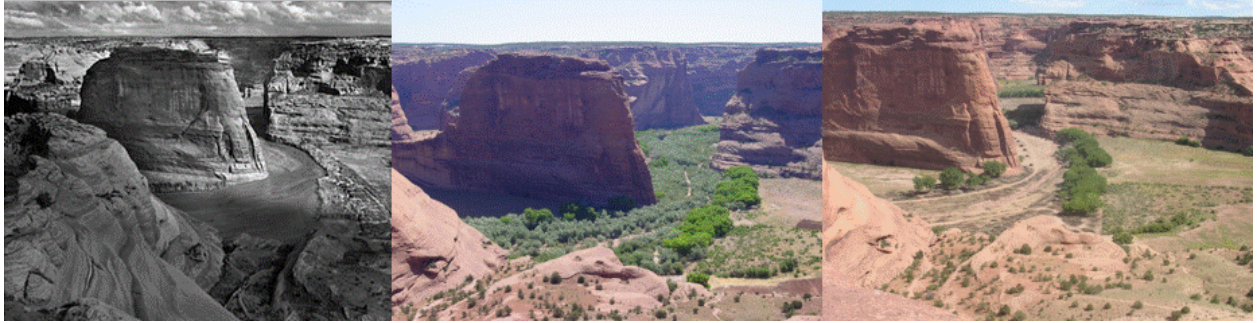
**Figure 1.** Photographs of Chinle Wash at White House Ruins overlook facing northeast, Canyon de Chelly National Monument, Arizona. Left photo was taken in 1942 by Ansel Adams (National Archives), middle photo was taken in 2005 by D. Cooper, right photo was taken in 2006 by L. Reynolds following removal of tamarisk and Russian olive at the site.

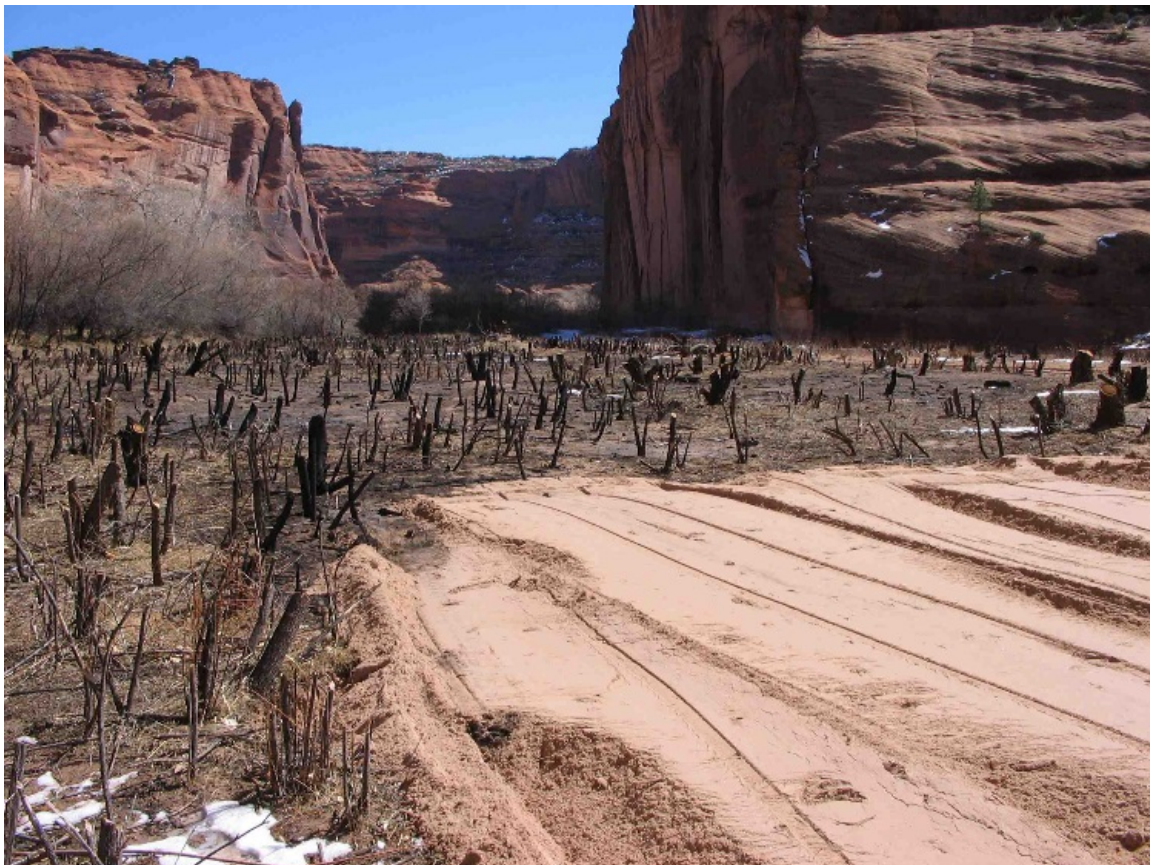
**Figure 2.** Photograph of tamarisk and Russian olive removal treatment: cut-stump shown on the left and whole-plant removal on the right (photo L. Reynolds, Colorado State University).

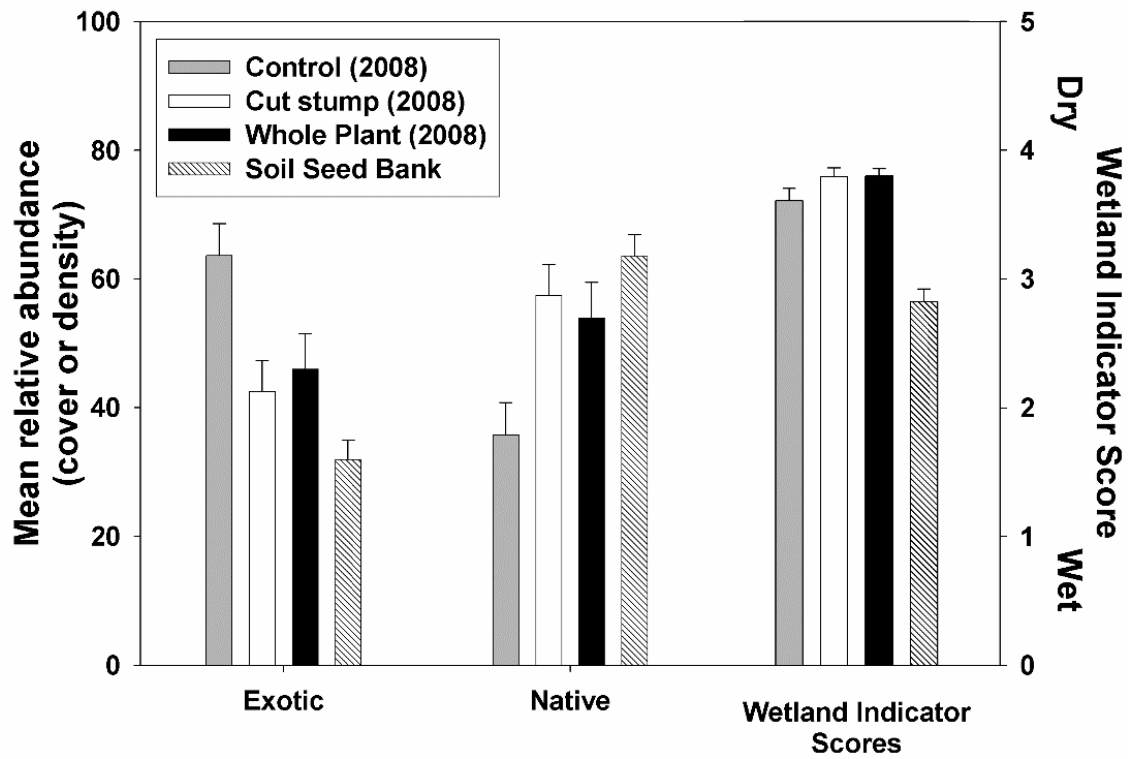
Figure 3. Graph of relative abundance (+standard error (SE) bars) (cover for treatments and density for seed bank: left axis) of exotic and native species and mean wetland indicator scores (right axis) for herbaceous plants in 2008 in treatment and seed bank sites: control (gray), cut-stump (white), whole-plant (black), and seed bank (hatched). See Reynolds and Cooper (2011) for more details.

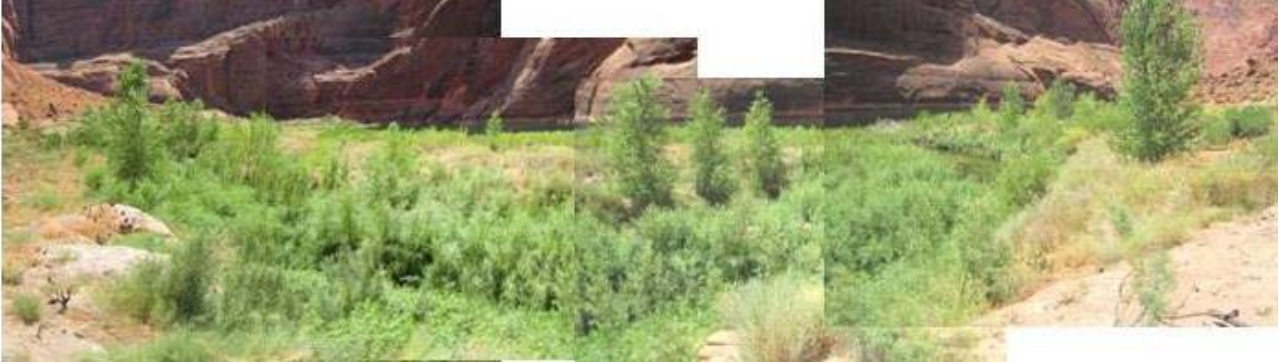
Figure 2. Panorama of Hidden Slough (Colorado River Mile -6.5R) in July 2014 (photo L. Stevens, GCWC).

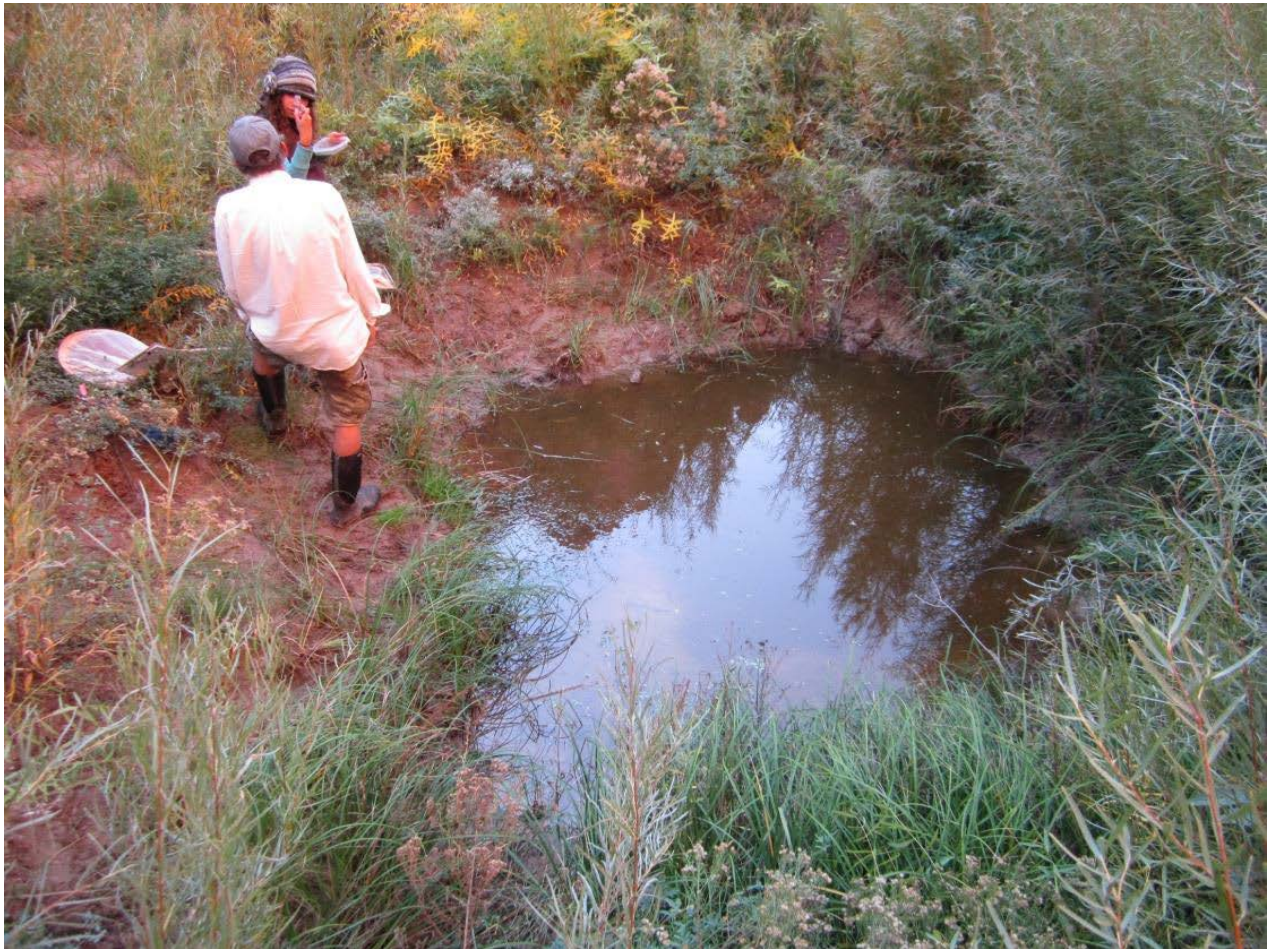
Figure 3. The Hidden Slough pond (photo L. Stevens, GCWC).

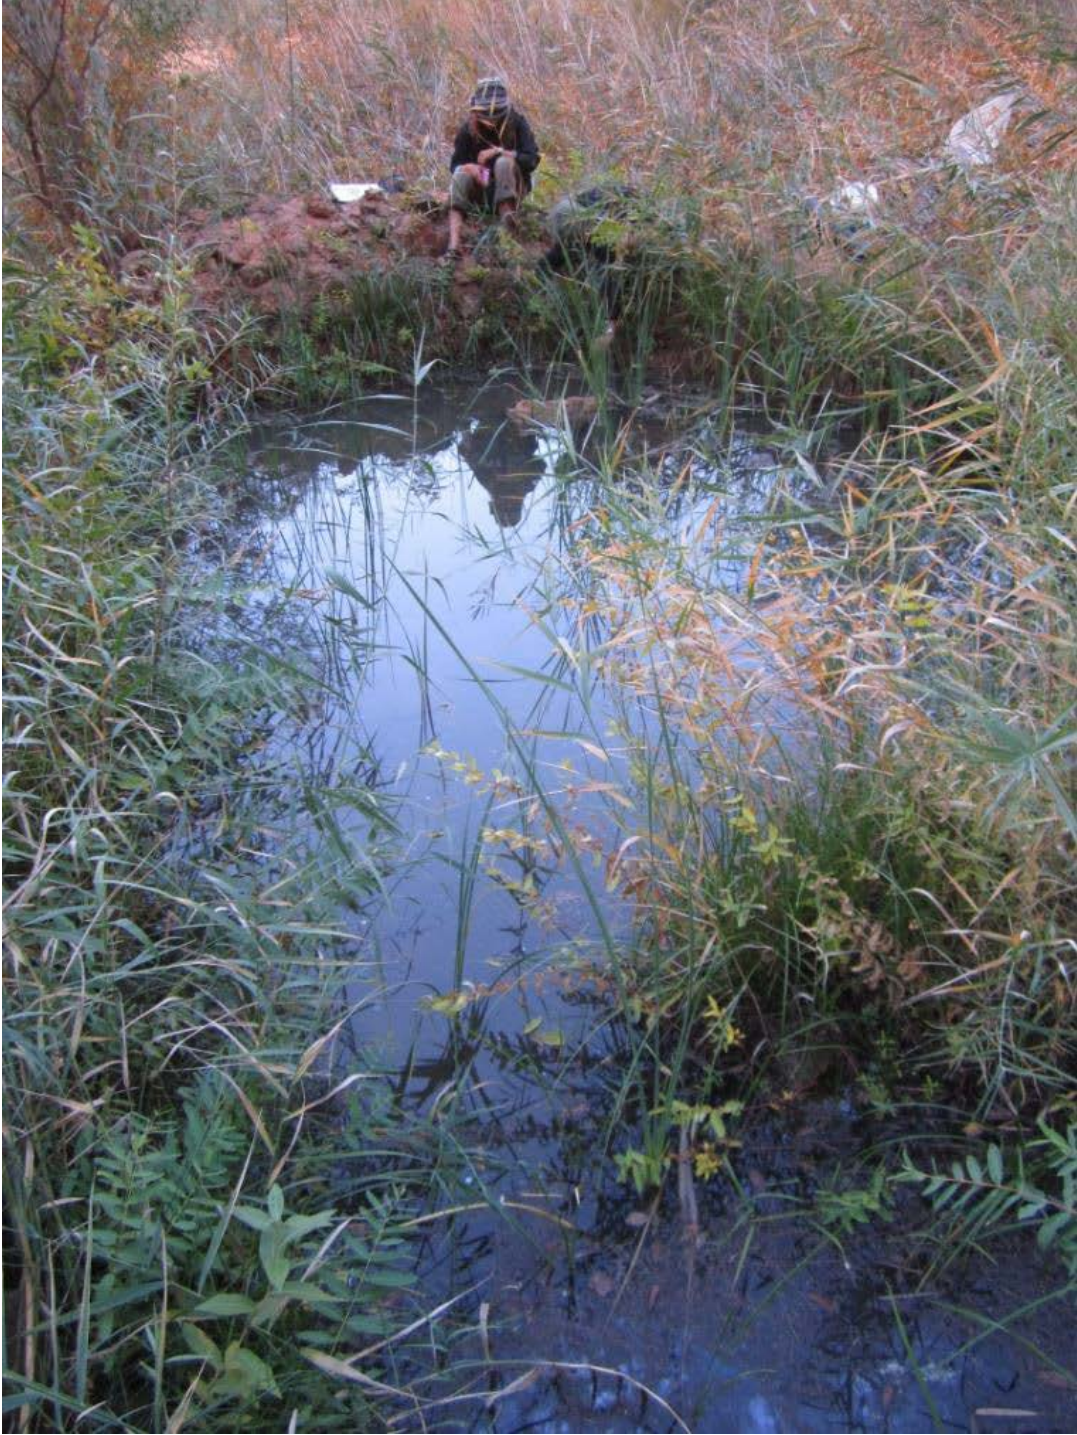
Figure 4. The Leopard Frog Marsh ponds (photo L. Stevens, GCWC).

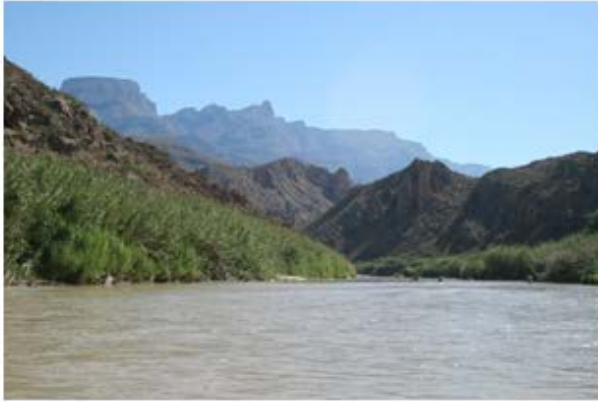
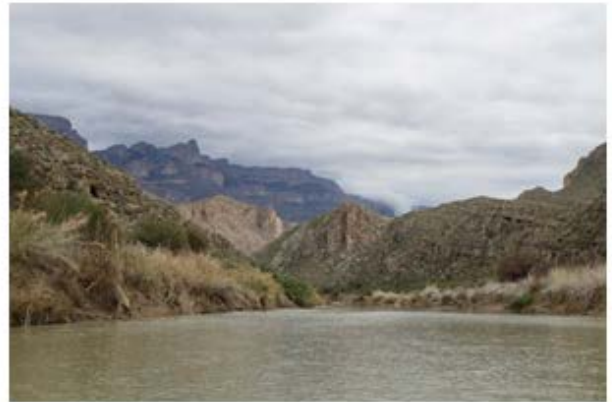
**Figure 2.** Photograph depicting healthy stand of giant cane (left), and the same stand post-treatment (right) (photos J. Bennett, NPS).

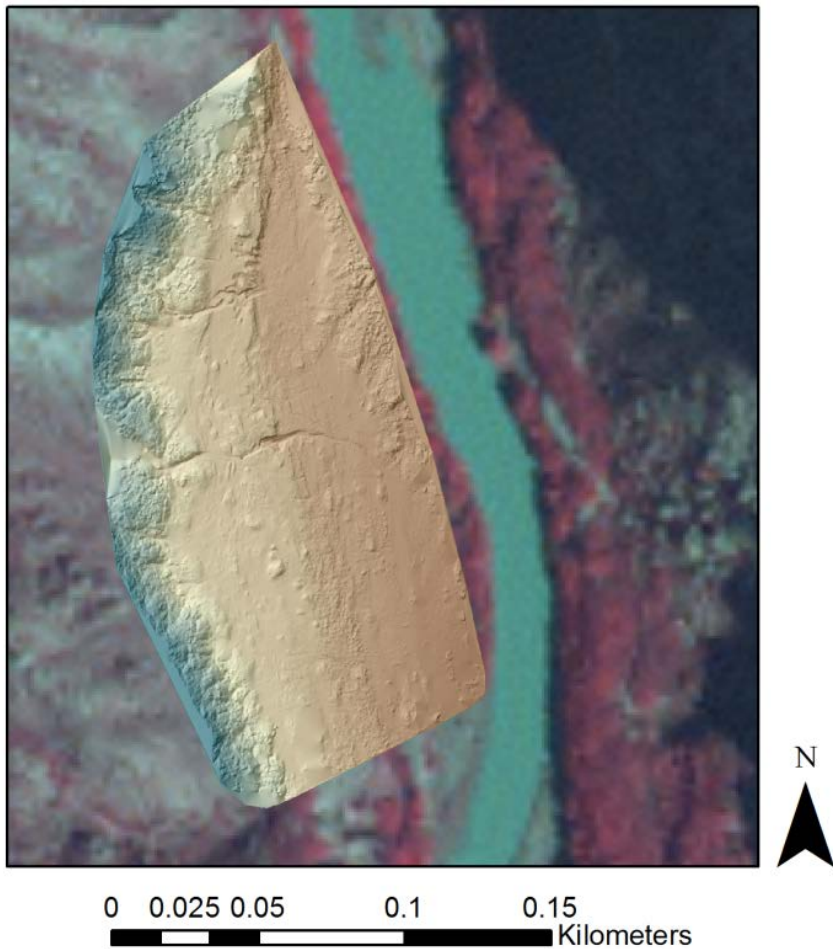
**Figure 3.** Example of a digital elevation model collected with terrestrial light detection and ranging (LiDAR). Dark brown colors depict low elevations, and light brown and blue colors depict higher elevations. Background image is a color infrared image taken in 2004 (National Agriculture Imagery Program, USDA). Note the dark bands of cane (red vegetation) along the channel margins in 2004. These stands have been removed. Note the overflow flood channel shown in the area of the darkest brown color. Flow is from bottom to top.

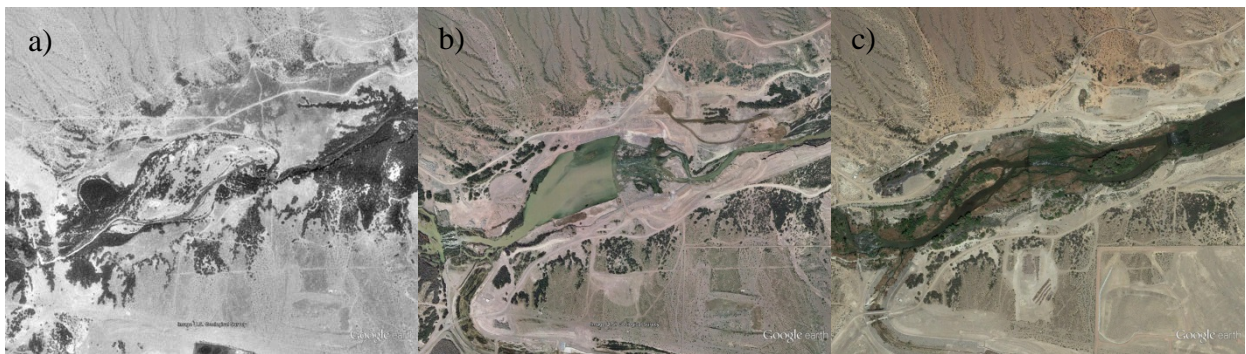
**Figure 1.** Time-series of aerial photographs evidencing stream channel changes as a result of installing a weir in Las Vegas Wash: a) May 1990 image showing a narrow stream channel surrounded almost entirely by exotic tamarisk (*Tamarix ramossisima*); b) March 2004 image showing a large water impoundment created by the weir; and c) March 2014 image showing the establishment of native wetland and riparian vegetation (imagery, Bureau of Reclamation).

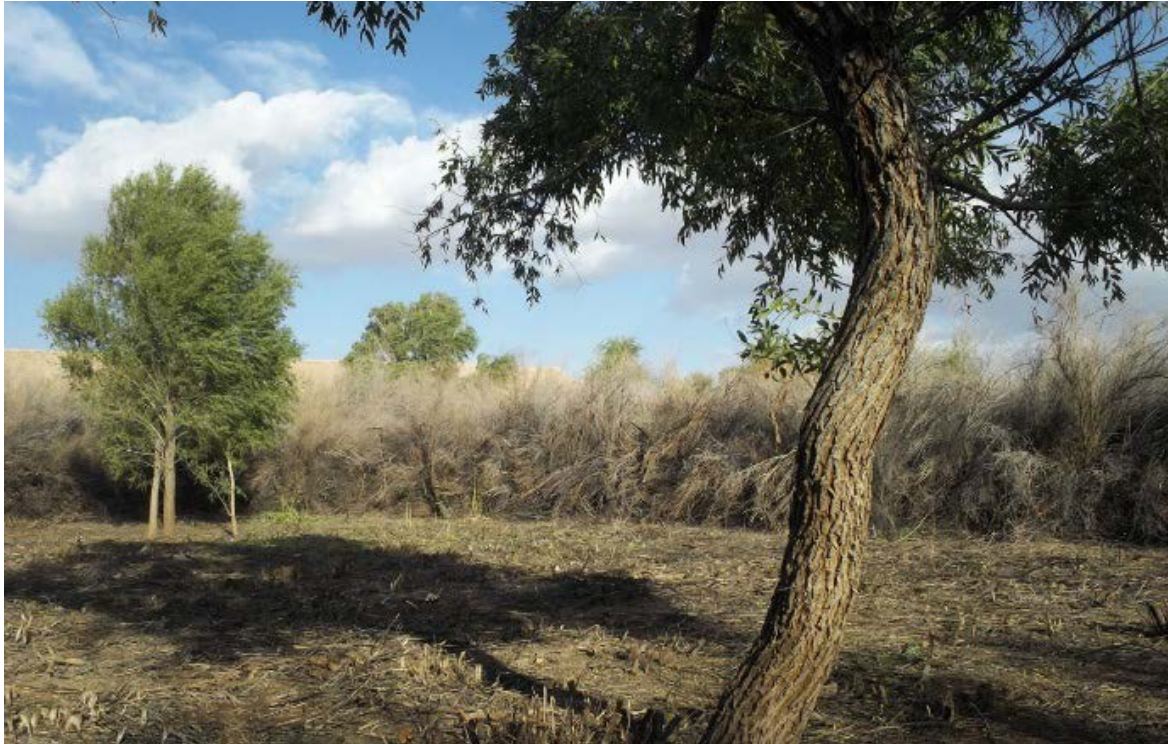
**Figure 1.** Mormon Mesa restoration site on lower Virgin River, Nevada showing a patch of recently cleared vegetation ready for replanting with native species located within the surrounding matrix of dense tamarisk (which appears brown because it has been defoliated by the tamarisk beetle) with scattered emergent willows (*Salix gooddingii*). Cut tamarisk was stacked around the edges of the clearing to create a barrier to help exclude cattle. Photo taken October 2013 (source: Clark County Desert Conservation Program).

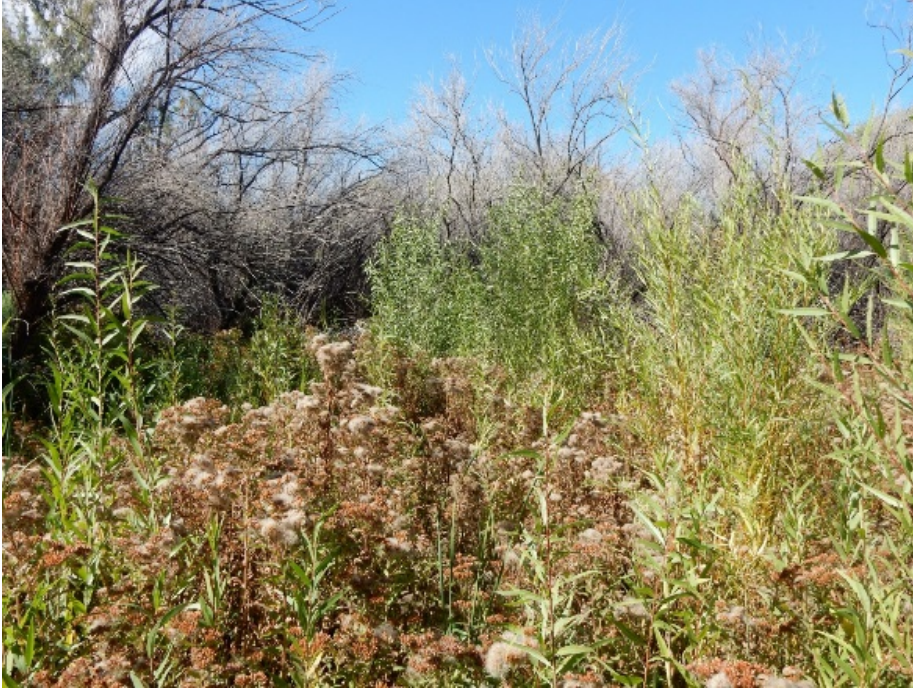
**Figure 2.** Mormon Mesa restoration site on lower Virgin River, Nevada showing surviving planted willows (*Salix gooddingii*) and naturally recruited *Pluchea odorata* less than 1 year after restoration. Photo taken October 2014 (source: Stillwater Sciences).

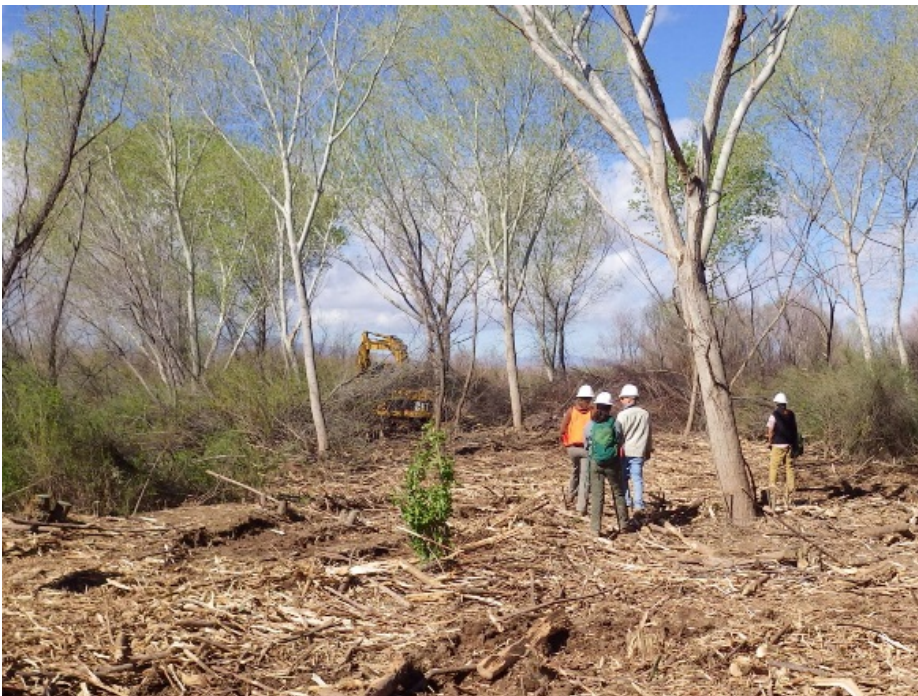
**Figure 3.** Example of using a mulcher to remove tamarisk while leaving native cottonwoods and willows intact at restoration site on the Upper Gila River, Arizona. Photo taken 23 February 2015 (source: Stillwater Sciences).

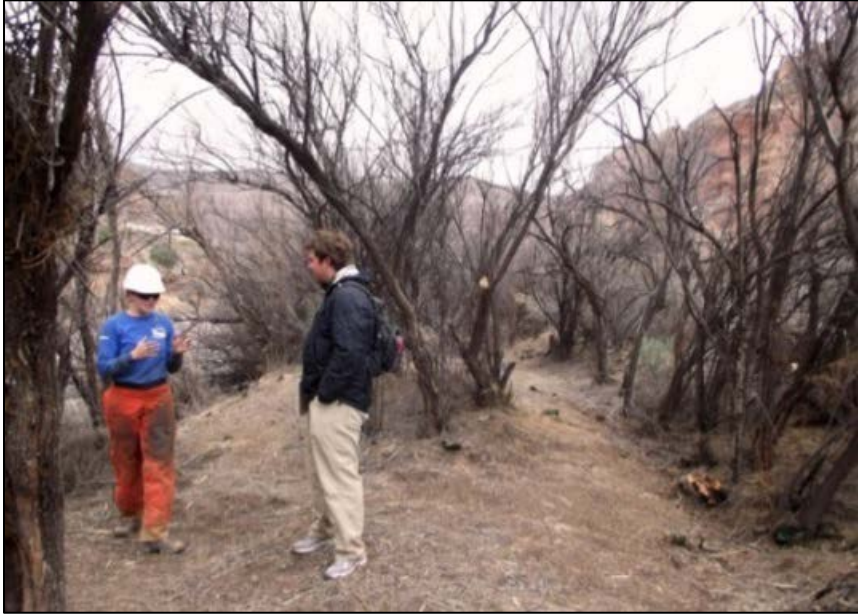
**Figure 1.** DRRP partners standing in a mosaic treatment, where pathways have been cleared through tamarisk by crews using chainsaws (photo, J. D. Oppenheimer, Tamarisk Coalition).

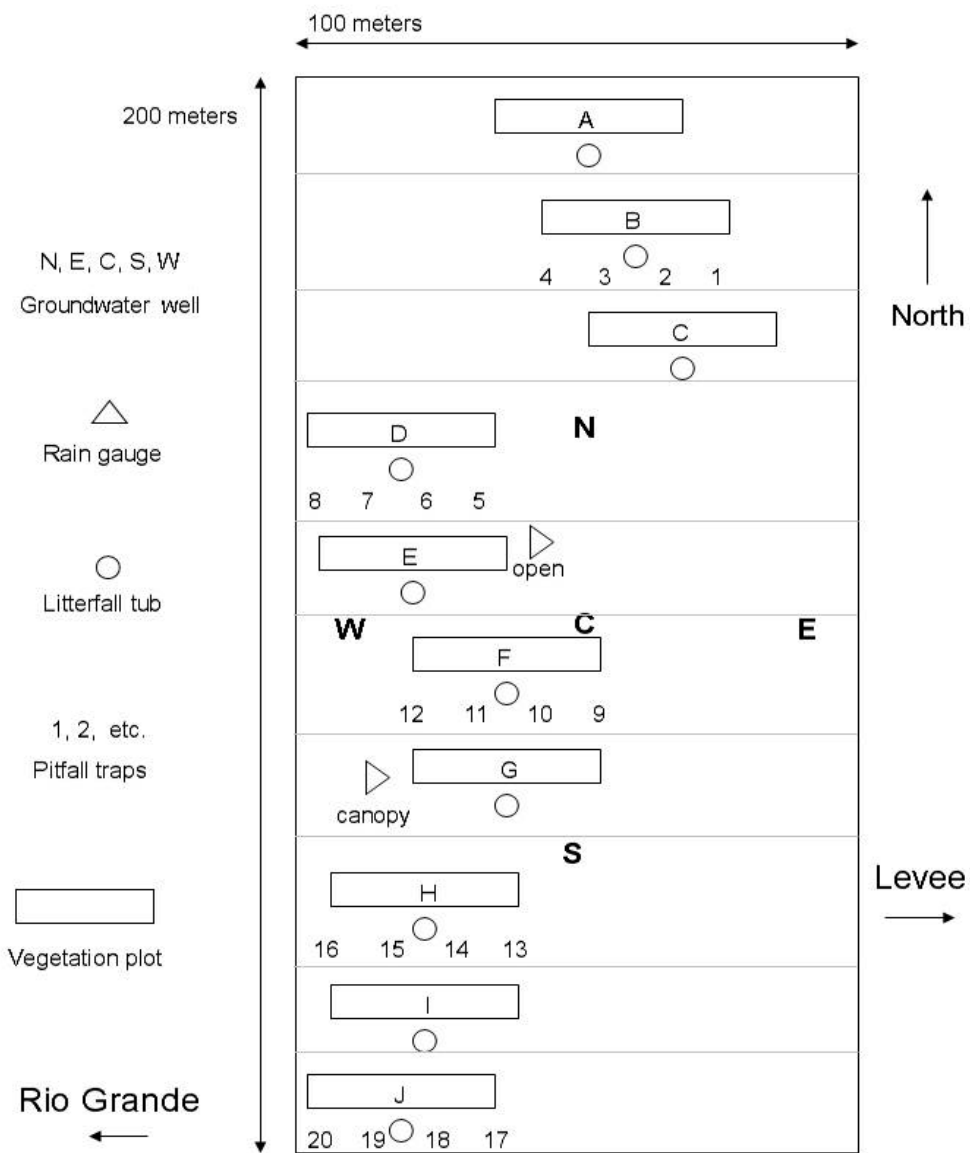
**Figure 1.** Example site layout in 100 m X 200 m dimensions with the long edge oriented North to South. Sites include vegetation plots (rectangles), numbered pitfall traps, rain gauges (triangle), litter tubs (circles) and groundwater wells (capital letters).

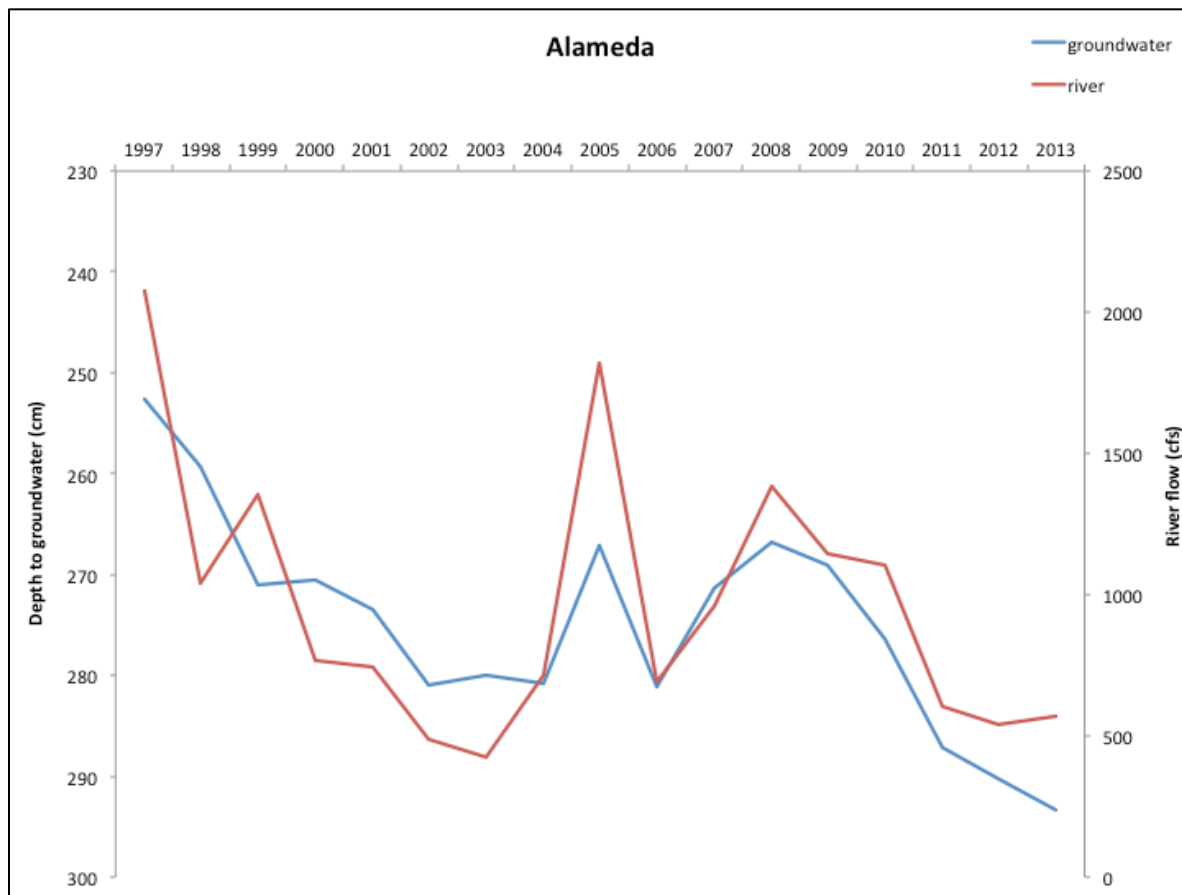
**Figure 2.** Trends in depth to groundwater at the Bosque Ecosystem Monitoring Program Alameda site in northern Albuquerque, NM. Depth to groundwater (cm) values (blue line) for the years 1997 to 2013 are compared with river discharge (cfs) values (red line) for the same period of time.

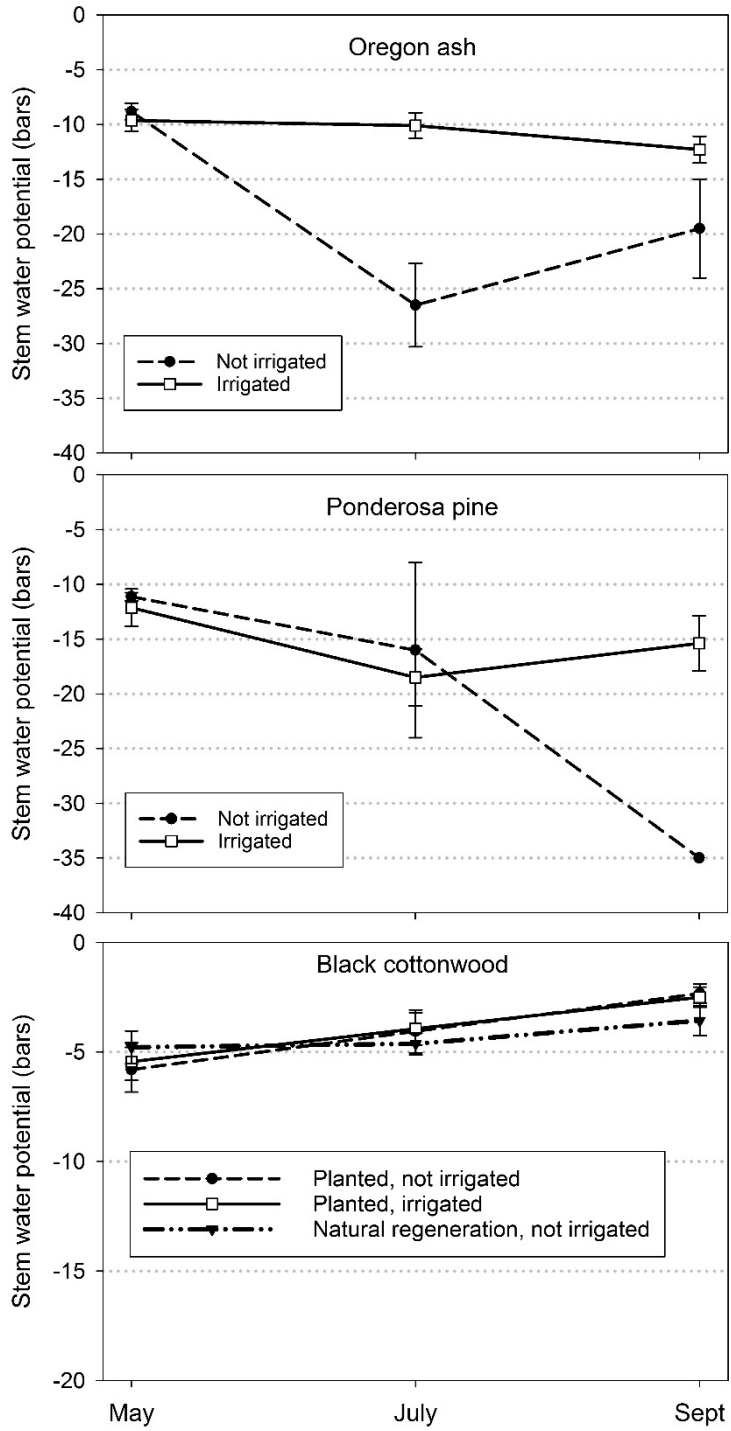
**Figure 1.** Mean and standard errors of pre-dawn plant moisture stress in three species during 2001 growing season at Harrisburg Pond. The severity of stress is indicated by the degree of tension in plant xylem, measured in negative atmosphere. Permanent wilting point for herbaceous plants is approximately -15 bars.
