Defining the New Normal for the Dolores River

Dolores River Adaptive Management Support Project

5-Year DRAMS Project Timeline

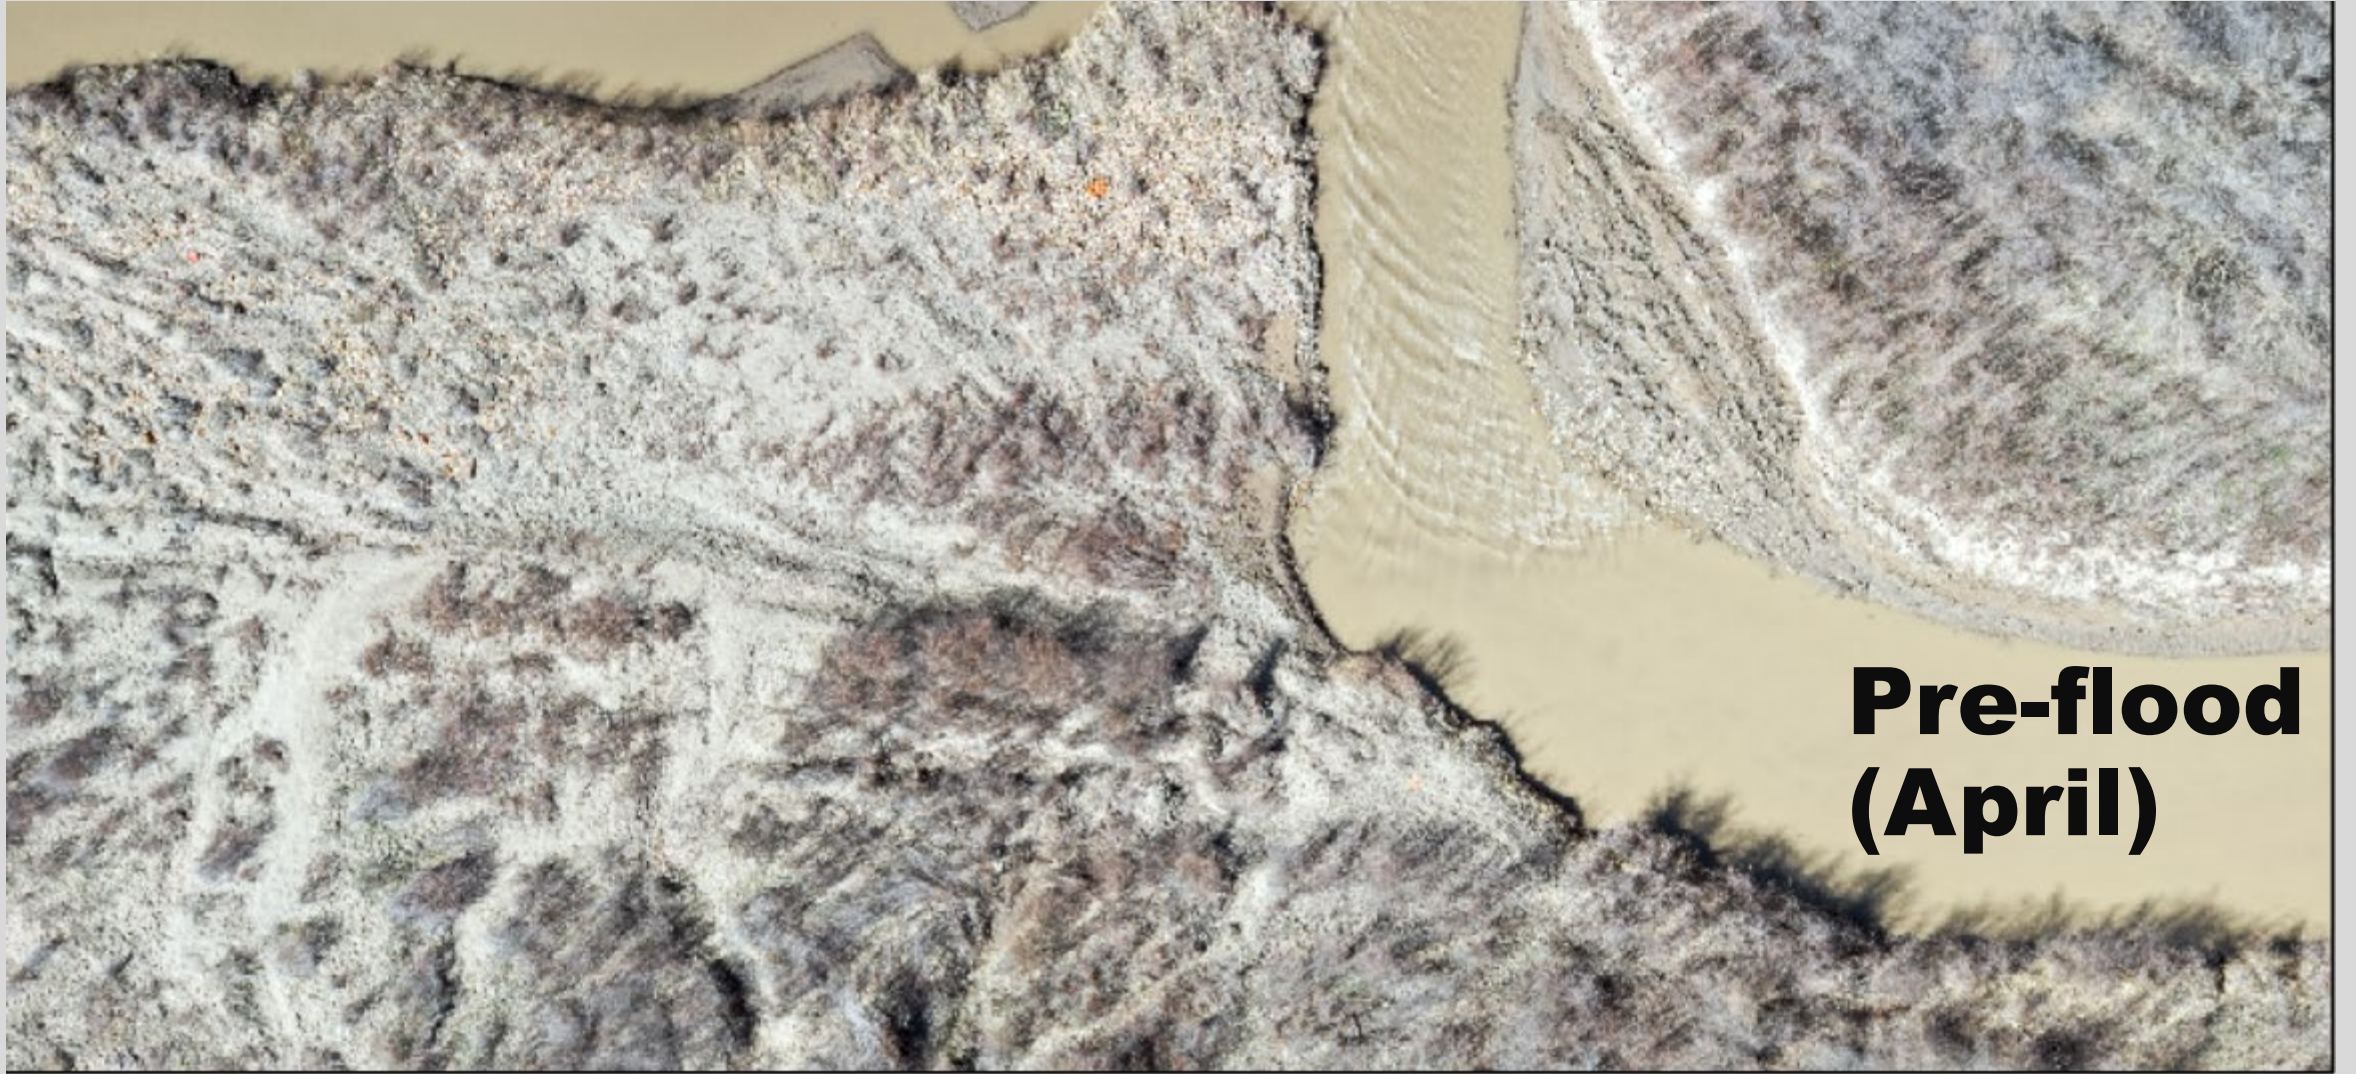
**Pre-flood
(April)**

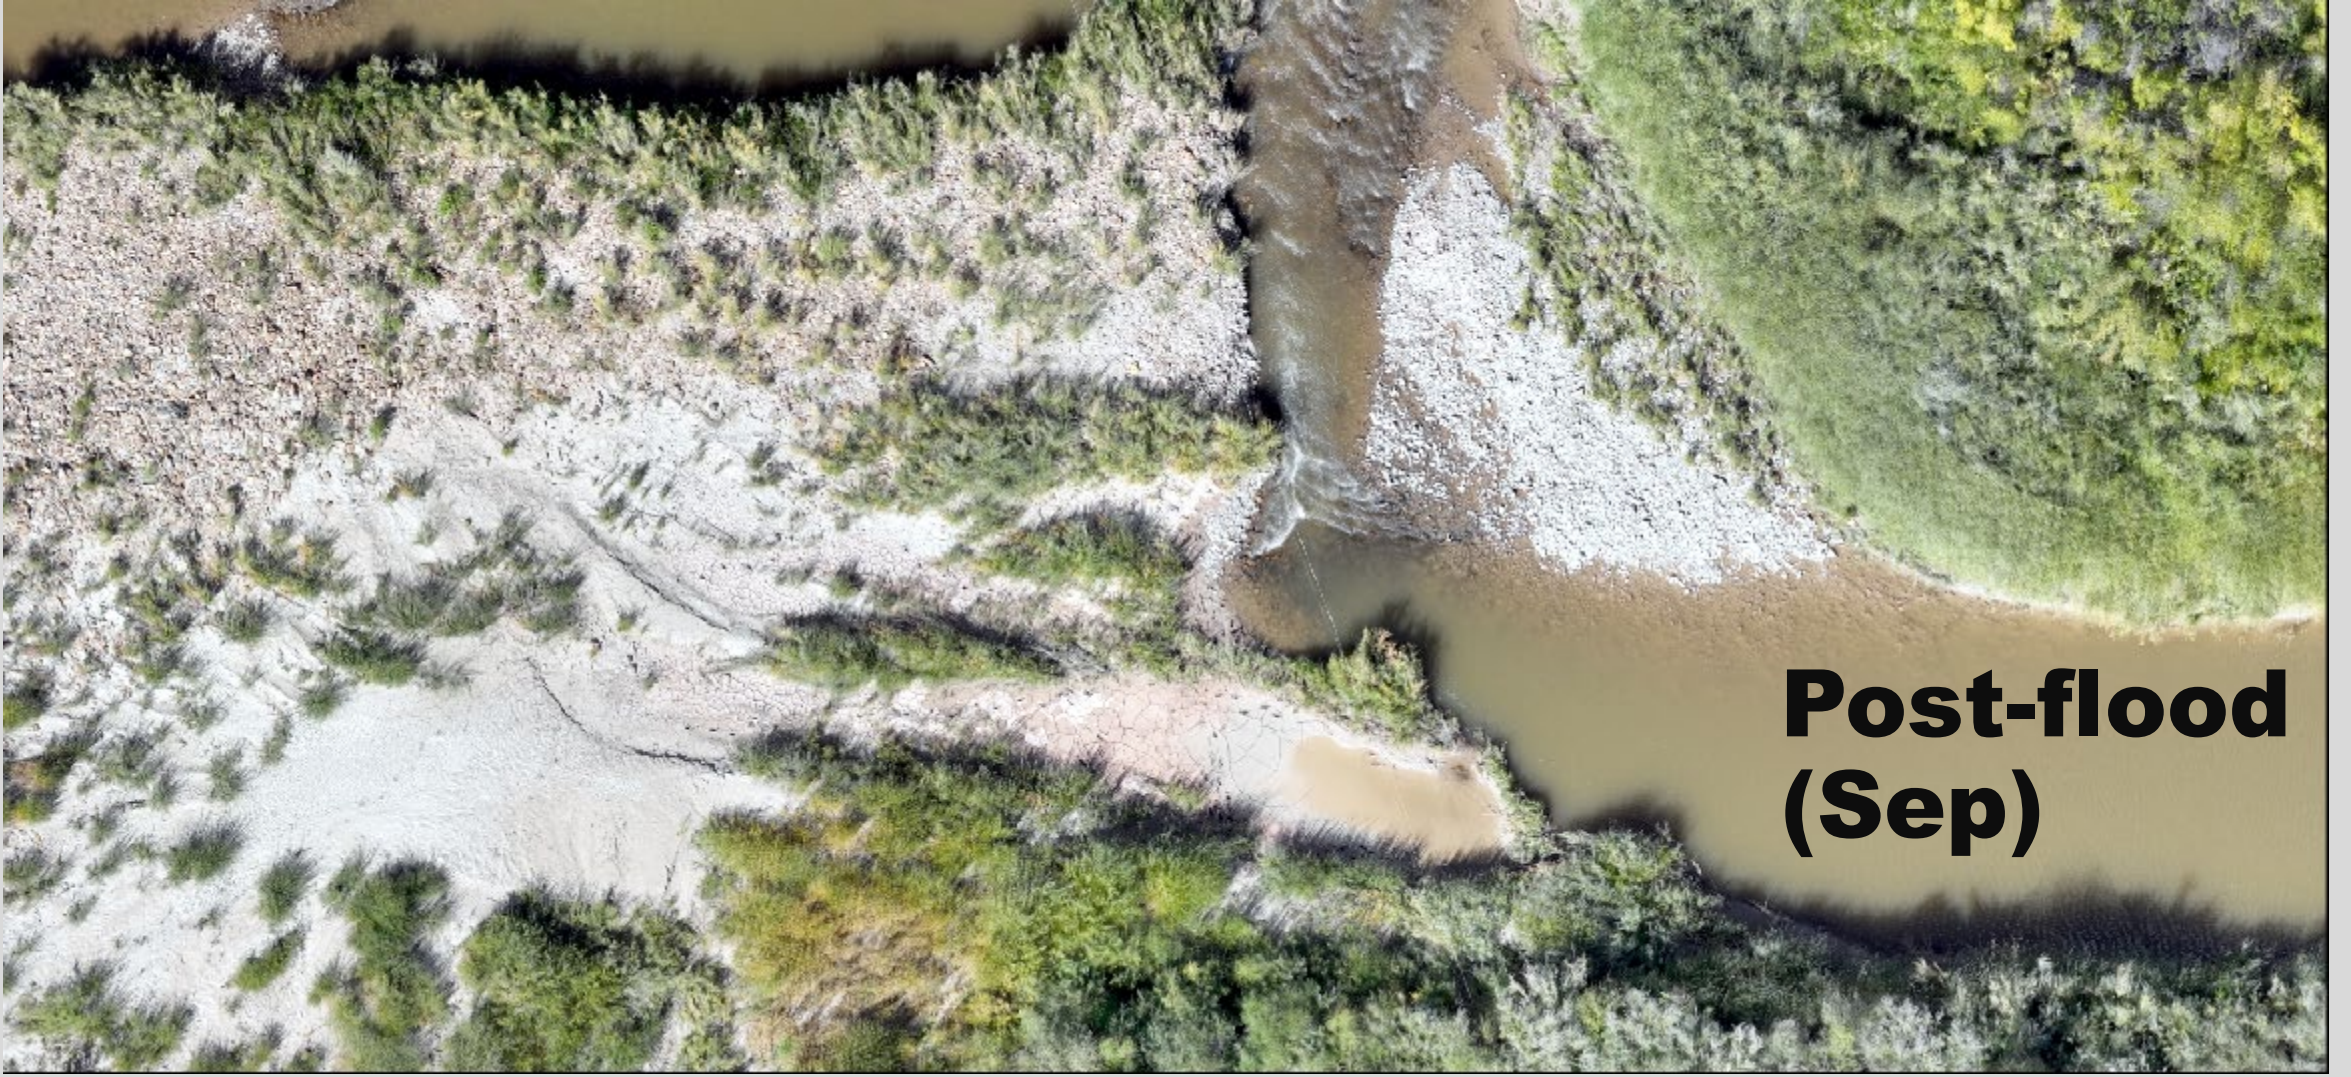
**Post-flood
(Sep)**

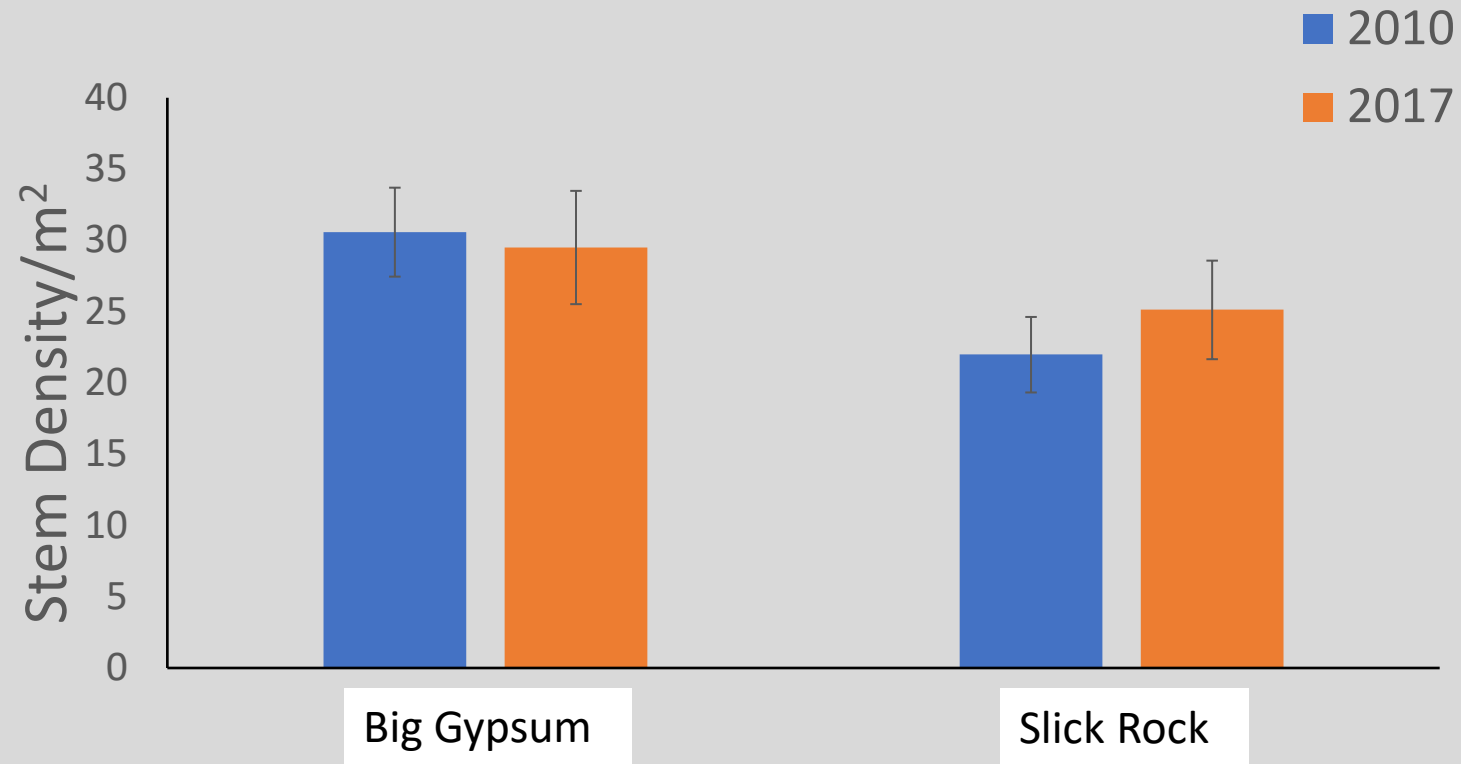
High Willow stem density, with no change at re-visited sites: Pre- (2010) vs. Post- (2017) high flow
