RIPARIAN RESTORATION CONFERENCE
Restoration for the Future: Promoting resilience in our rivers and communities

Two Decades of Restoration on the Middle Rio Grande

Ondrea Hummel, CERP, Ecology Discipline Lead, Senior Ecologist

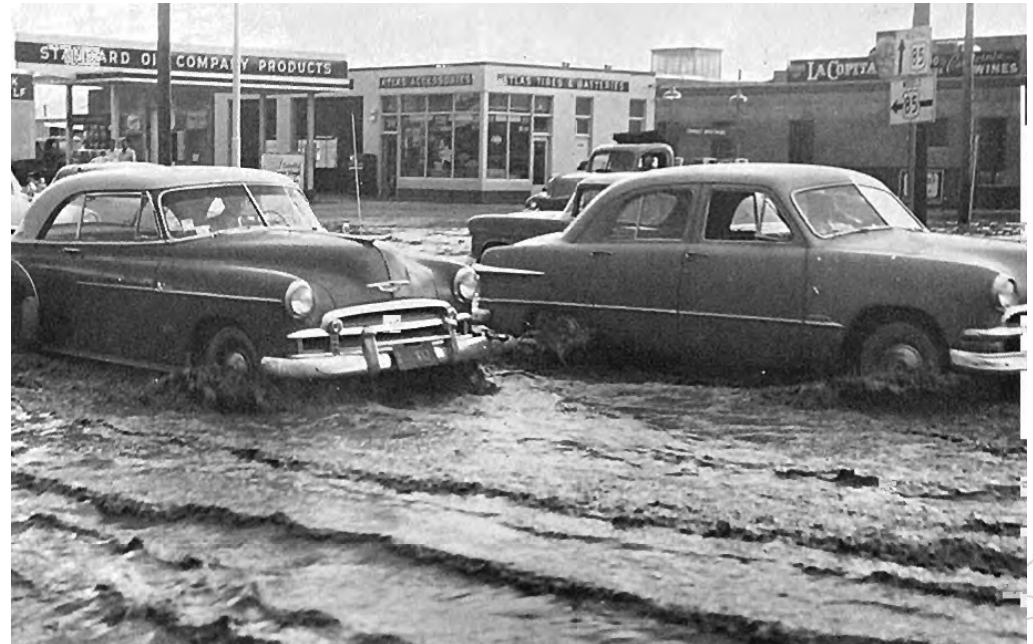
Peak Flows

Date	Flow (cfs)
4-24-1942	25,000
6-23-1949	10,800
5-30-1958	12,700
8-10-1967	13,300
9-15-1972	4,380
8-14-1980	7,600
8-11-1986	5,150
6-7-1993	7,210
8-20-2000	2,040
5-25-2008	5,400
9-13-2013	4,350
6-18-2019	5,720

USGS Rio Grande at Albuquerque

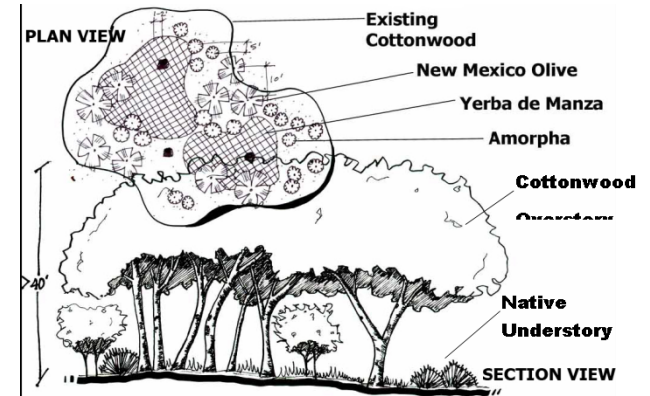
Figure 9. Schematic of a bosque forest

~ 50 % tree community (with 25% tree/grass; 25% tree/shrub),
 ~30% shrub community,
 ~16% grassland/ herbaceous,
 ~4% wet meadow/wetland community

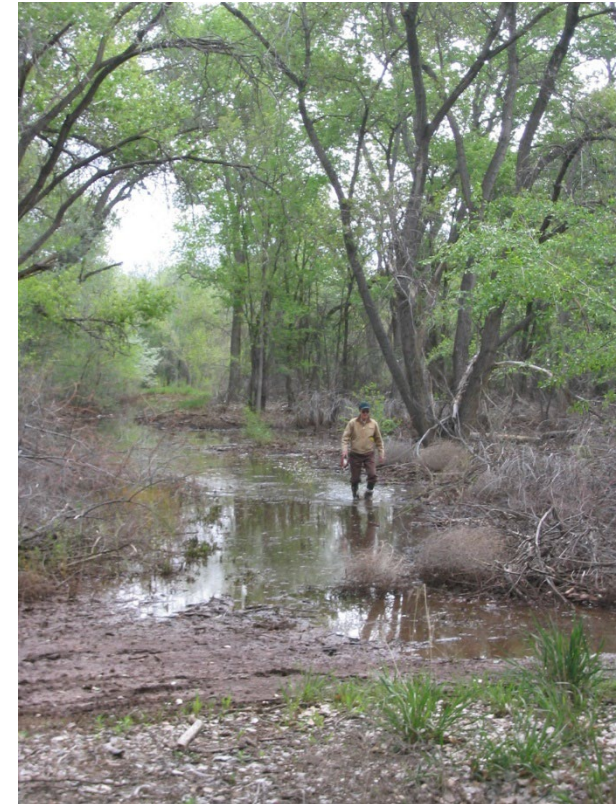
Albuquerque Overbank Project - 1998

*First floodplain connection project,
and with monitoring component*

Let the river do the work!

Bring the bosque to the river

Peak flows: 1998 – 4,060 cfs; 1999 – 4,920
COA Open Space Division, Reclamation, NHPM
Long-term monitoring reporting; Muldavin et al.

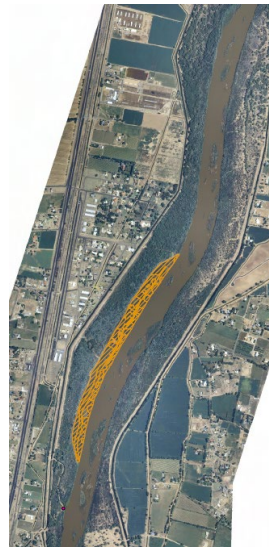
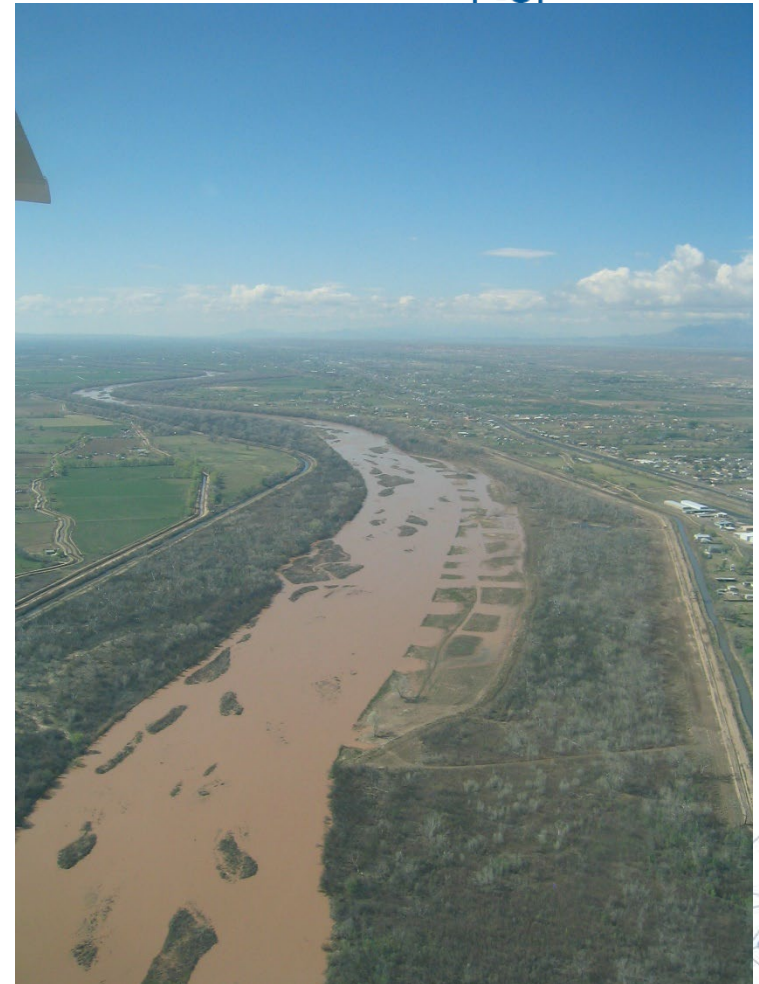
Los Lunas Habitat Restoration Project – 2002-2003

- April 2000 fire
- MRGESCP – Reclamation/USACE leads
- Floodplain connection project
 - Terraces
 - High flow and backwater channels
 - Swales
- Annual monitoring of vegetation, birds, groundwater

2002	2002-09-10	1,770
2003	2003-03-21	1,880
2004	2004-04-03	3,590
2005	2005-06-03	6,780

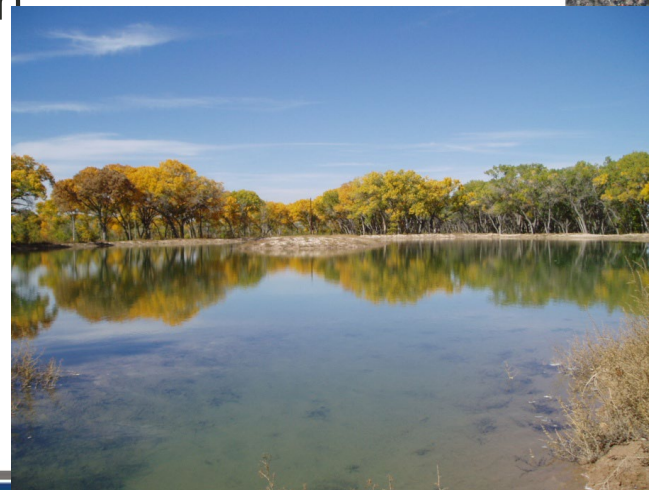
Revitalization @ Route 66 Project

- Fuel reduction, exotic thinning
- Jetty jack removal
- Start of Floodplain connection components:
 - High flow channel
 - Willow swale construction
 - (still not as much terracing/bank lowering)
- Native Revegetation

Finished construction before 2010 high flow

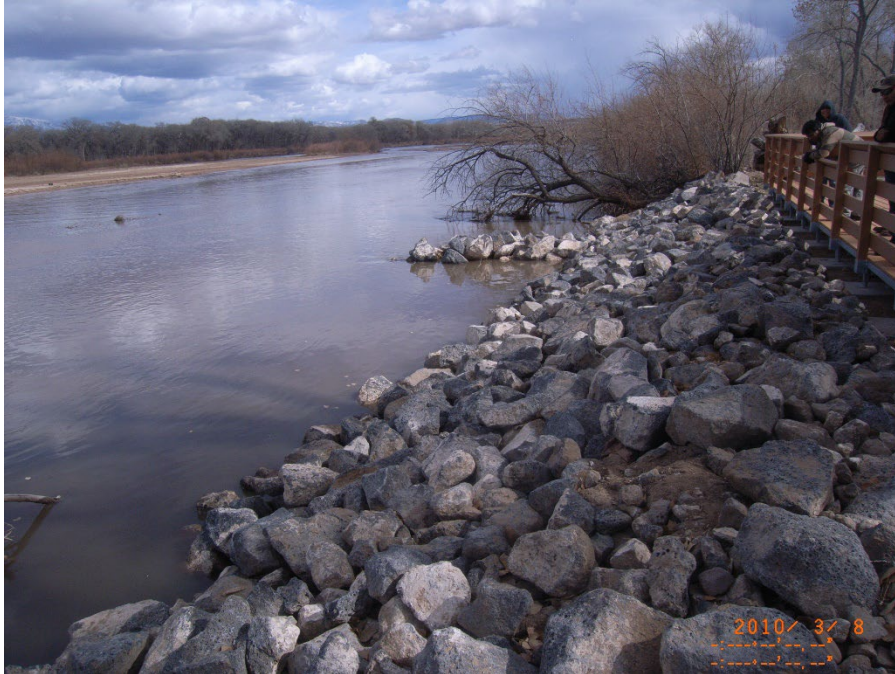
Peak flows:

2010 – 5,140

2011 – 2,710

2012 – 2,510

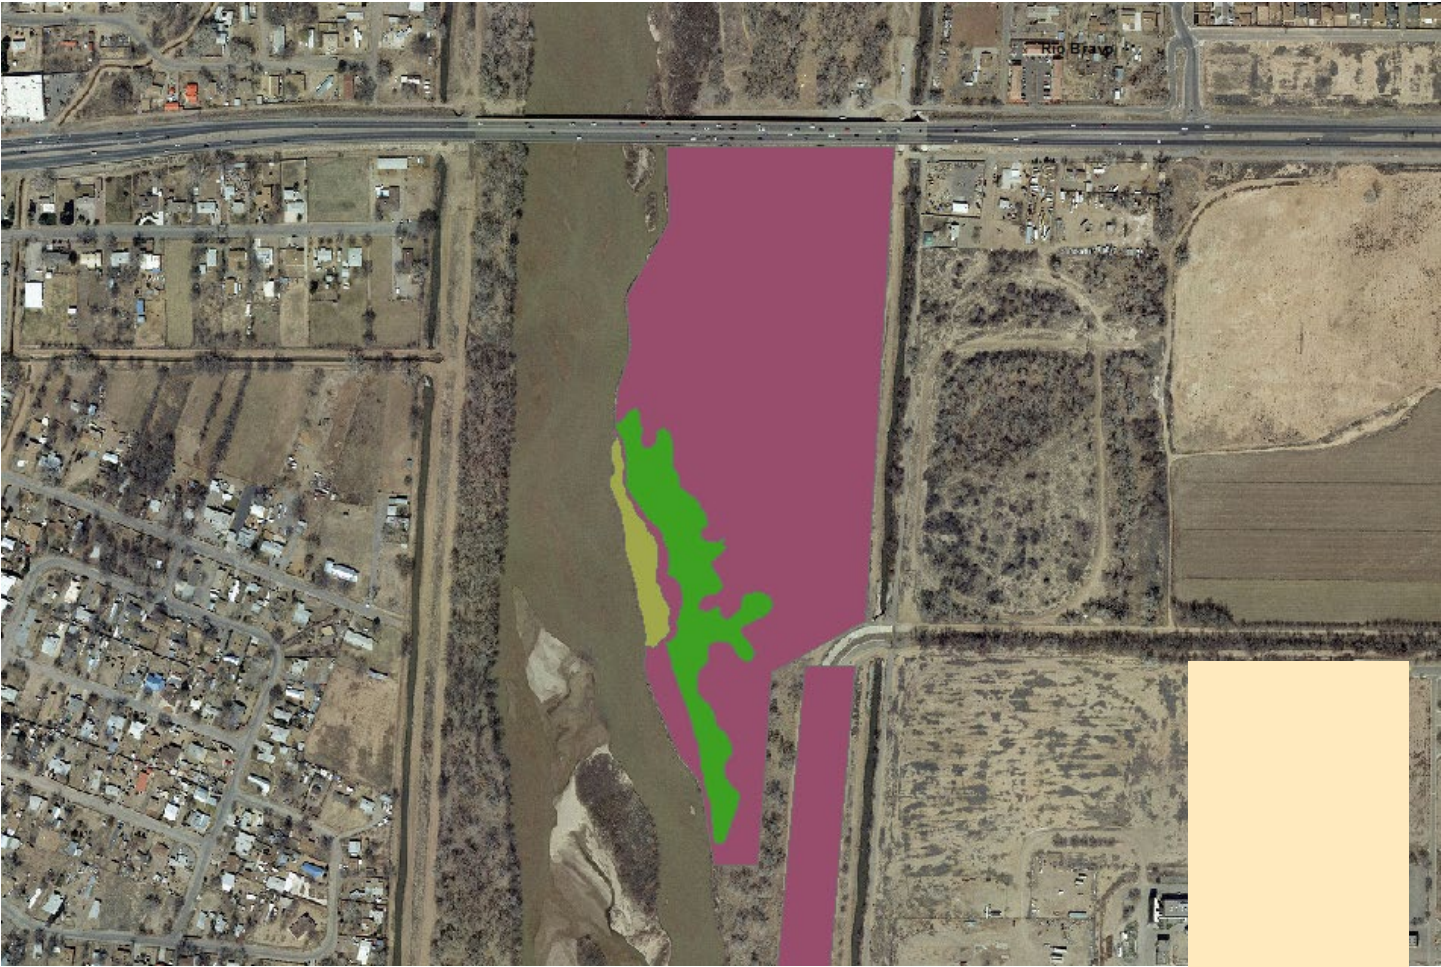
4B – Rio Bravo

Peak flow:
2011 – 2,710,
2012 – 2,510,
2013 – 4,250

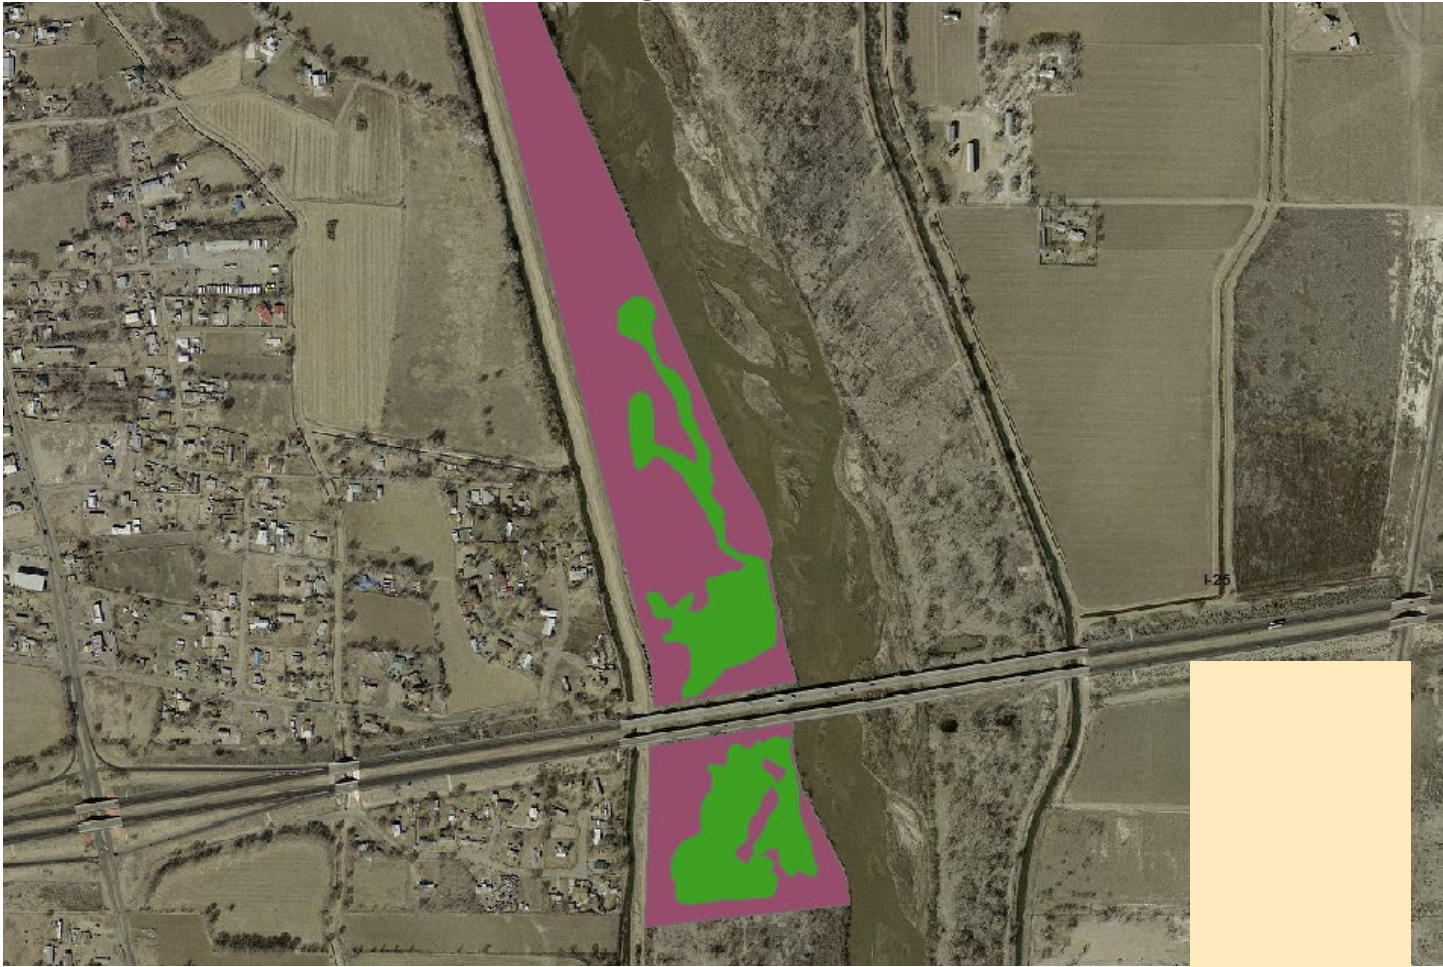
5D and

Peak flow:
2011 – 2,710,
2012 – 2,510,
2013 – 4,250

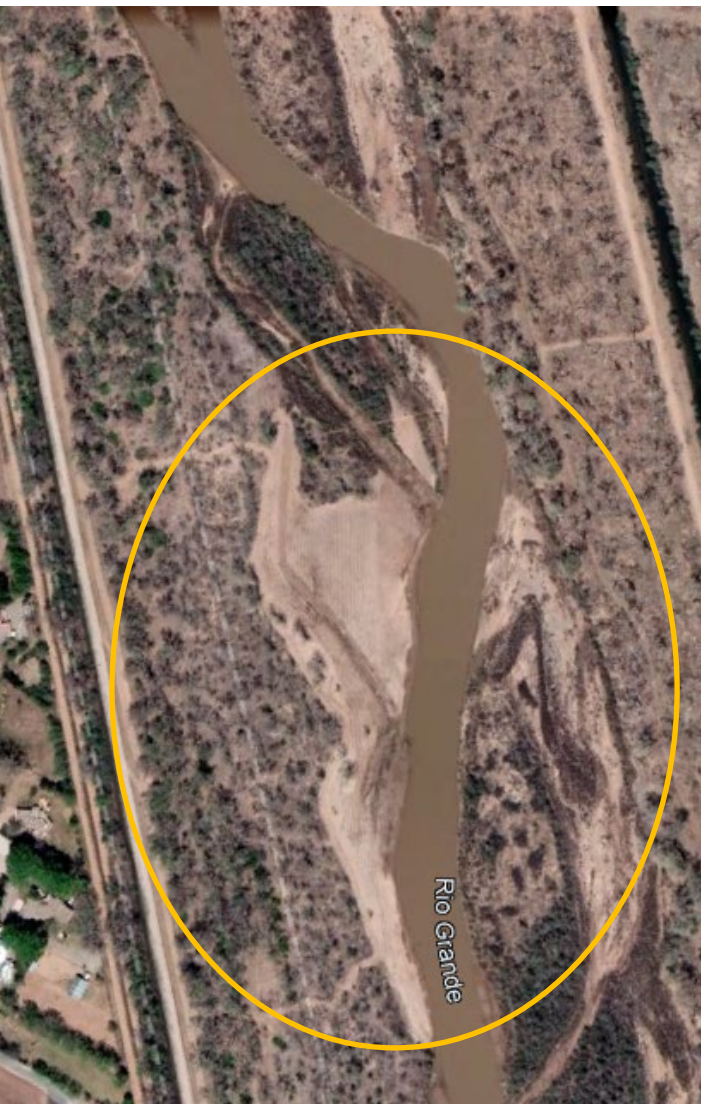
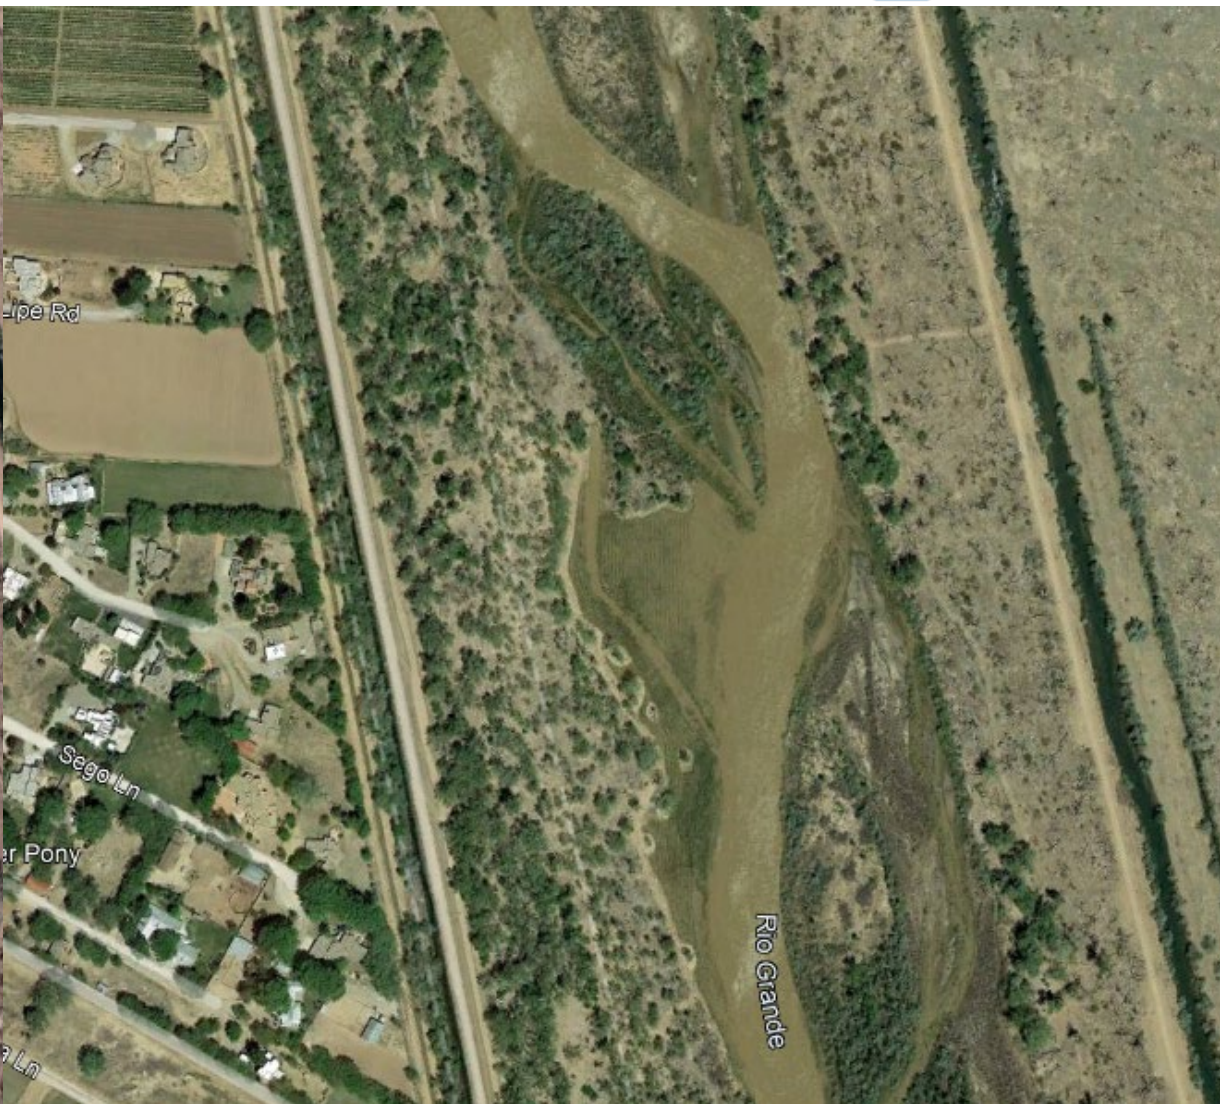
Corrales 1A

April 2016 (June 2016 3,950 cfs)
cfs

April 2017 - (May 10, 2016 - 5,660)

Excavation quantity - field design change
