Rapid spontaneous restoration of Glen Canyon ecosystems as Lake Powell dries

Seth Arens

Western Water Assessment

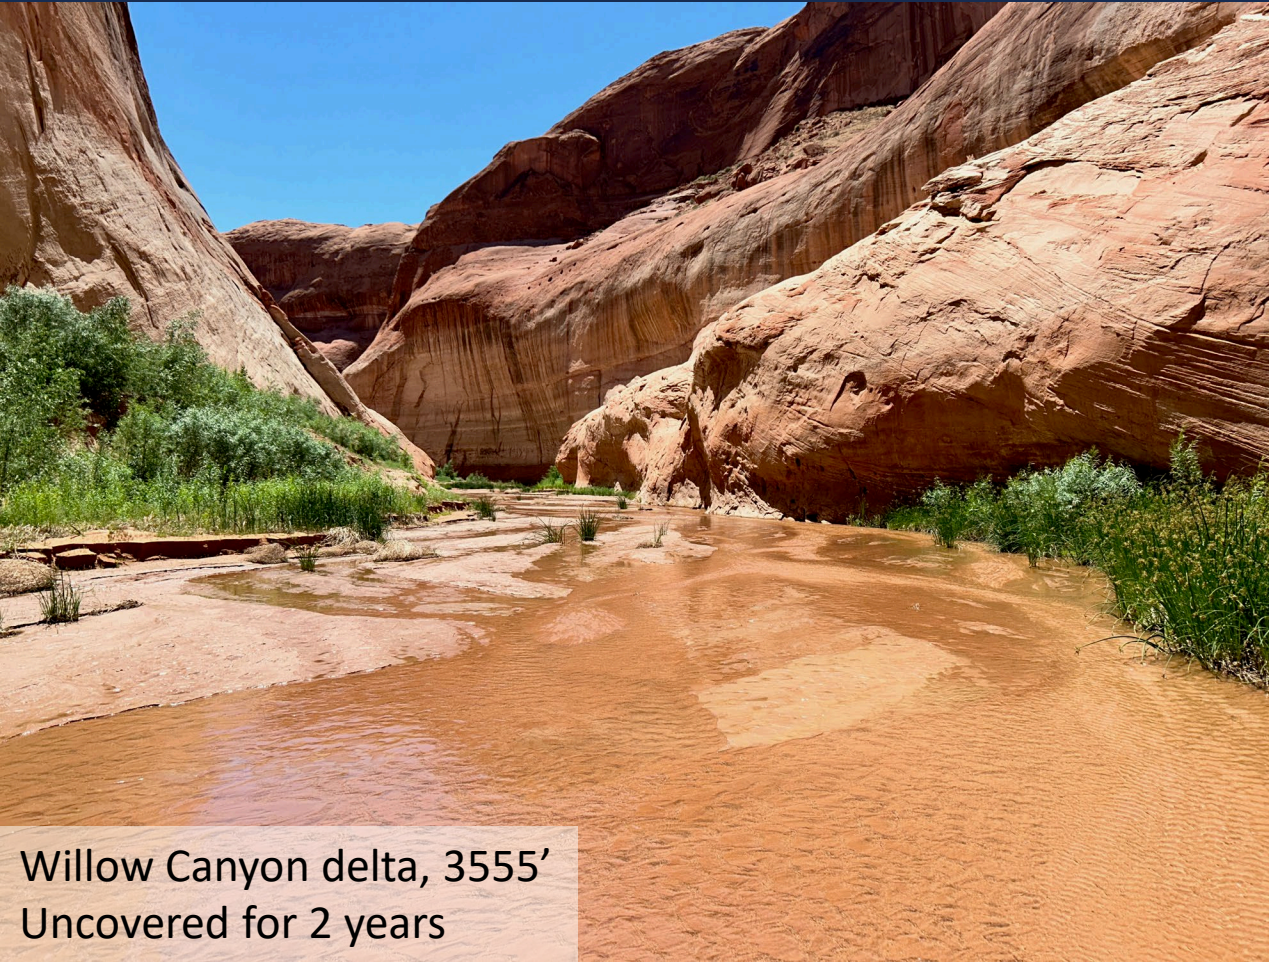
Willow Canyon delta, 3555'
Uncovered for 2 years

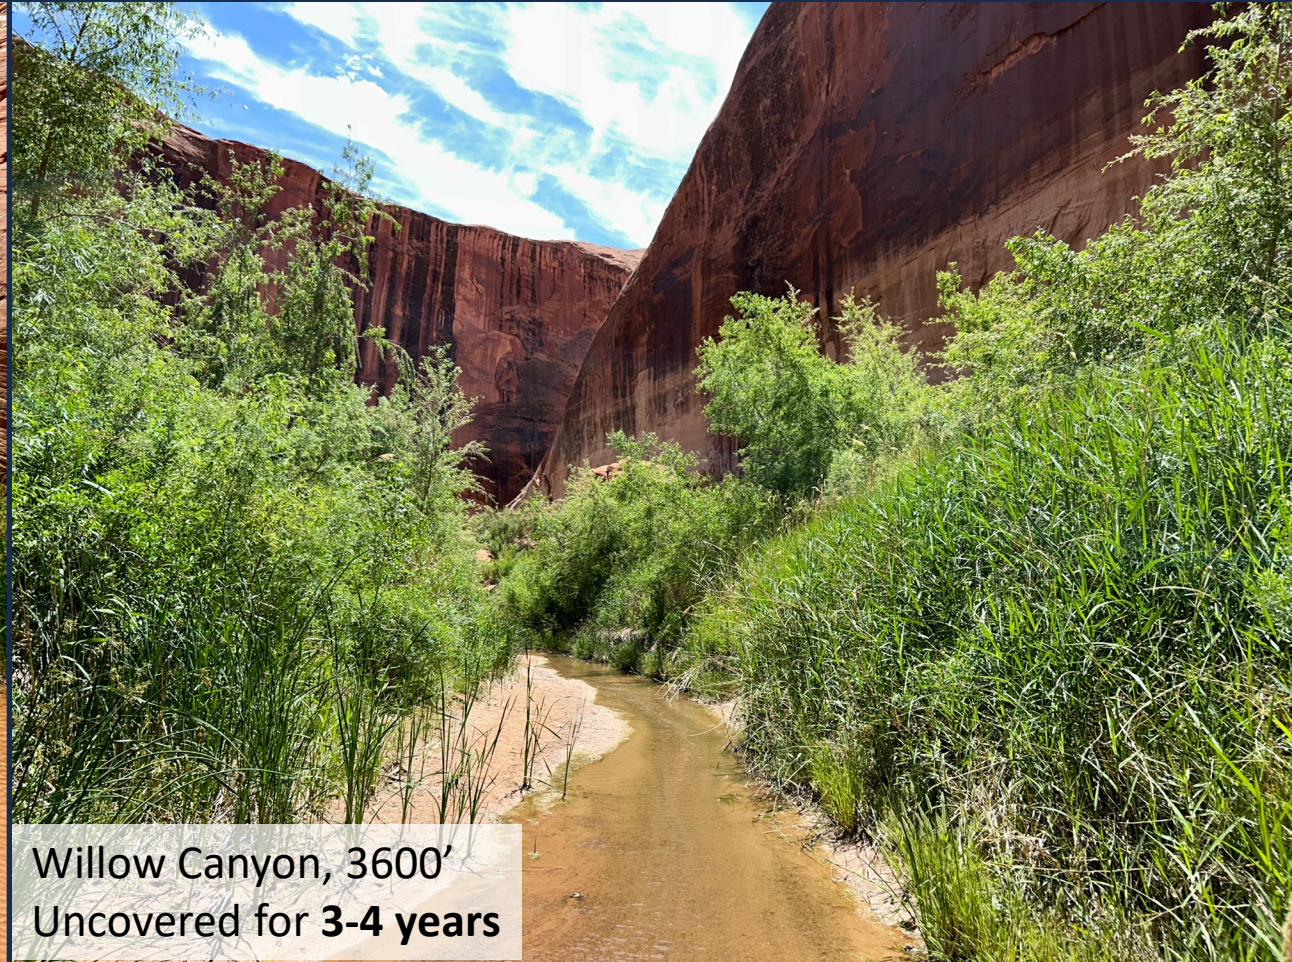
Willow Canyon, 3600'
Uncovered for **3-4 years**

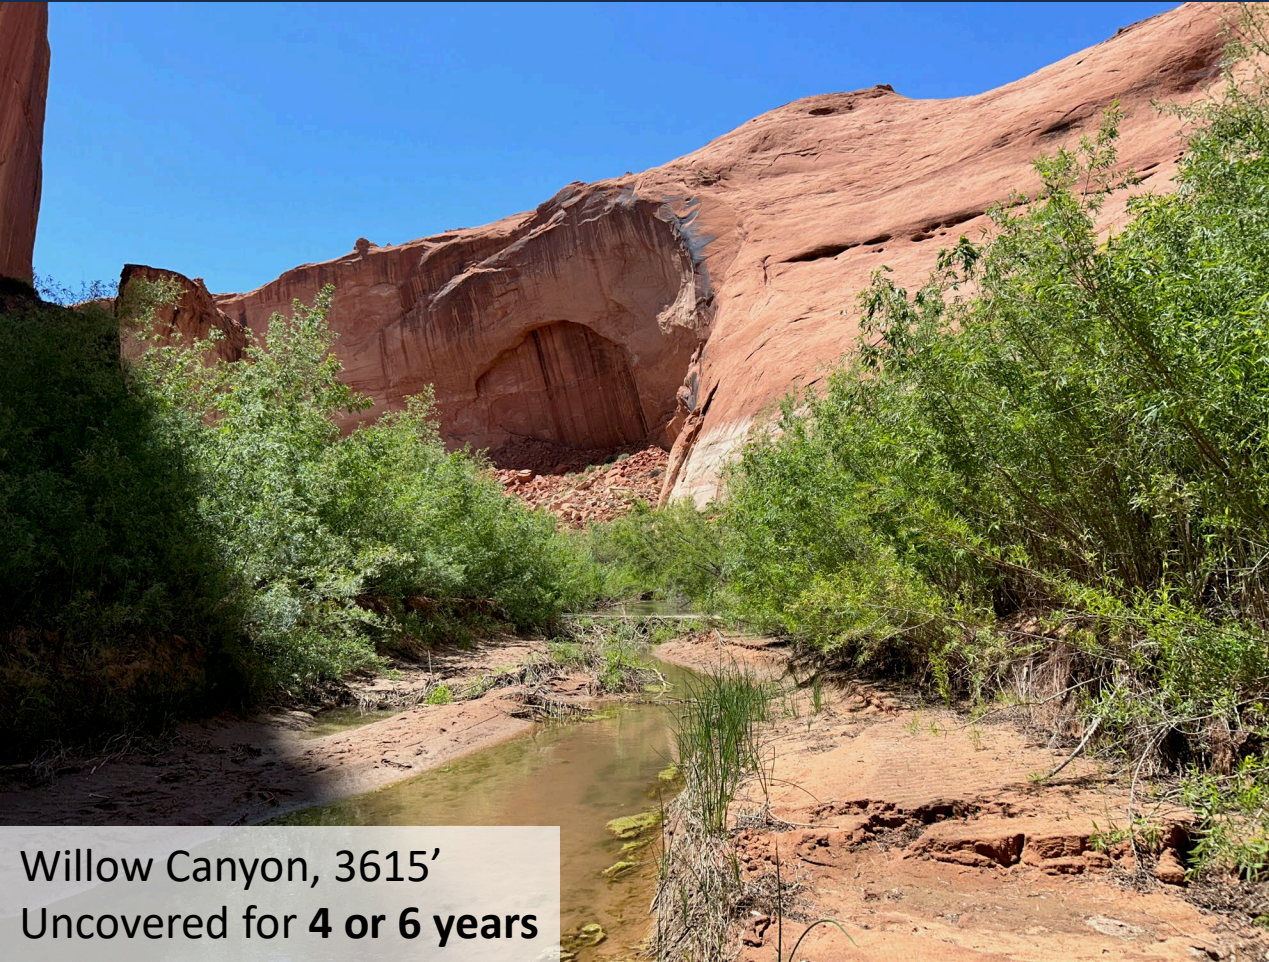
Willow Canyon, 3615'
Uncovered for 4 or 6 years

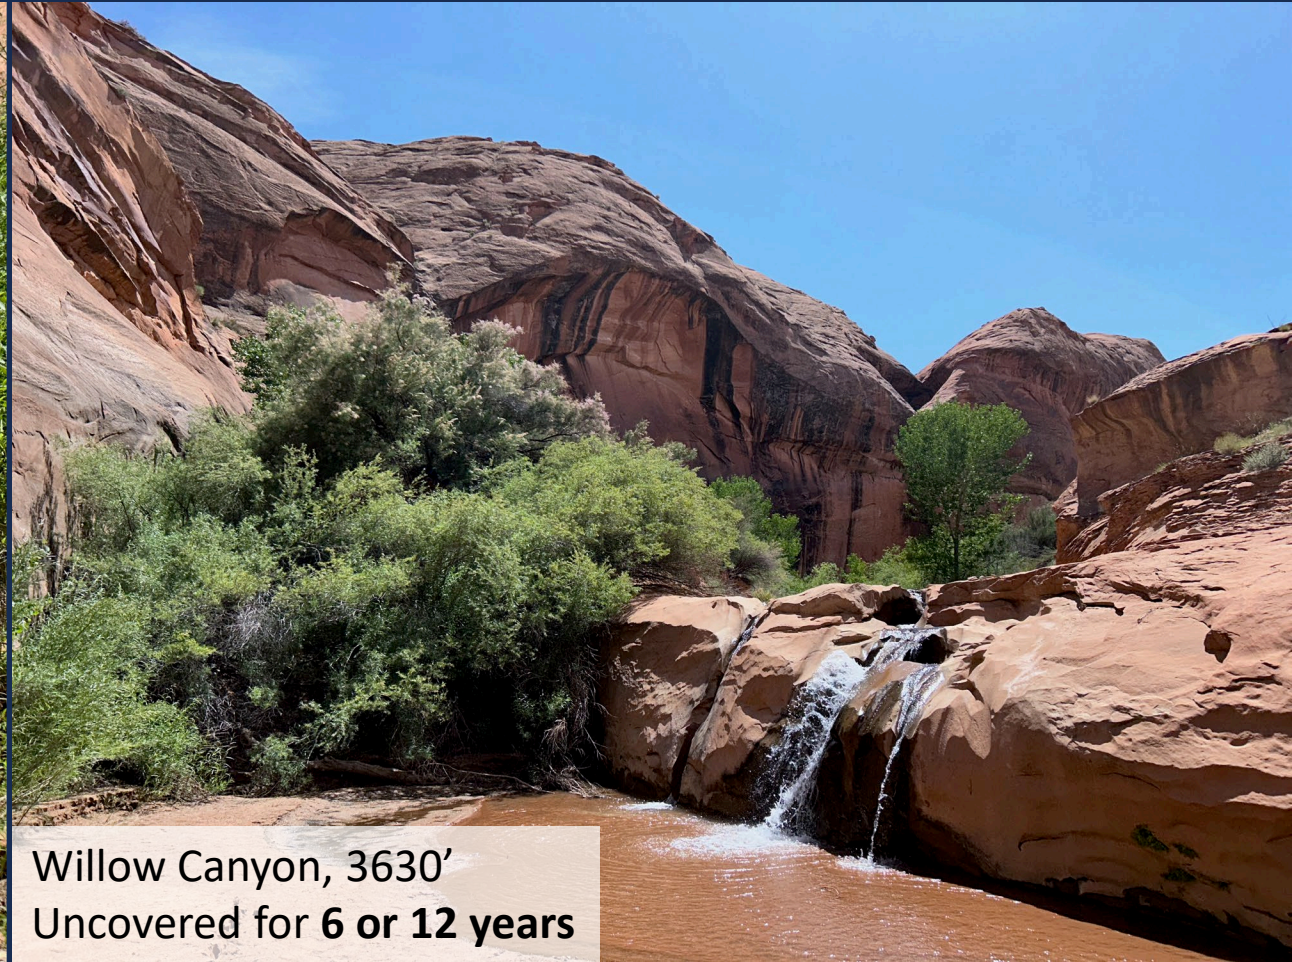
Willow Canyon, 3630'
Uncovered for 6 or 12 years

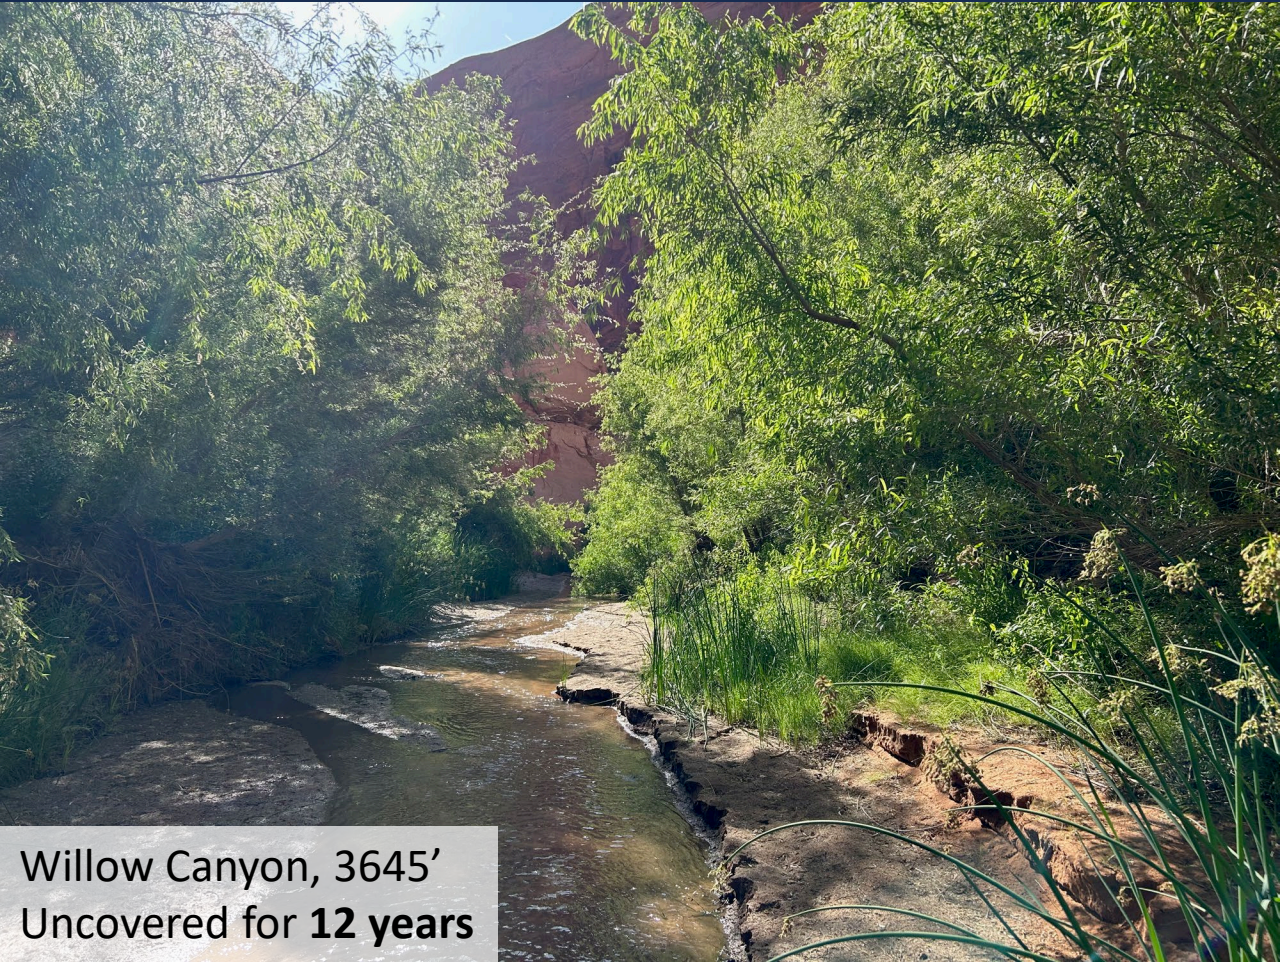
Willow Canyon, 3645'
Uncovered for **12 years**

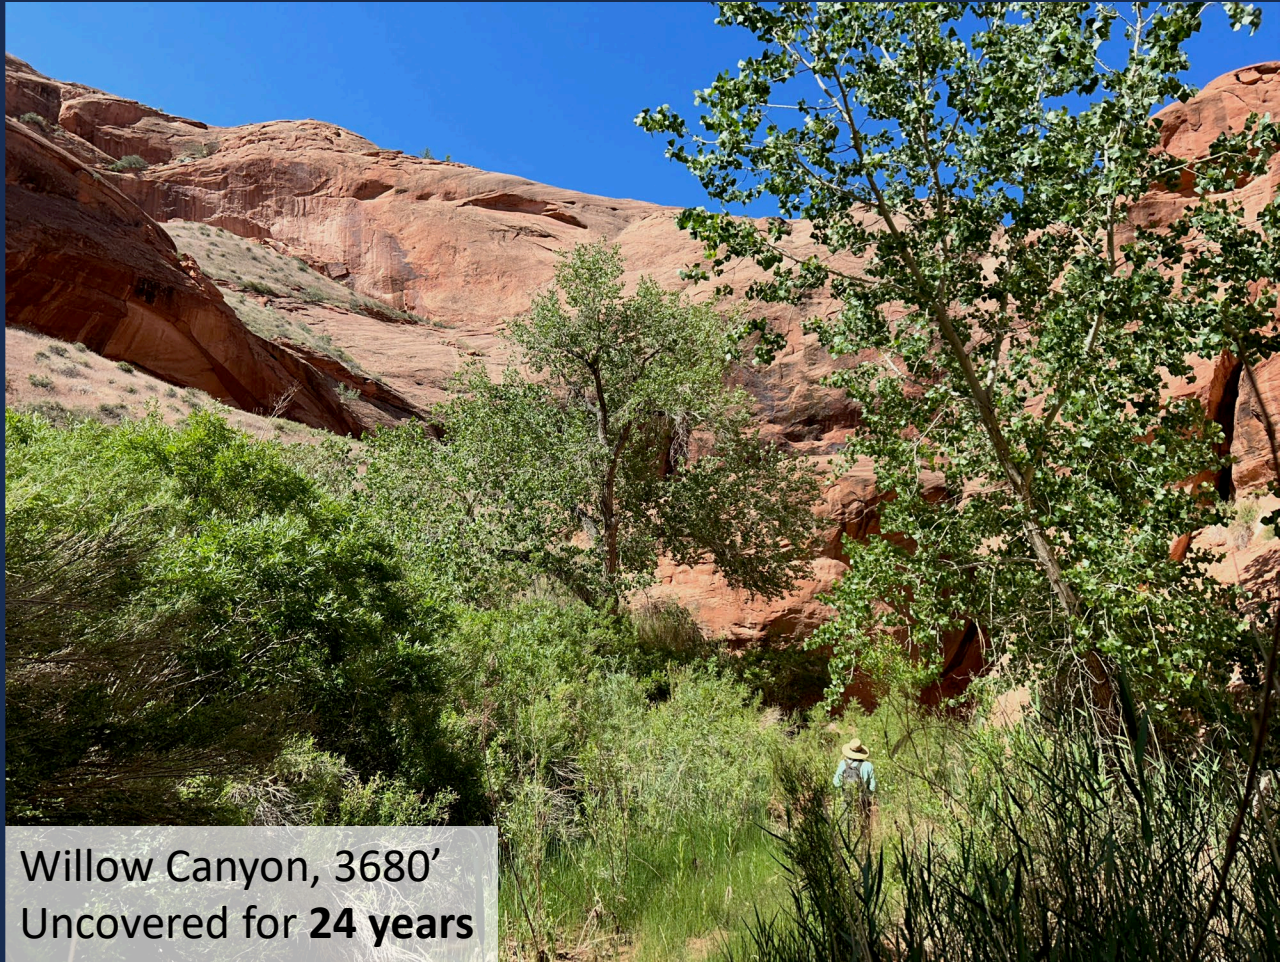
Willow Canyon, 3680'
Uncovered for **24 years**

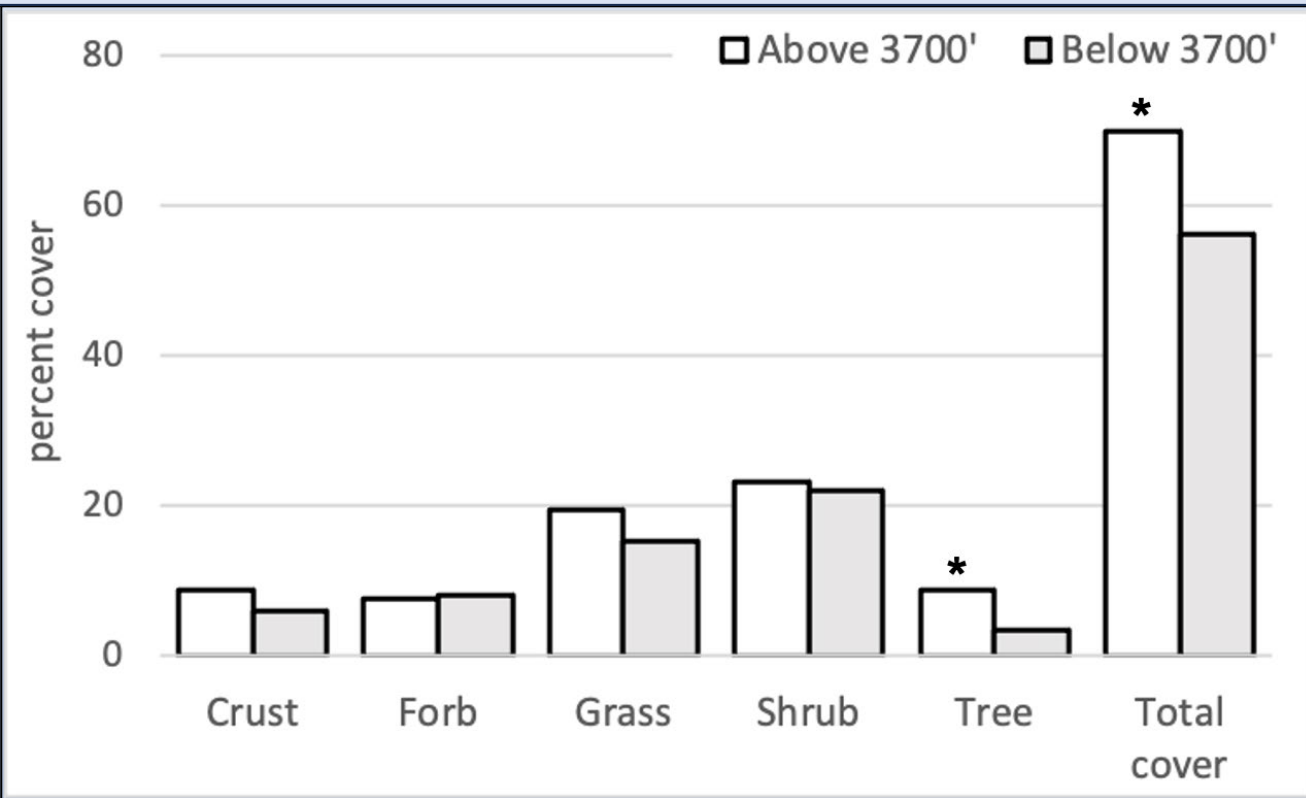
What types of plants are growing?

- Greater **total cover** and **tree cover** at sites above 3700'
- Similar cover of forbs, grasses and shrubs
- More crust above 3700'
 - Crust well-established at many sites exposed for >12 years

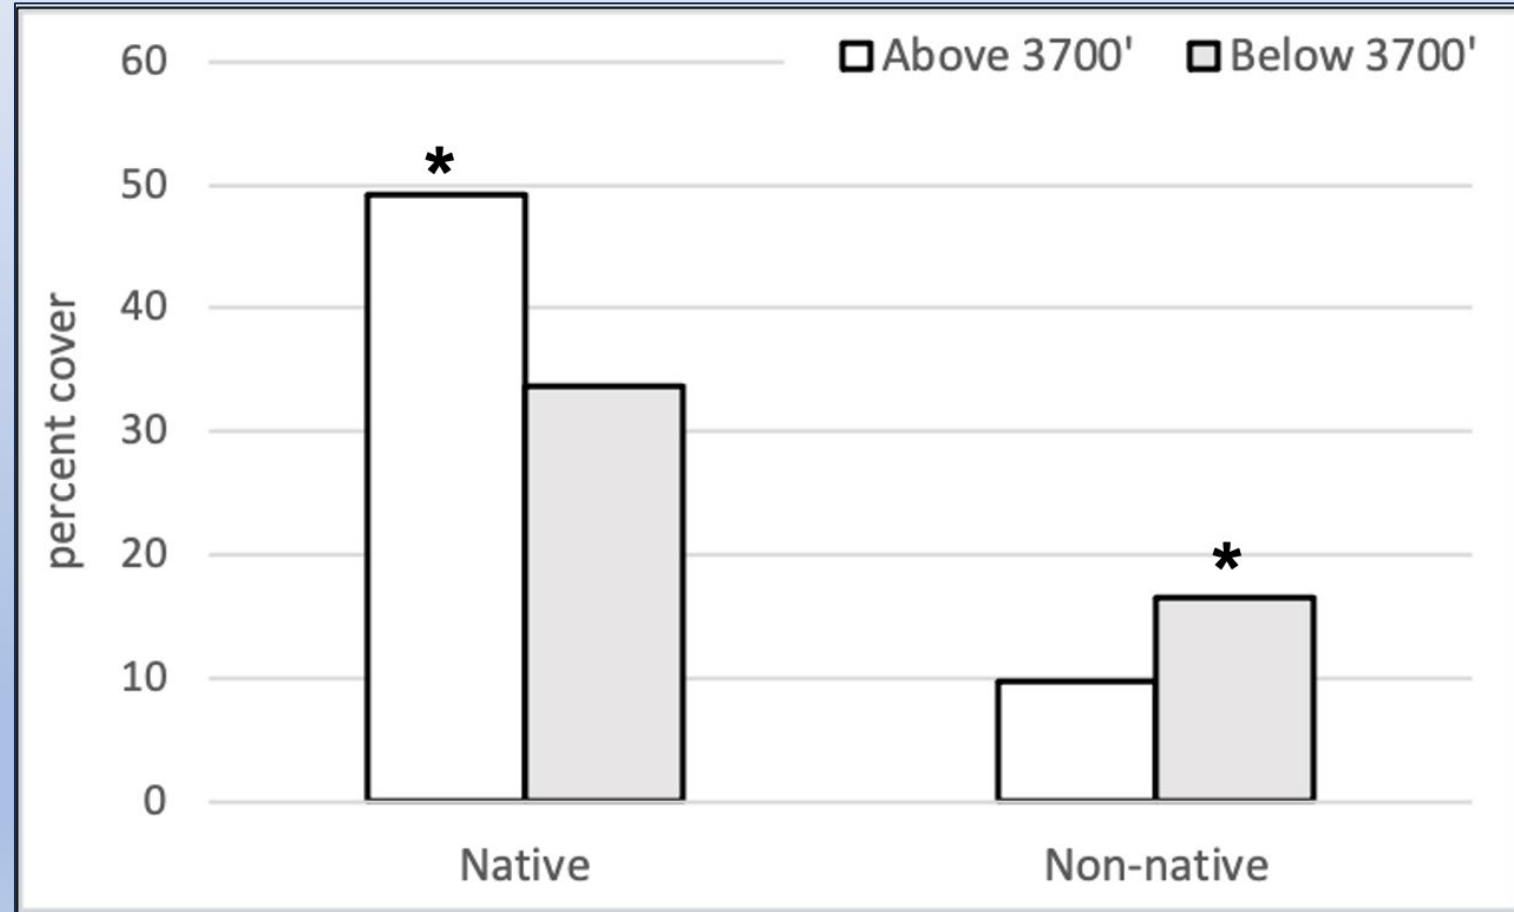
Native v. non-native plants

- Greater cover of native plants above 3700'
- Greater cover of non-native plant below 3700'
- Most abundant non-native species:
 - Tamarisk
 - Russian thistle
 - Cheat grass
 - Awned barnyard grass
 - Ravenna grass
 - Russian olive
