RiversEdge West
Riparian Restoration Conference
March 2024

The Original Ecological Engineer:
How Can Beavers Help With Restoration and Resiliency
of Streams and Riparian Areas?

Fenton Lake State Park Fishing Enhancement with Beaver Dam Analogs

Phase 1 – Planning and Assessment

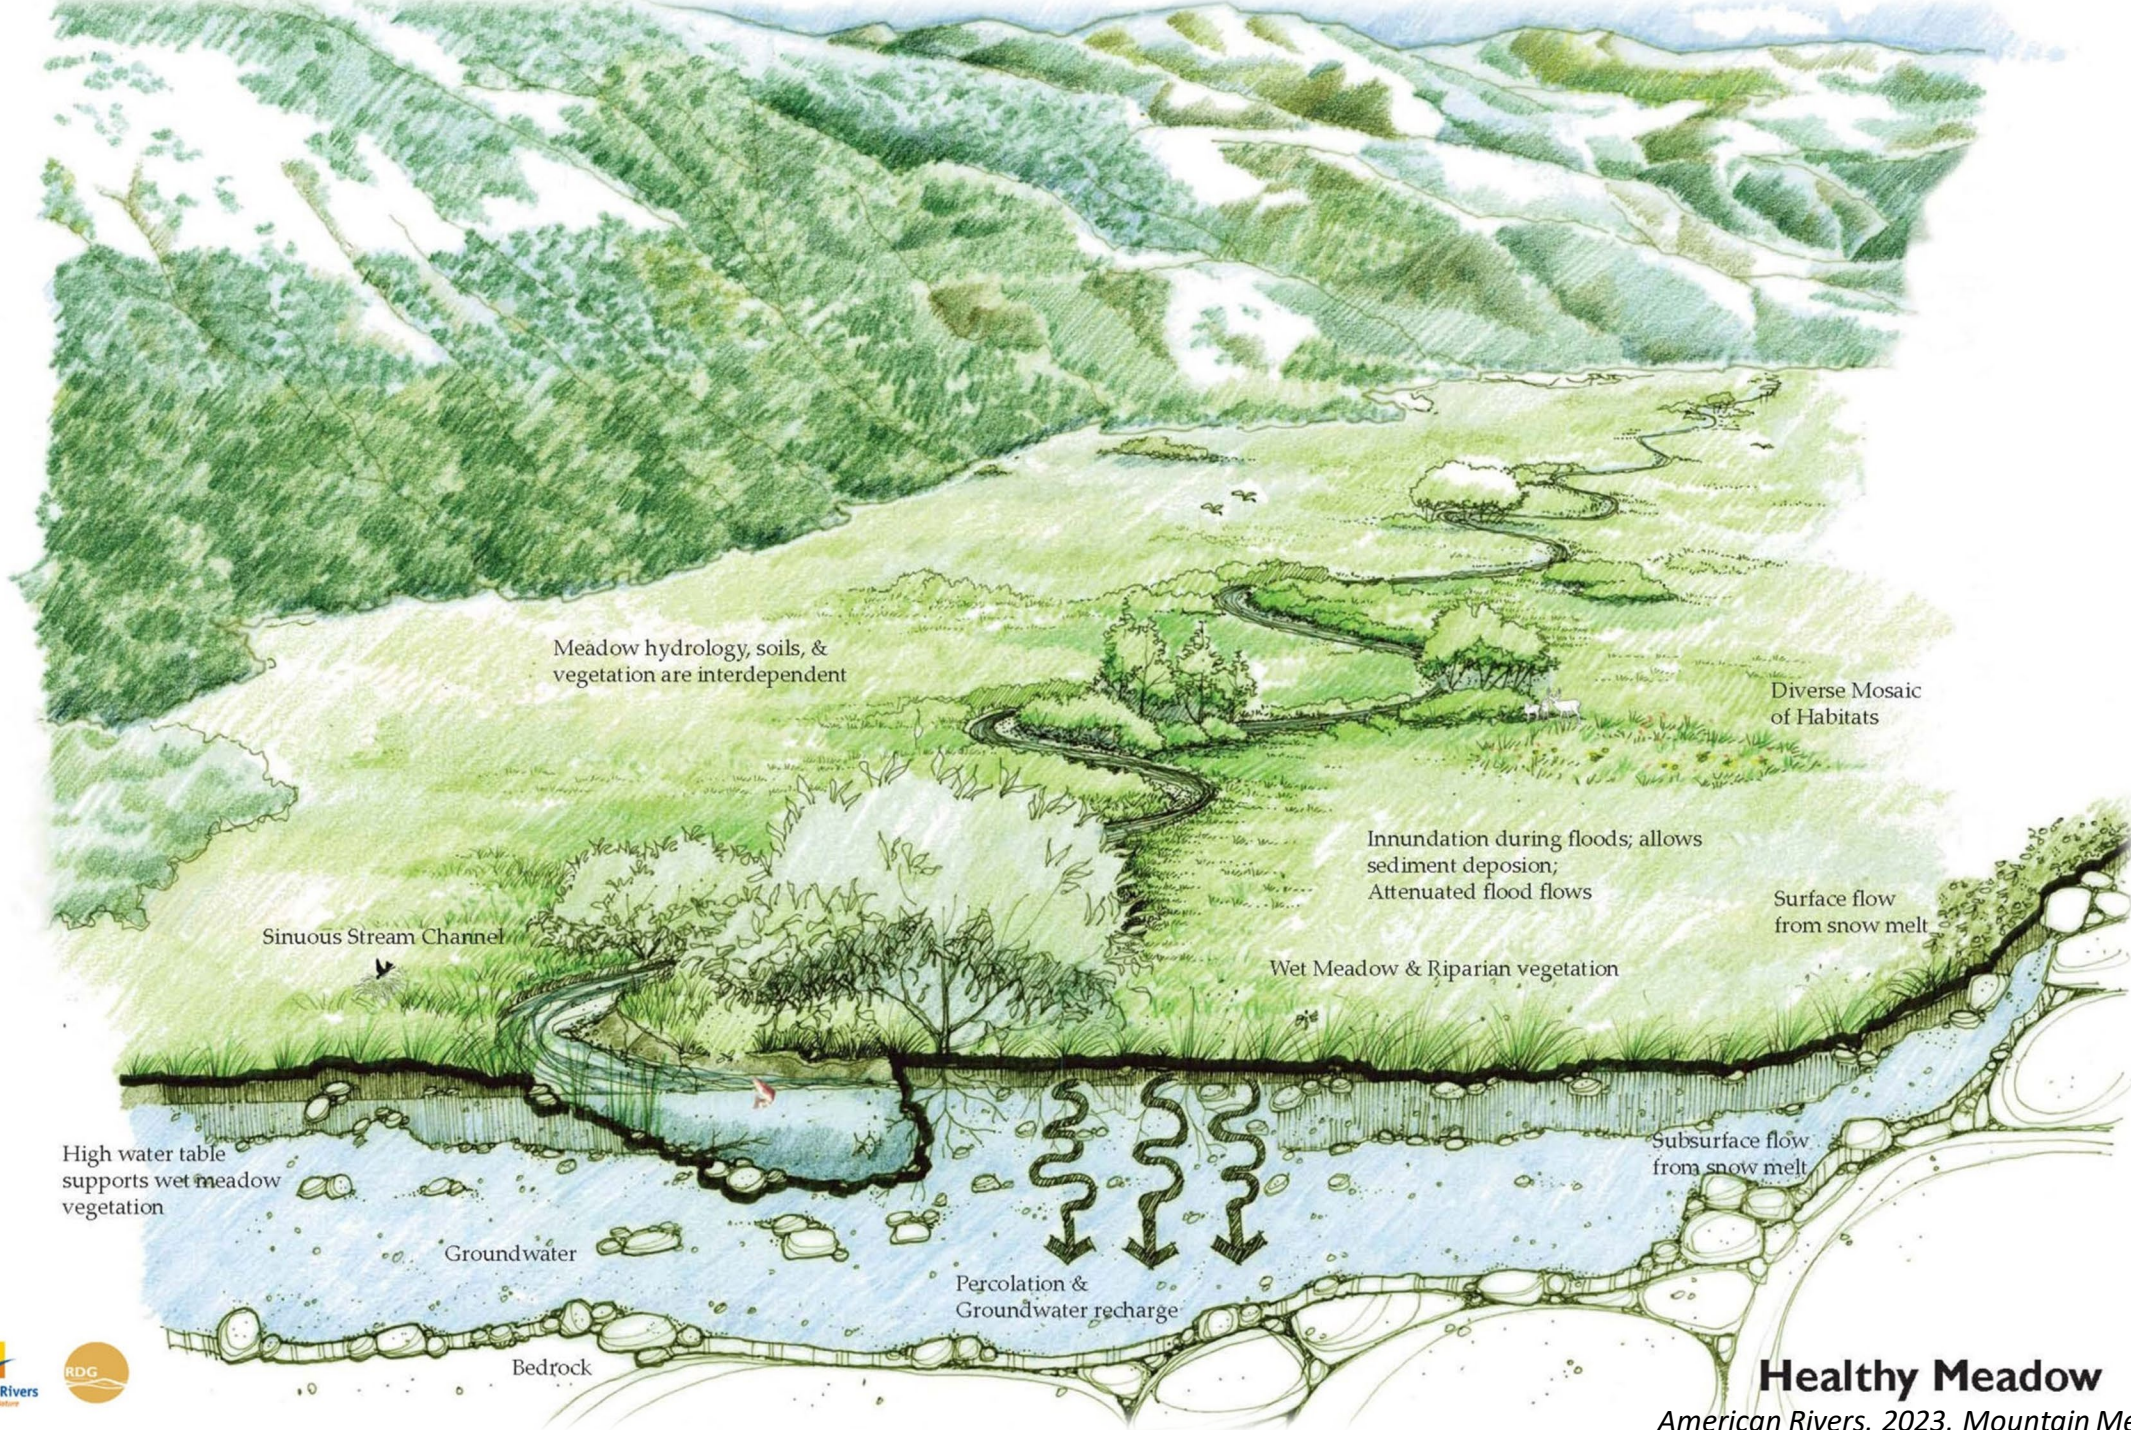
Healthy Meadow

Meadow hydrology, soils, & vegetation are interdependent

Diverse Mosaic of Habitats

Sinuous Stream Channel

Inundation during floods; allows sediment deposition; Attenuated flood flows

Surface flow from snow melt

Wet Meadow & Riparian vegetation

High water table supports wet meadow vegetation

Subsurface flow from snow melt

Groundwater

Percolation & Groundwater recharge

Bedrock

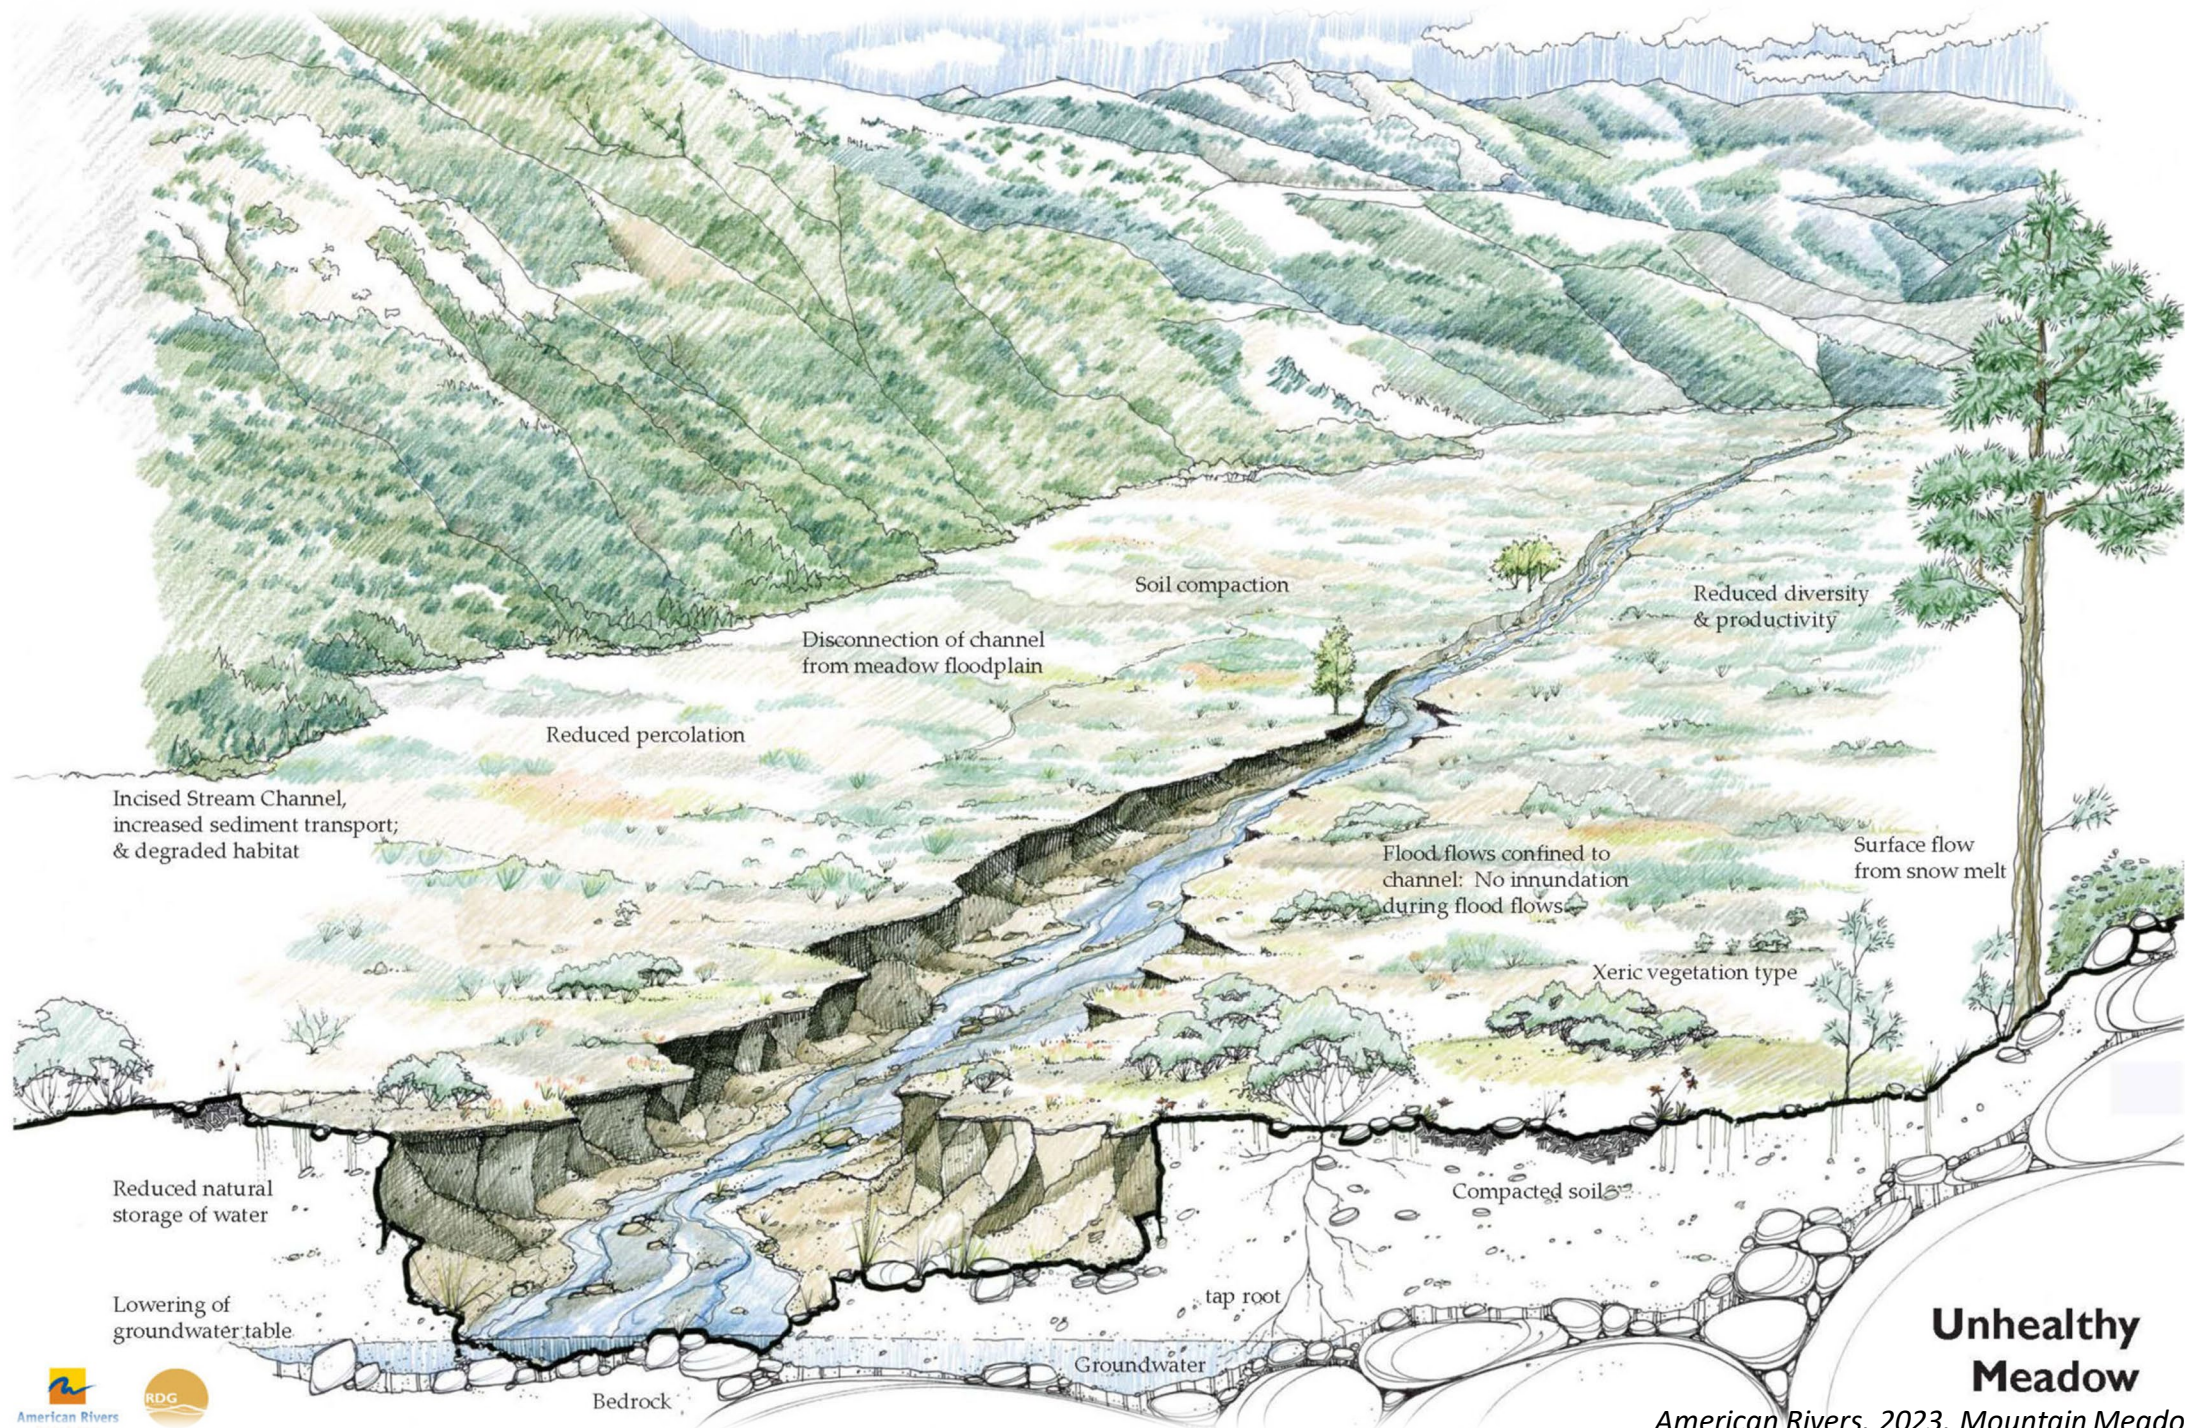
Unhealthy Meadow

Soil compaction

Disconnection of channel from meadow floodplain

Reduced diversity & productivity

Reduced percolation

Incised Stream Channel, increased sediment transport; & degraded habitat

Flood flows confined to channel: No inundation during flood flows

Surface flow from snow melt

Xeric vegetation type

Reduced natural storage of water

Lowering of groundwater table

Compacted soil

tap root

Groundwater

Bedrock

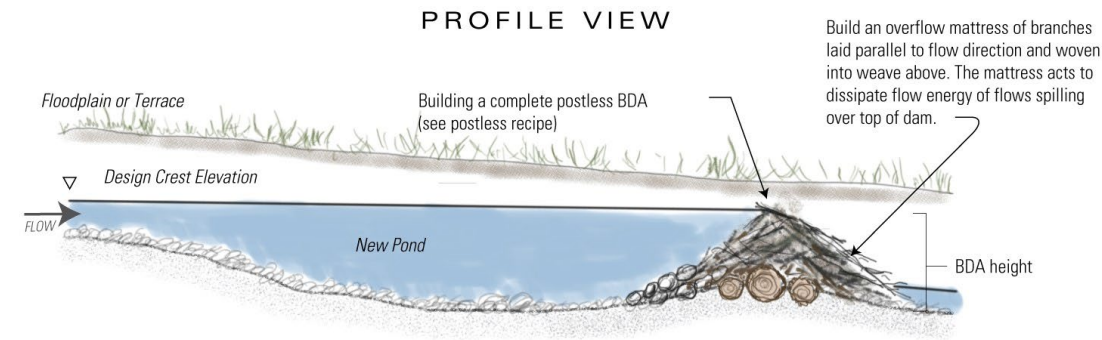
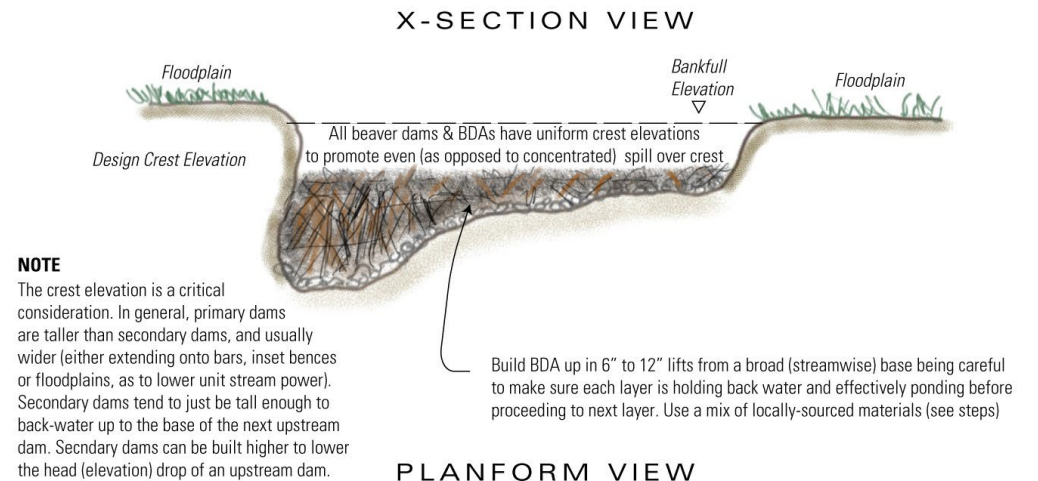
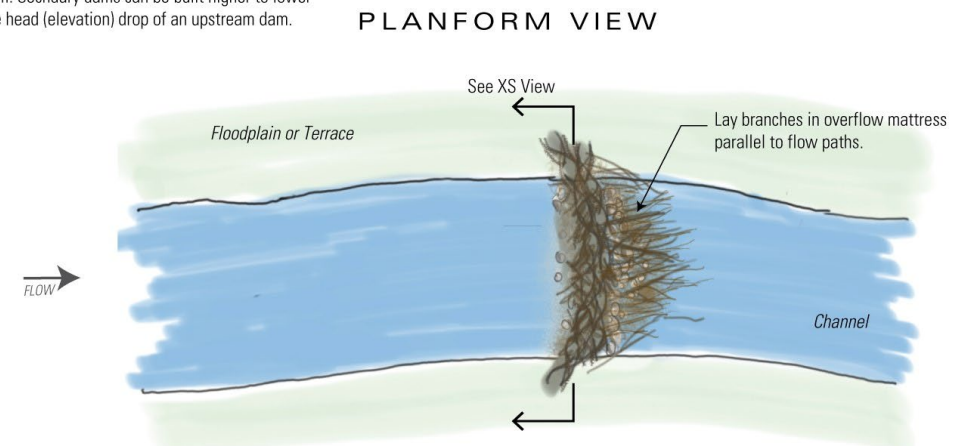
Beaver Dam Analog (BDA) Structures:

“A permeable, channel-spanning structure with a constant crest elevation, constructed with a mix of woody debris and fill material to form a pond and mimic a natural beaver dam.”

- Mimic and promote beaver dam activity
- Encourage hydraulic diversity
- Hand-built with locally sourced natural material
- Permeable
- Not permanent without beaver involvement
- Should be built in high numbers

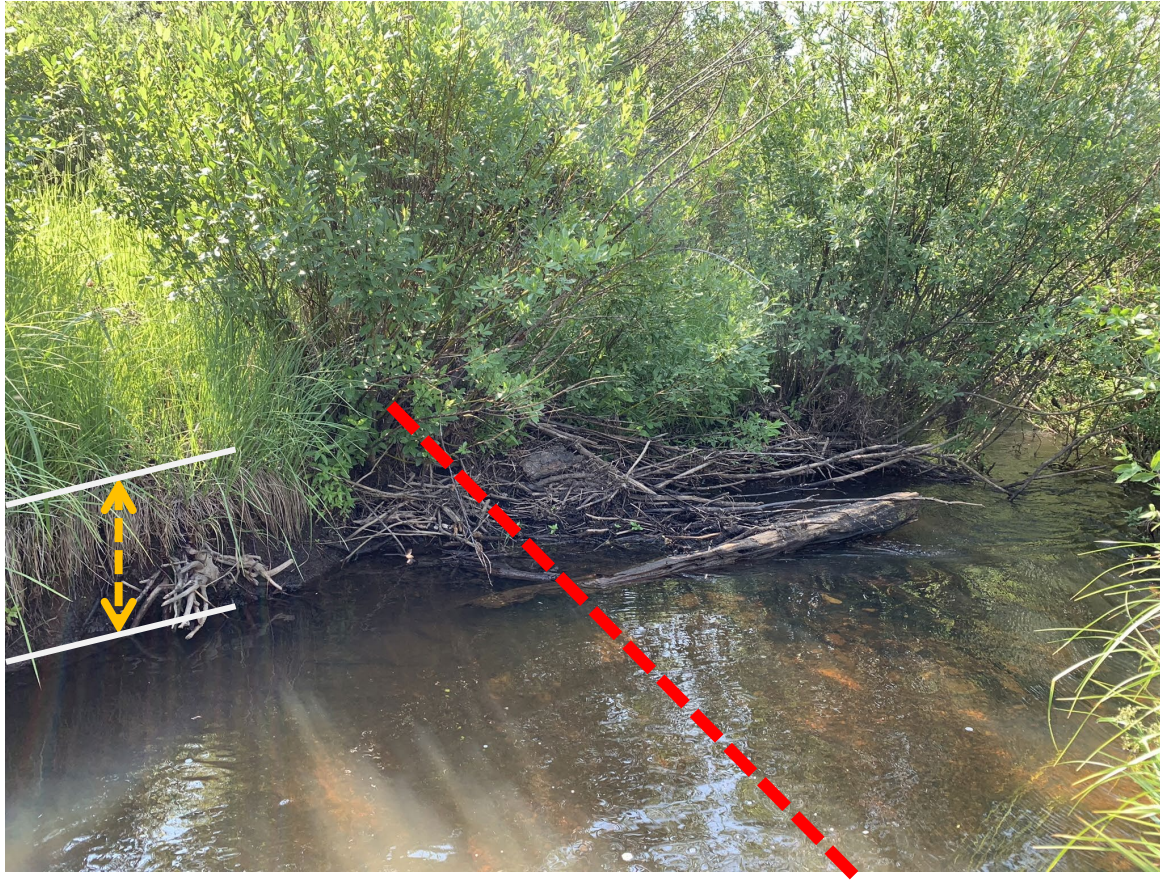
Before:

Before and After BDA Construction

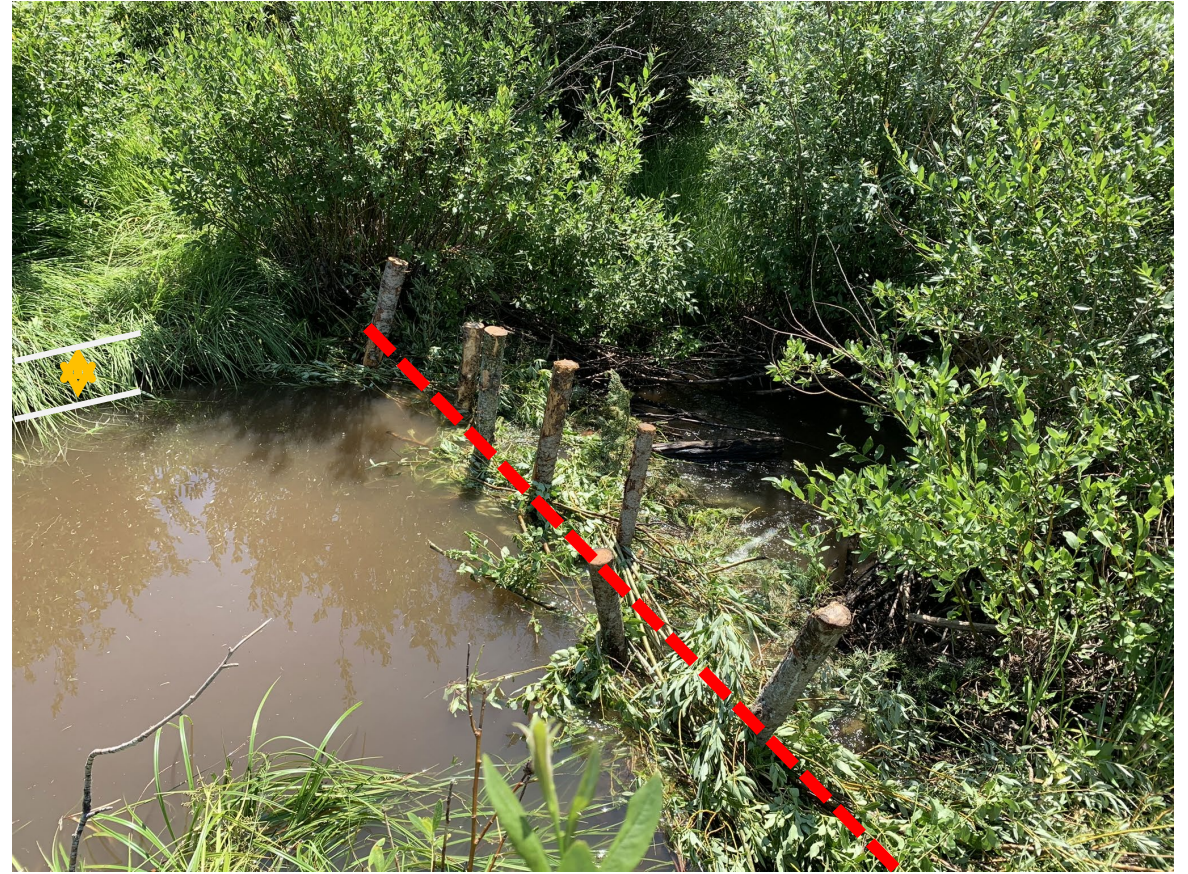
After:

Distance of Water Surface to Top of Bank
Structure Location

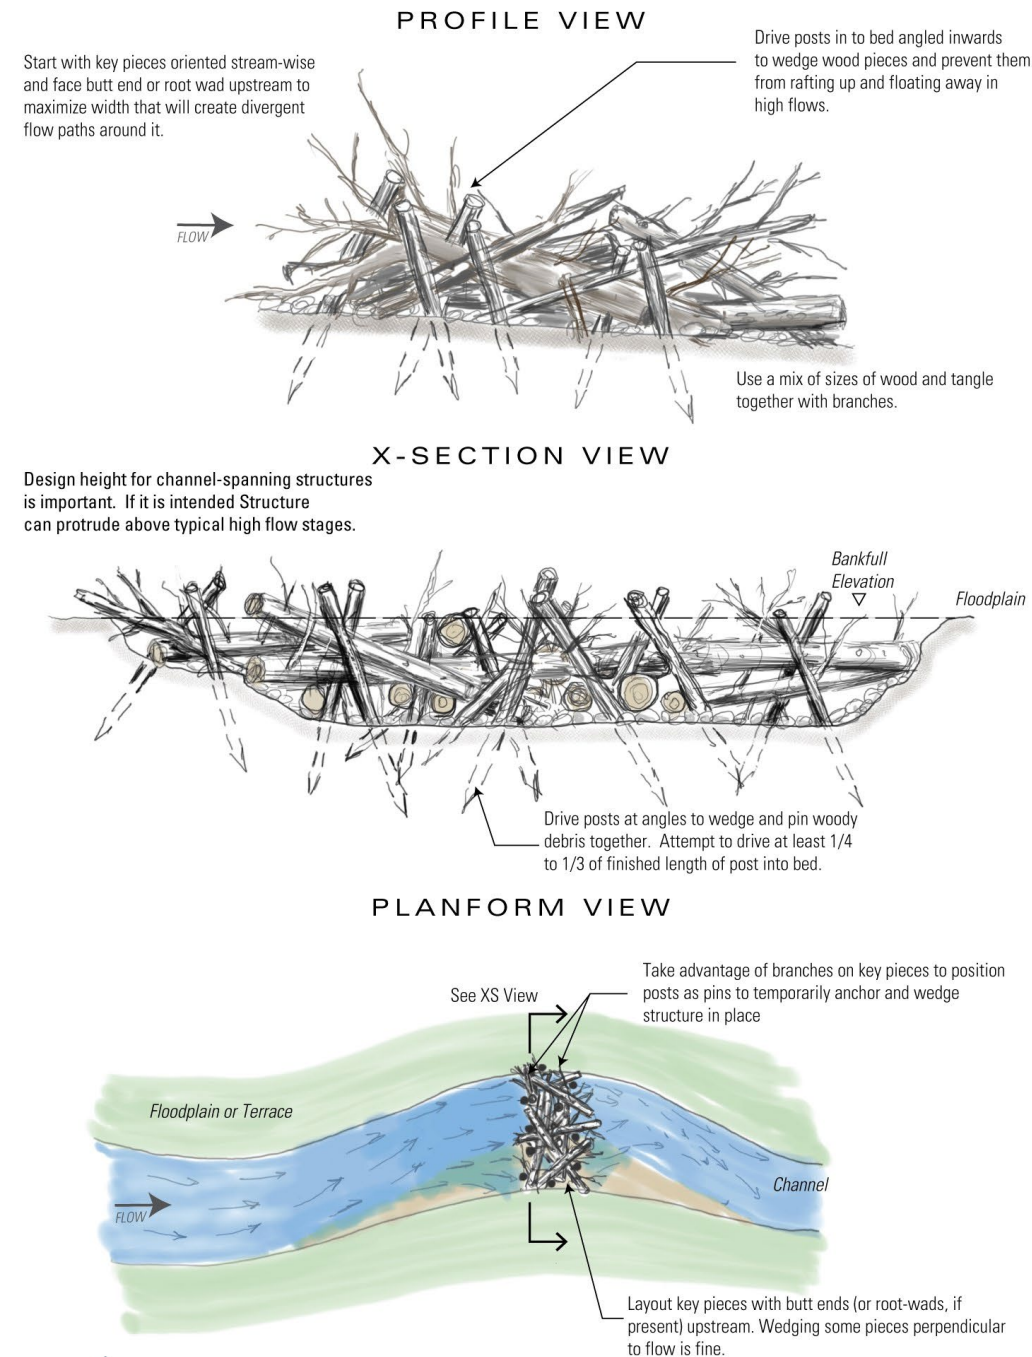
Post-Assisted Log Structures (PALS):

“Woody material of various sizes pinned together with untreated wooden posts driven into the substrate to mimic natural wood accumulations”

- Mimic and promote the processes of wood accumulation
- Hand-built with locally sourced natural material
- More permeable, temporary
- Should be built in high numbers
- Range of shapes, sizes and orientations

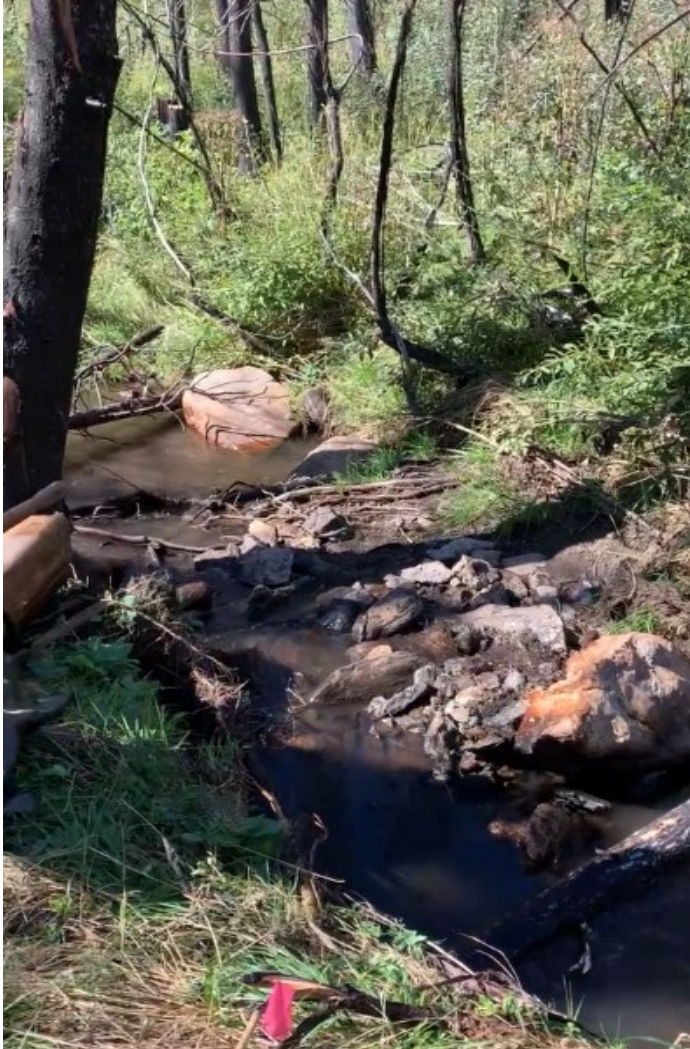
Before:

Before and After PALS Construction

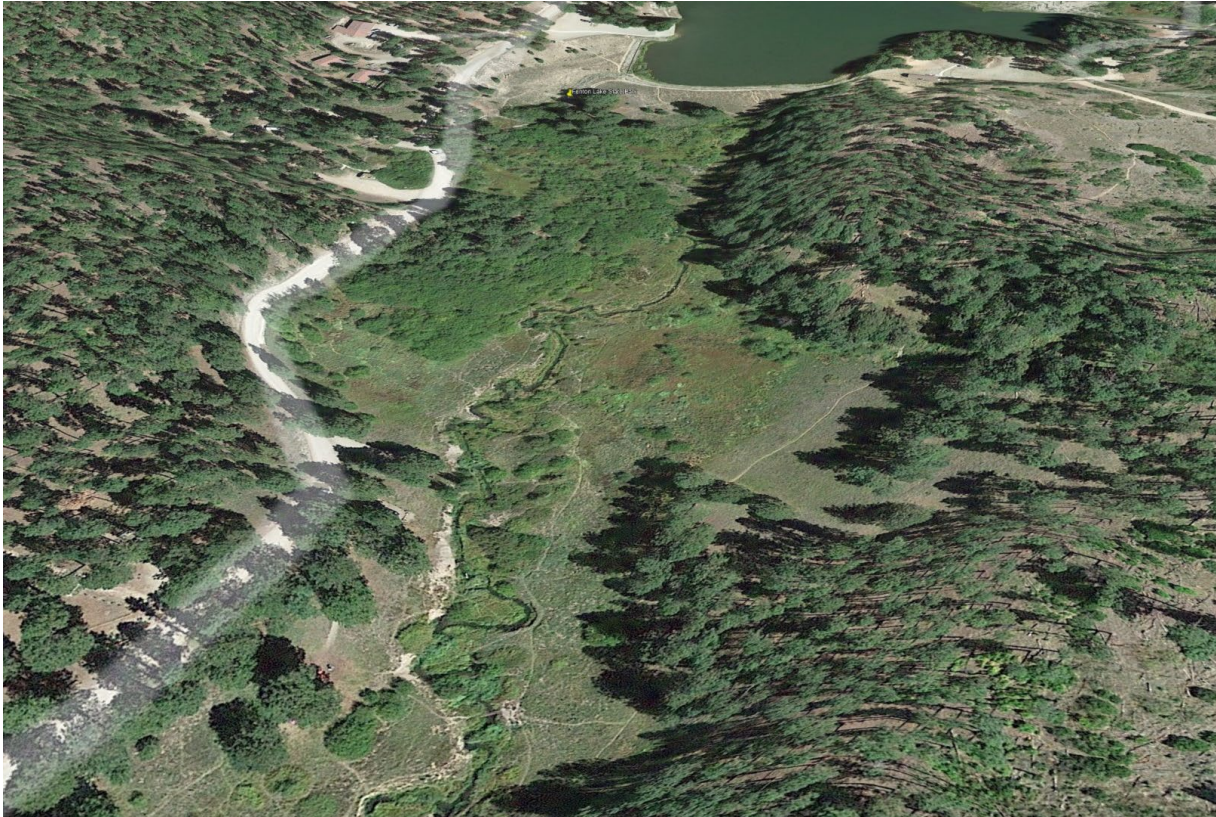
September 2017
No Beavers

Fenton Lake Aerial Comparison

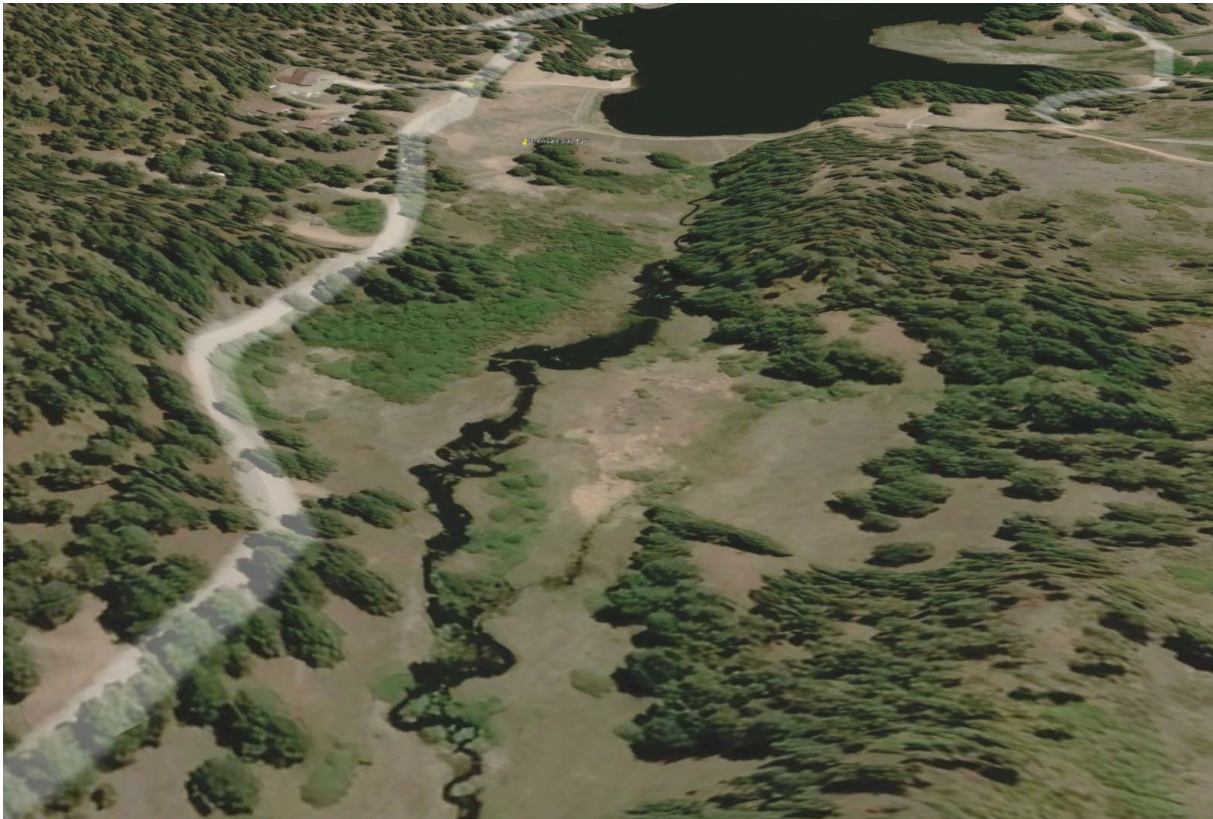
**May 2020
Beavers!**

Aerial Comparison (continued)

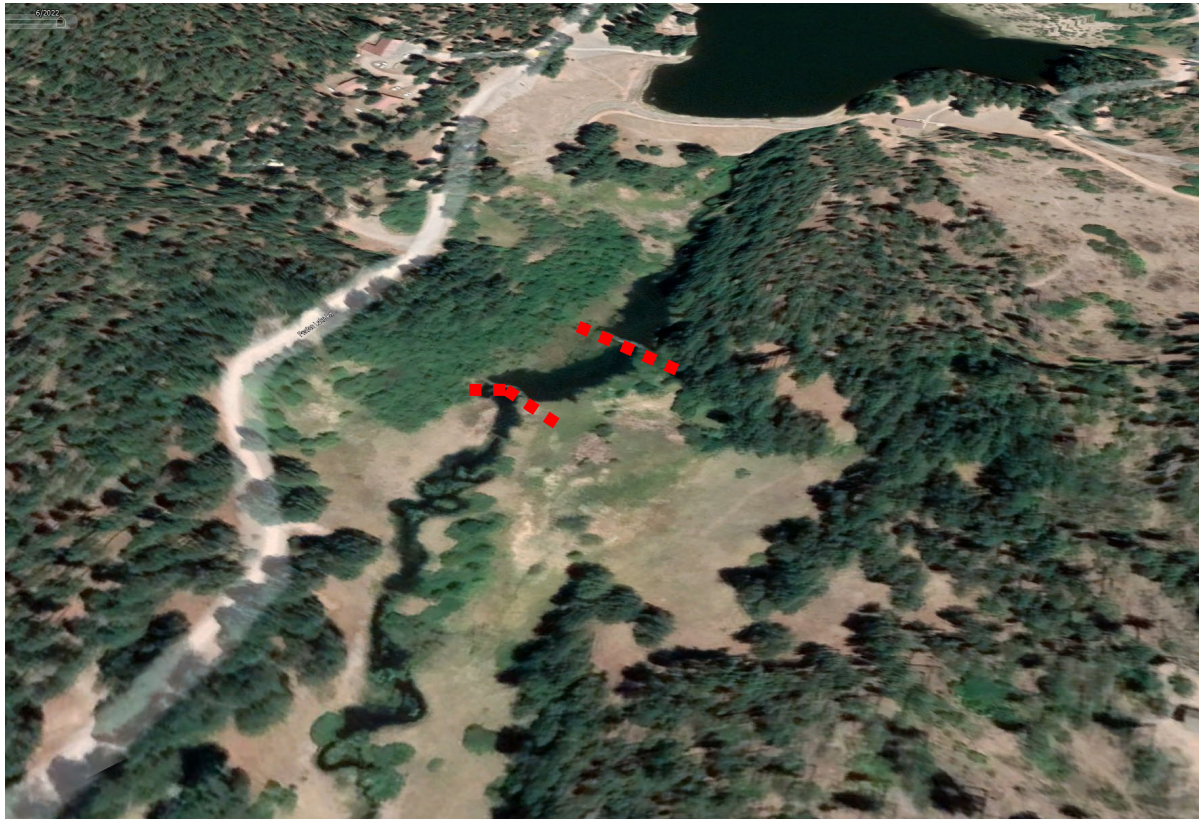
June 2022 (Google Earth)
Beavers!

Aerial Comparison (continued)

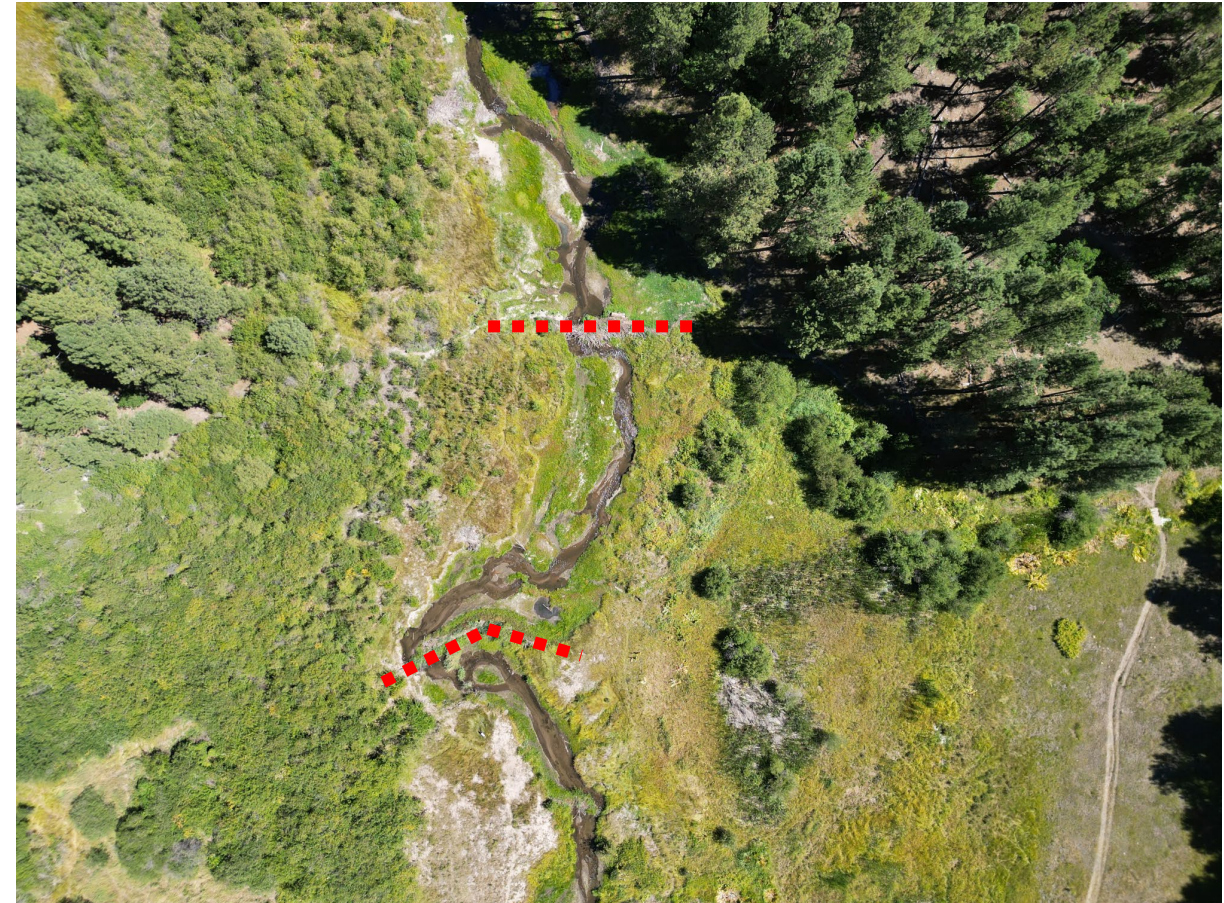
August 2023 (drone flight)
No Beavers 😞

VALLEY BOTTOM MARGIN

BEAVER DAM STRUCTURE

OLD FLOODPLAIN EXTENTS

OLD WETTED EXTENTS

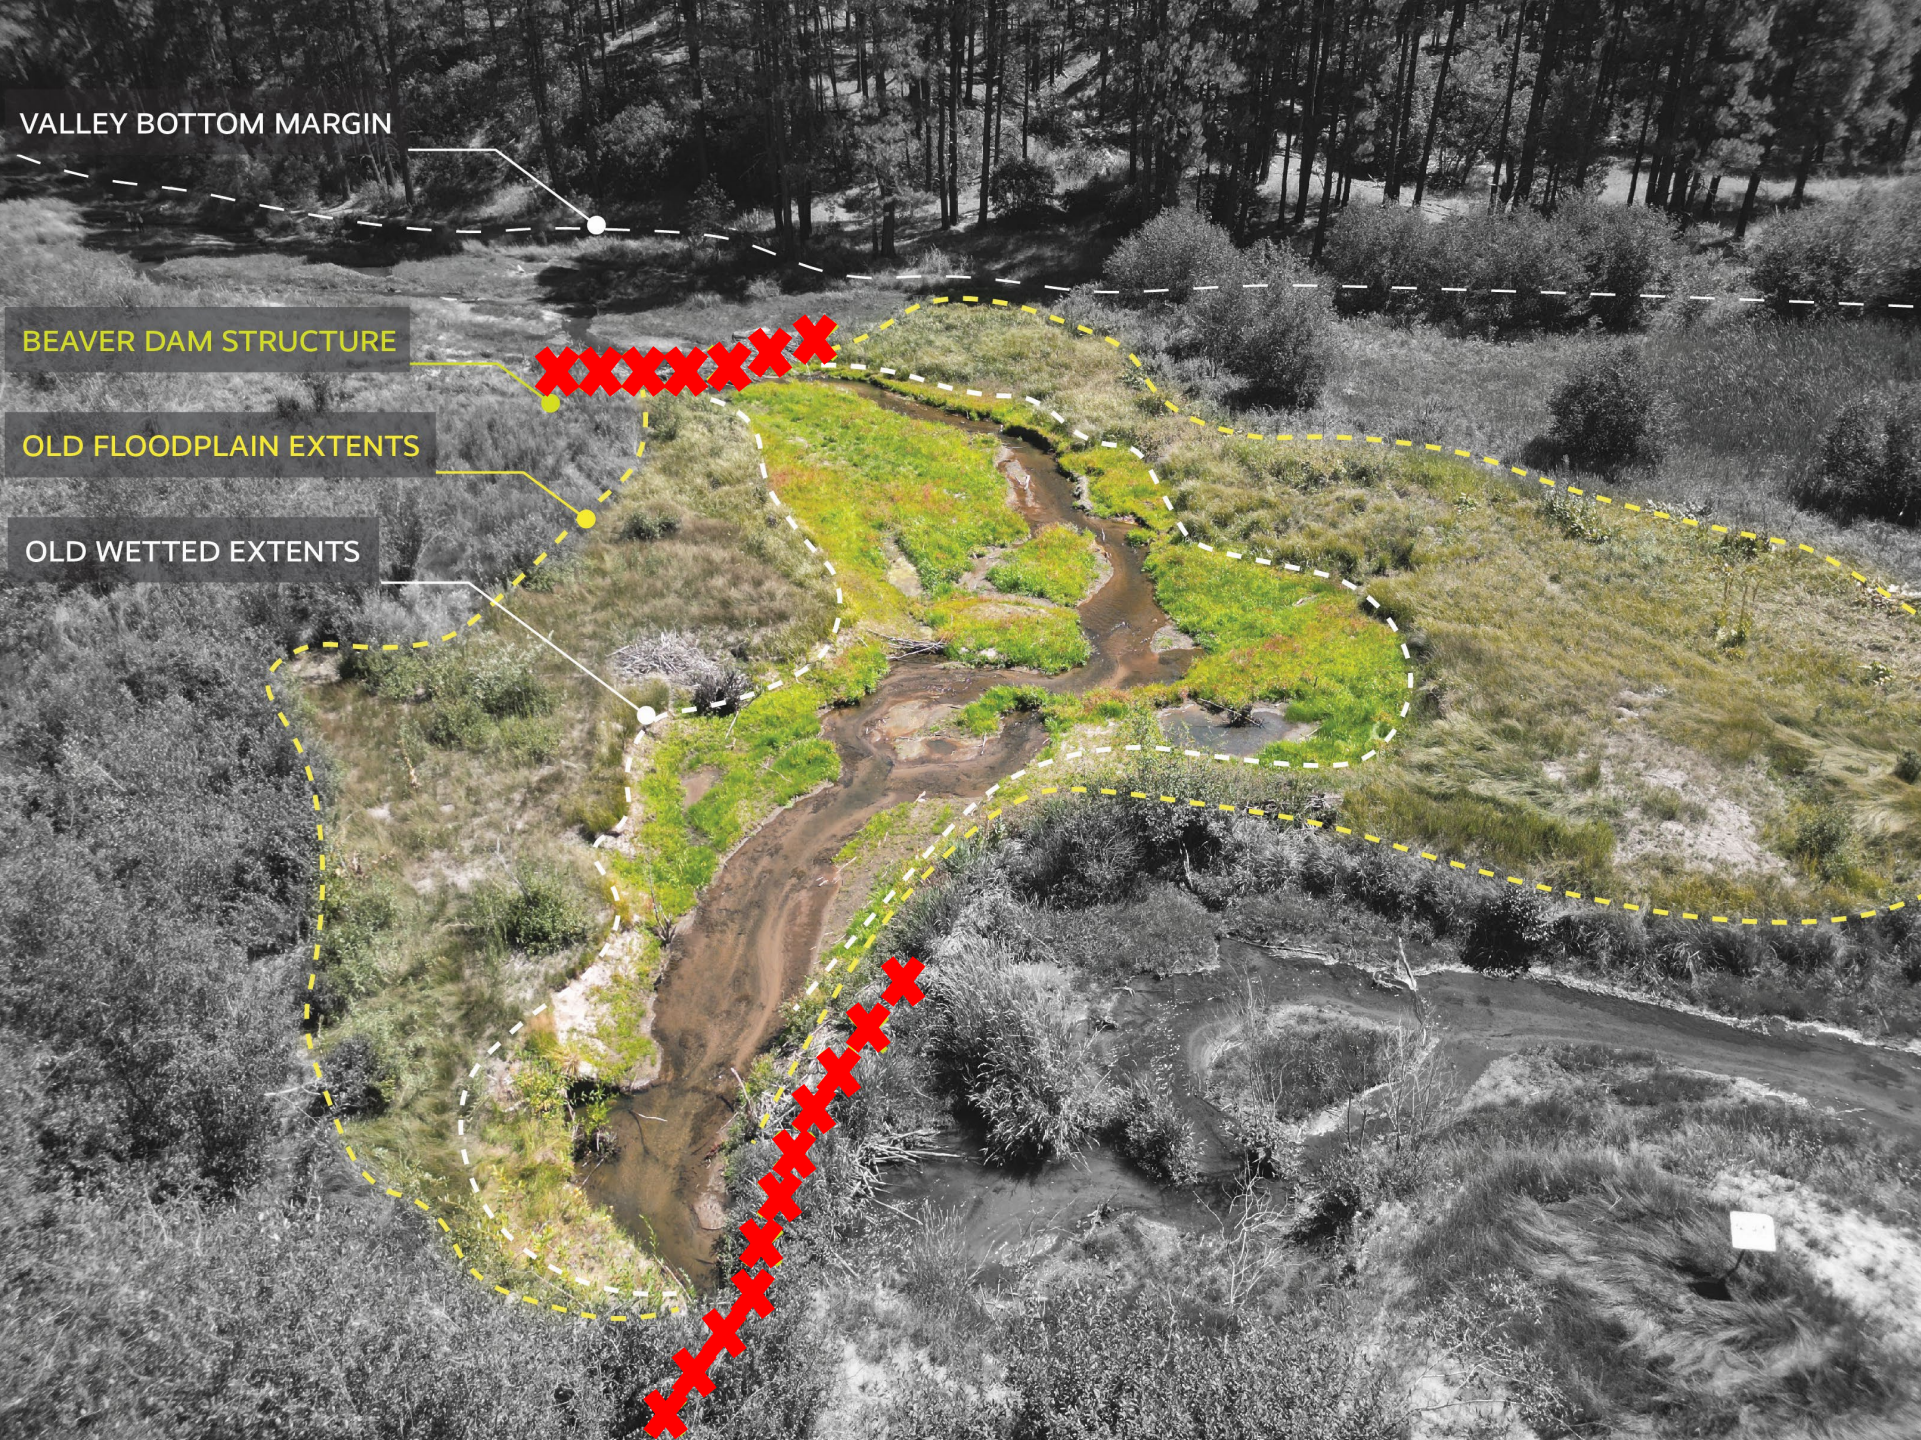
VALLEY BOTTOM MARGIN/
PROJECTED WETTED
EXTENTS

BEAVER DAM STRUCTURE

PROJECTED WETTED
EXTENTS

OLD WETTED EXTENTS

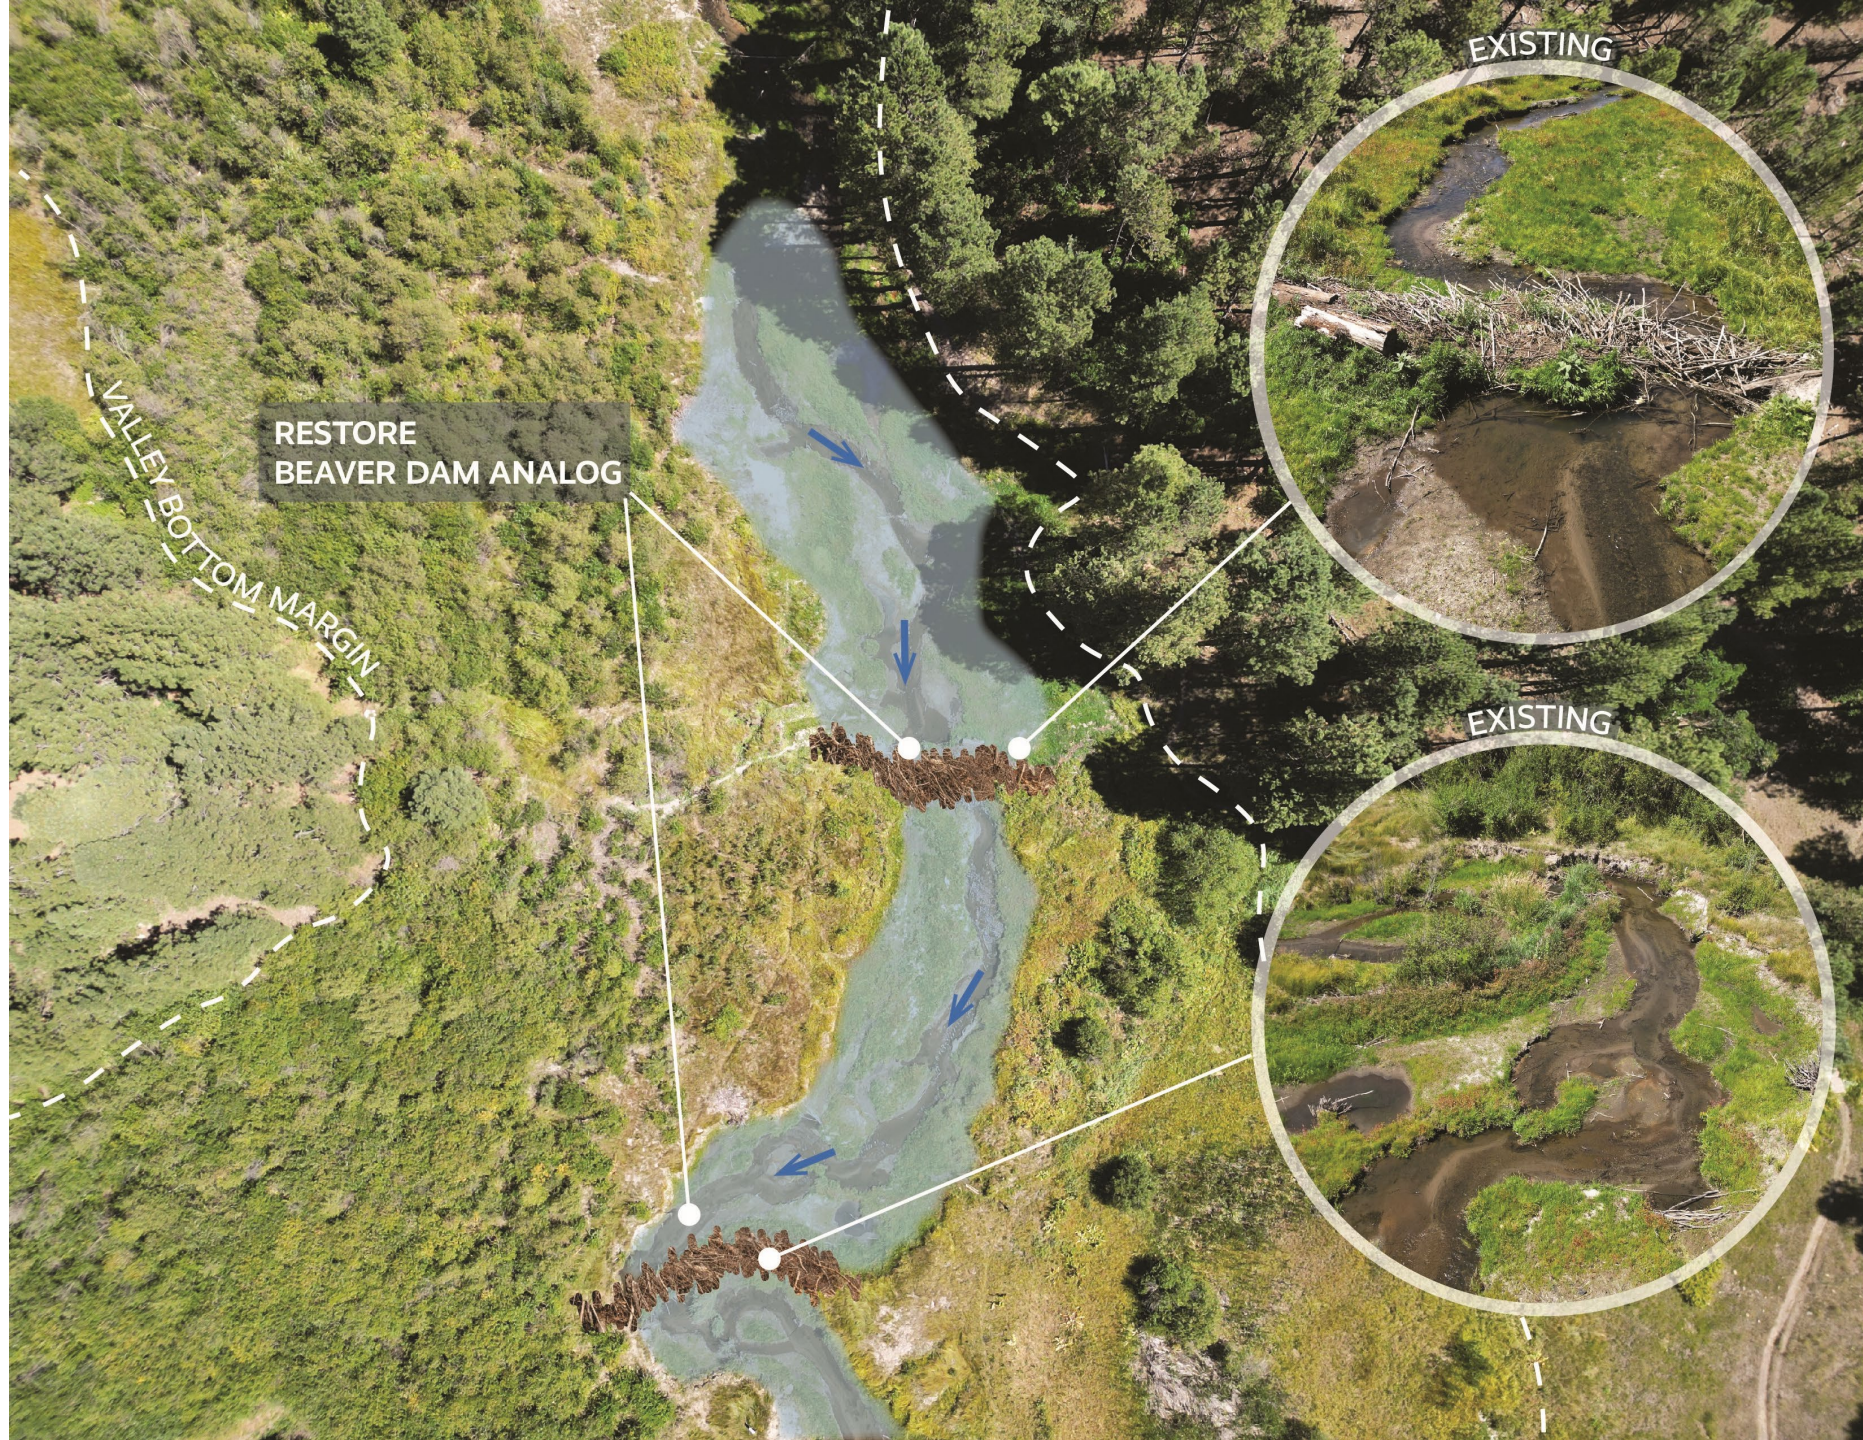
RESTORE
BEAVER DAM ANALOG

VALLEY BOTTOM MARGIN

COMPLEX 03

FENTON LAKE

SYSTEM STATS

- Q 2yr = 226 cfs
- Slope = 0.5%
- Width = 10'
- Sinuosity = 1.36
- Drainage Area = 48 sq miles
