# MEADOW VALLEY WASH

## Final Baseline Ecological Assessment

**March 2005**

# Meadow Valley Wash Riparian Evaluation

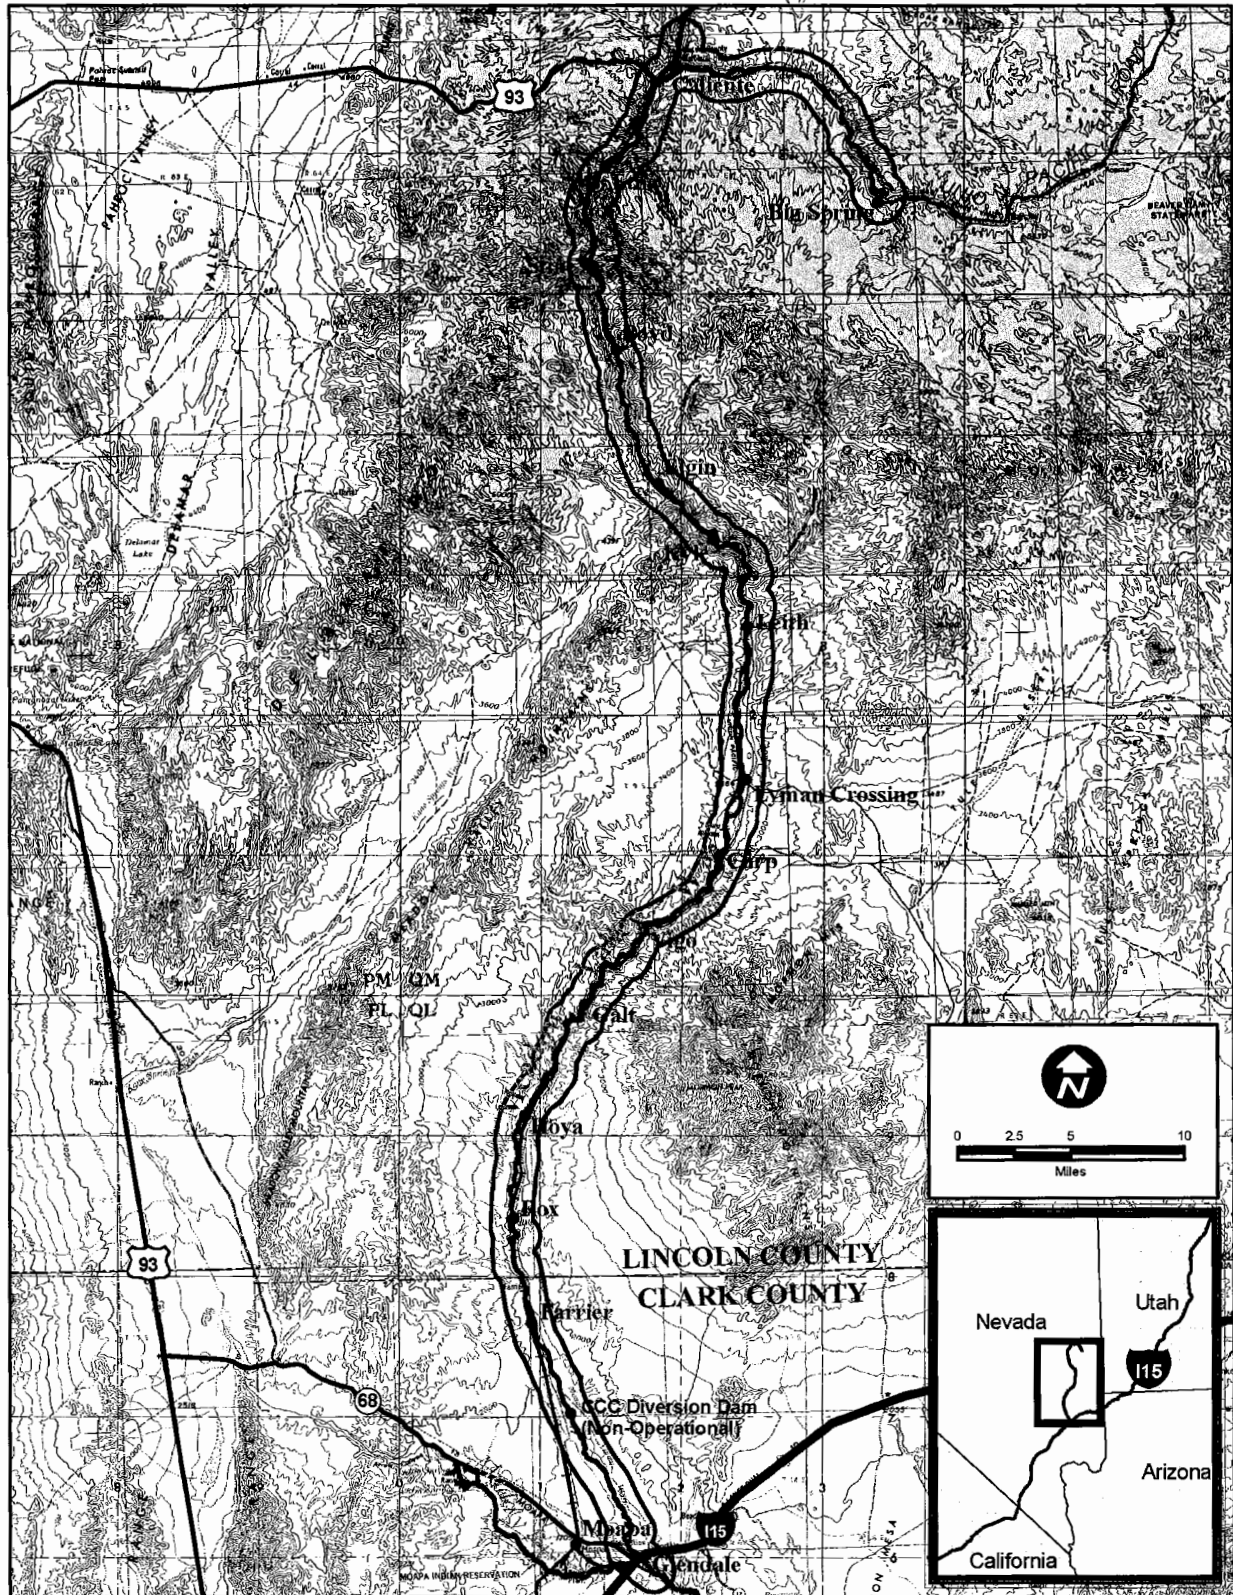
Figure 1. Meadow Valley Wash Study Area.

The terrain within the Study Area is a series of canyons and open valleys dependent upon the underlying geology. South of Caliente Meadow Valley Wash enters Rainbow Canyon, which cuts through about 600 feet of volcanic rock (tuffaceous rocks, welded tuffs, and thin rhyolite flows) for approximately 20 miles down to Elgin, Nevada (Averett 1995). The volcanic tuffs and rhyolite, with multiple, thin basalt overlying beds, continue south and open rapidly just north of Leith, Nevada. From Leith to past Carp, Nevada, the terrain consists of Tertiary and Quarternary gravels (Averett 1995). The open valley continues south from Leith for approximately 10 miles, then it constricts into a canyon again near Carp. From Carp south to Rox, Nevada, the terrain is primarily a canyon, although it is broader and generally less confining than Rainbow Canyon. South of Rox the terrain is primarily alluvium valley.

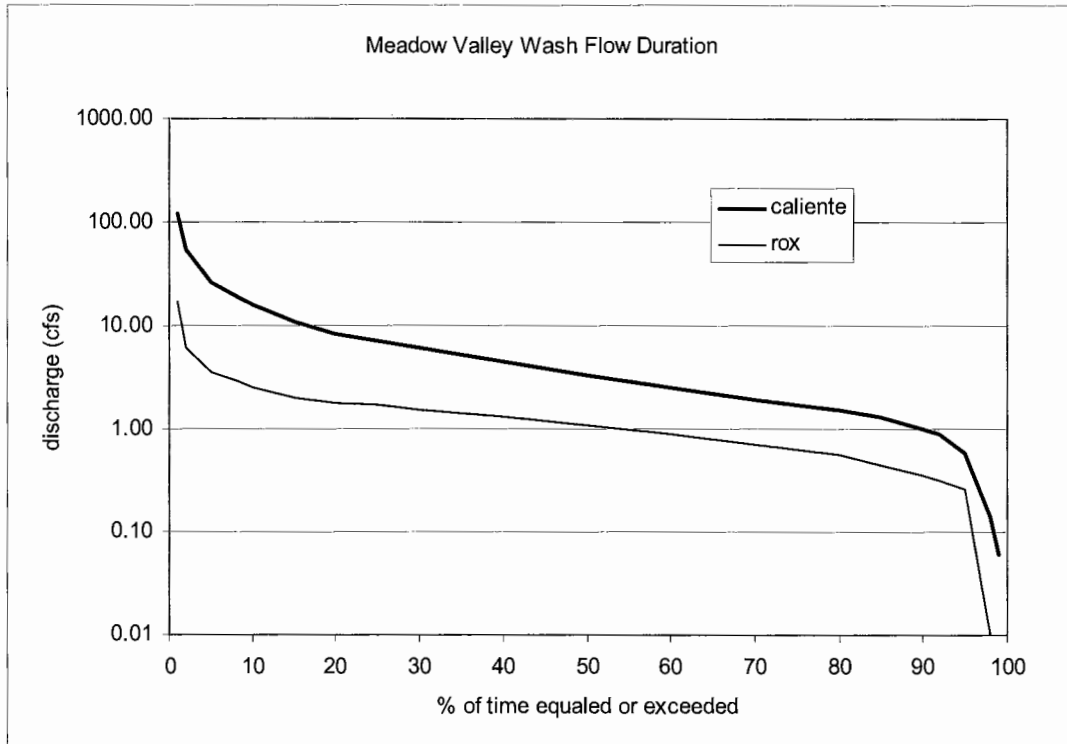
Figure 3.1. Flow duration curves for USGS gages on Meadow Valley Wash.

As seen in the flow duration curves developed from the historical USGS gage data, (Figure 3.1), flows at Rox are typically between 0.3 and 3 cubic feet per second (cfs); at Caliente flows are typically between about 1 and 10 cfs. Streamflow at both gages follows a similar seasonal pattern, with the highest flows occurring in the winter and early spring and the lowest flows occurring in the summer and early fall (Figure 3.2). Based on log-Pearson Type III analysis of the Caliente gage peak flow data, the magnitude of a flood with a recurrence interval of 1 year is about 4 cfs, while the 2-year flood magnitude is about 300 cfs (Figure 3.3).

As evident in Figures 3.1 and 3.2, discharge is typically greater at the Caliente gage than at the Rox gage, even though the total drainage area is greater downstream at Rox. This is just one indication of the fact that surface flows in Meadow Valley Wash do not follow “typical”, straightforward hydrologic patterns. Within the Study Area, Meadow Valley Wash passes through highly variable geologic settings, including wide alluvial valleys and constricted, steep canyons. Numerous tributary arroyos bring in large amounts of sediment that are deposited in various locations along the mainstem valley. The Wash starts off at an elevation of 4400 feet in Caliente and drops to less than 1800 feet as it reaches Moapa, resulting in major temperature and climate differences between the upstream and downstream parts of the Study Area.

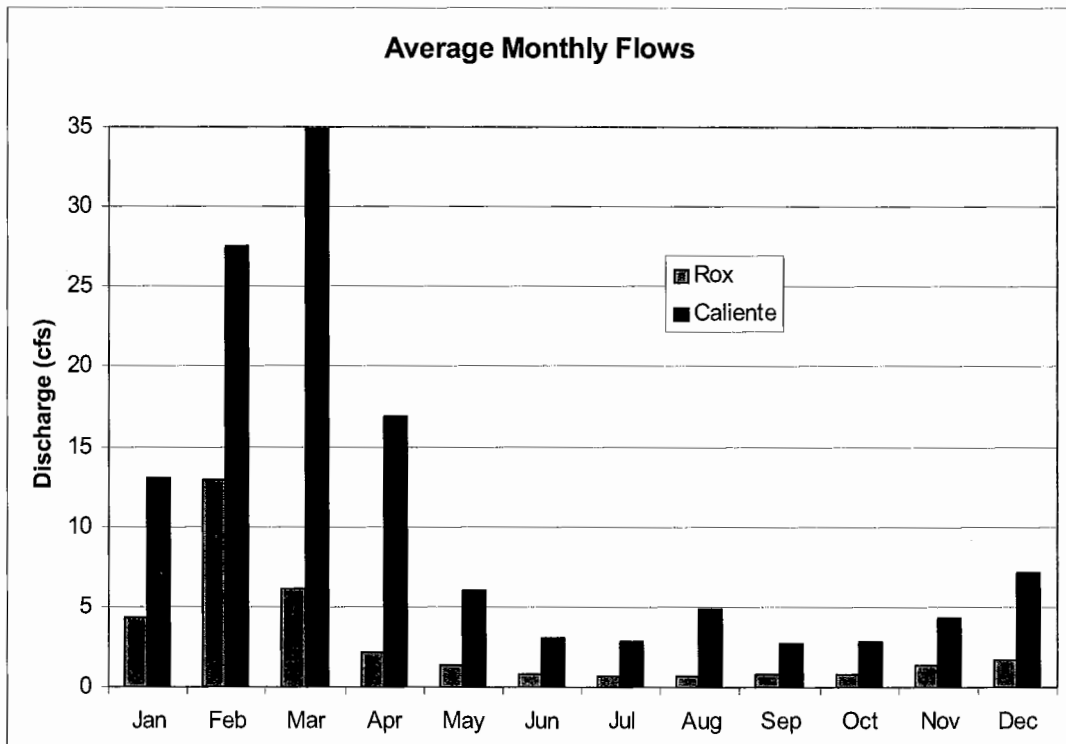
Figure 3.2. Average Meadow Valley Wash mean monthly streamflows at the Rox and Caliente gages.

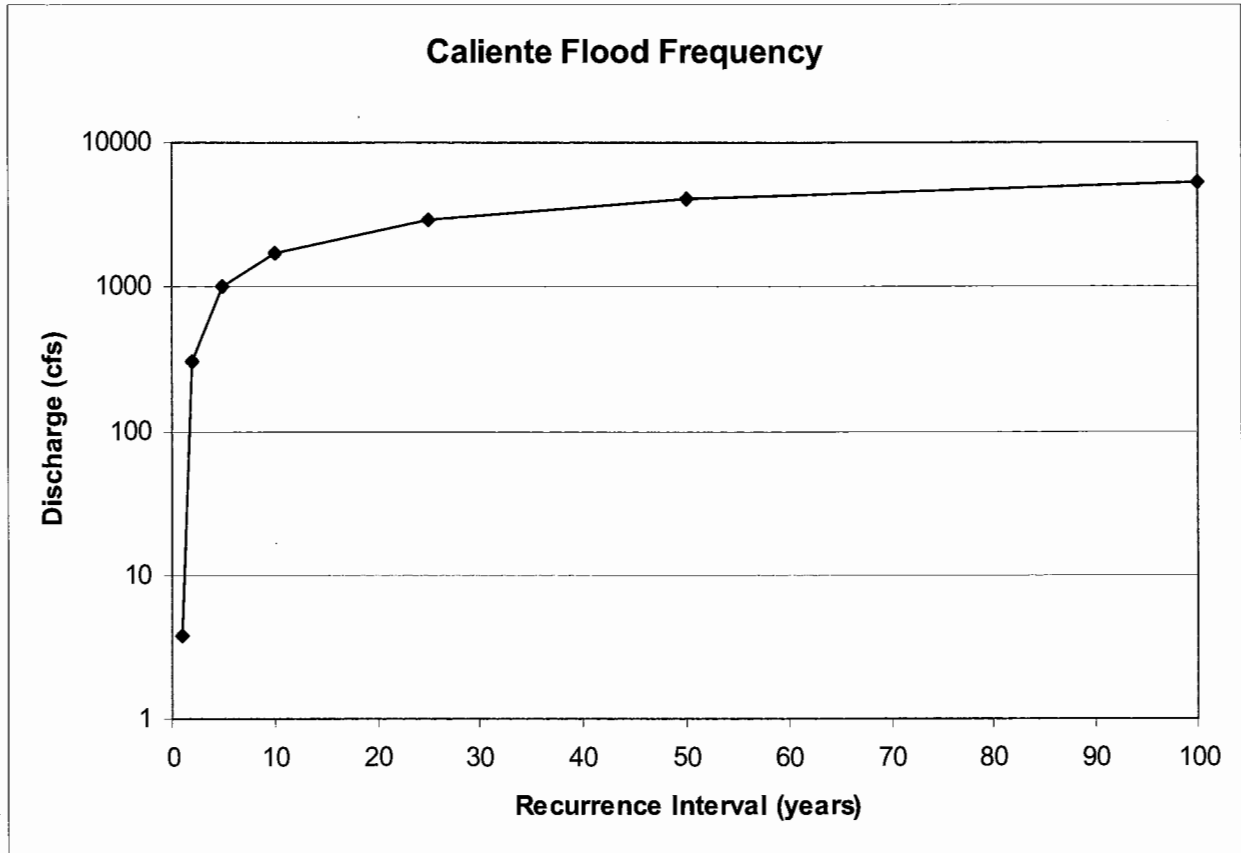
**Figure 3.3. Flood frequency (log-Pearson Type III) curve for Meadow Valley Wash near Caliente.**

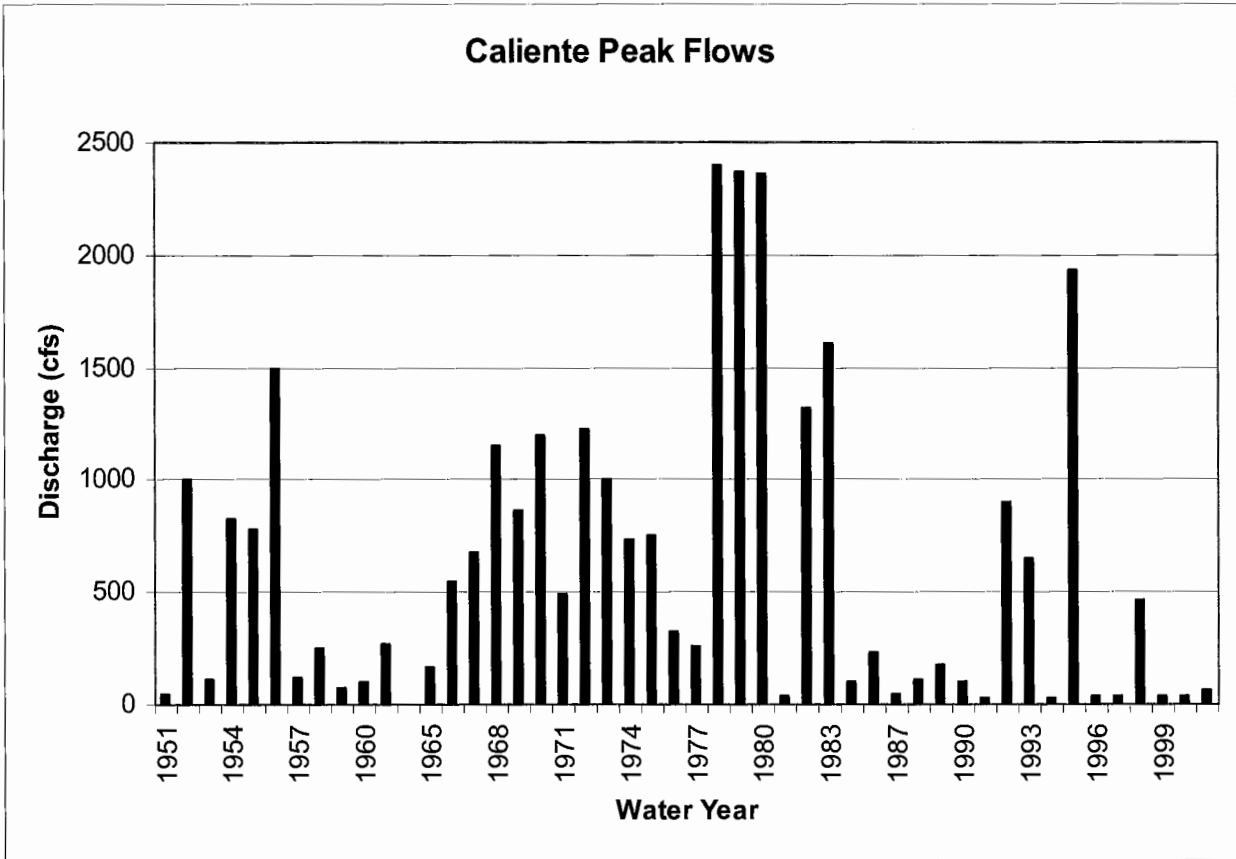
**Figure 3.4. Annual peak flows reported for the USGS gage at Caliente.**

Annual peak flows reported for the Caliente gage since 1951 range from a low of 25 cfs in 1991 to a high of 2,400 cfs in March, 1978 (Figure 3.4). Five of the seven highest recorded peak flows occurred during the wet period from the late 1970's to the early 1980's. The highest flow within the last 10 years – 1,930 cfs – occurred in March, 1995.

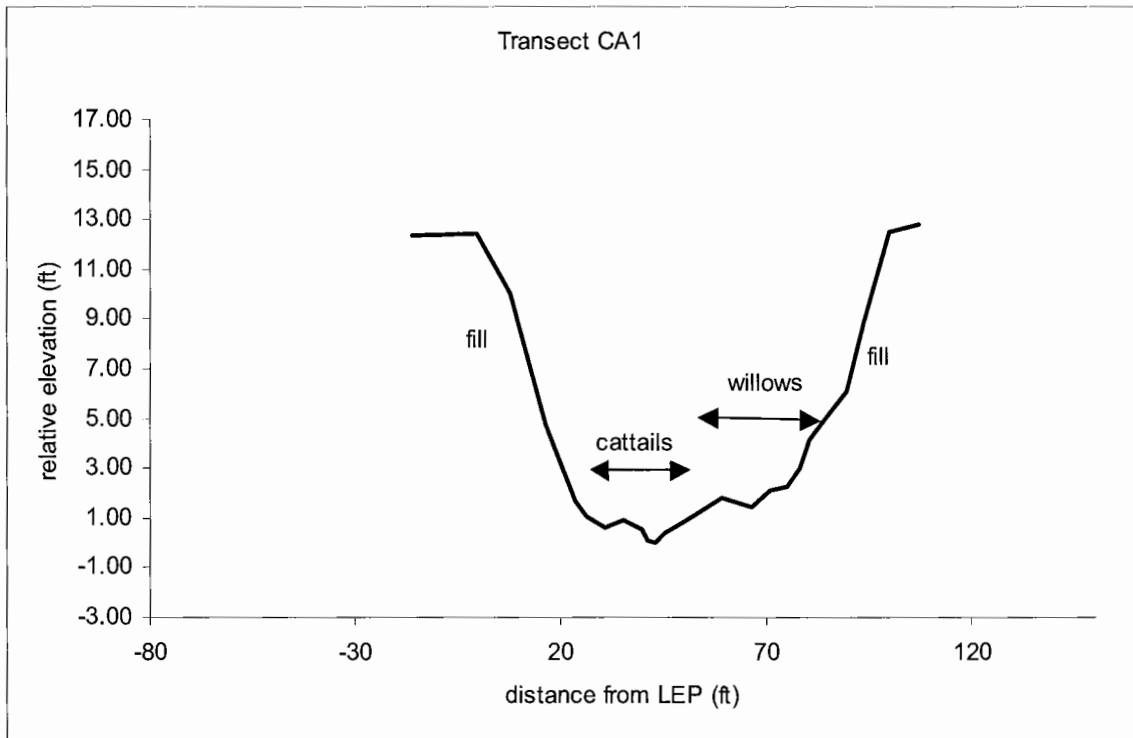
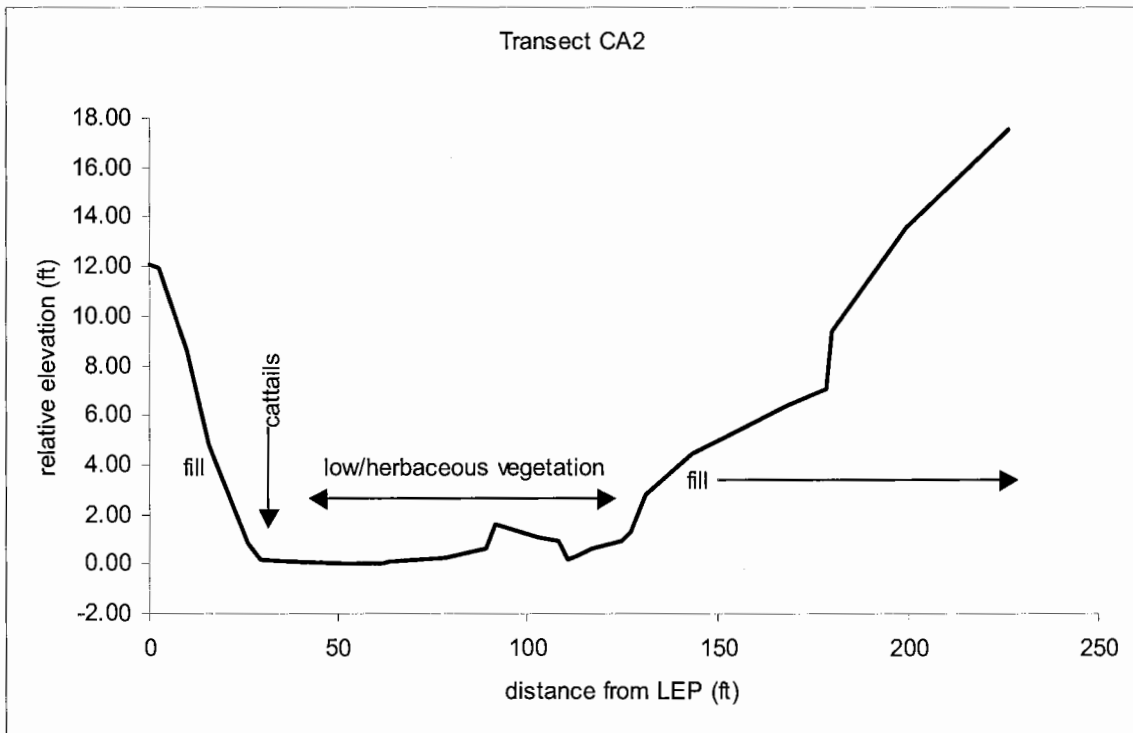
Figure A1. Caliente Reach transect plots. Dashed blue line indicates water surface at time of survey.

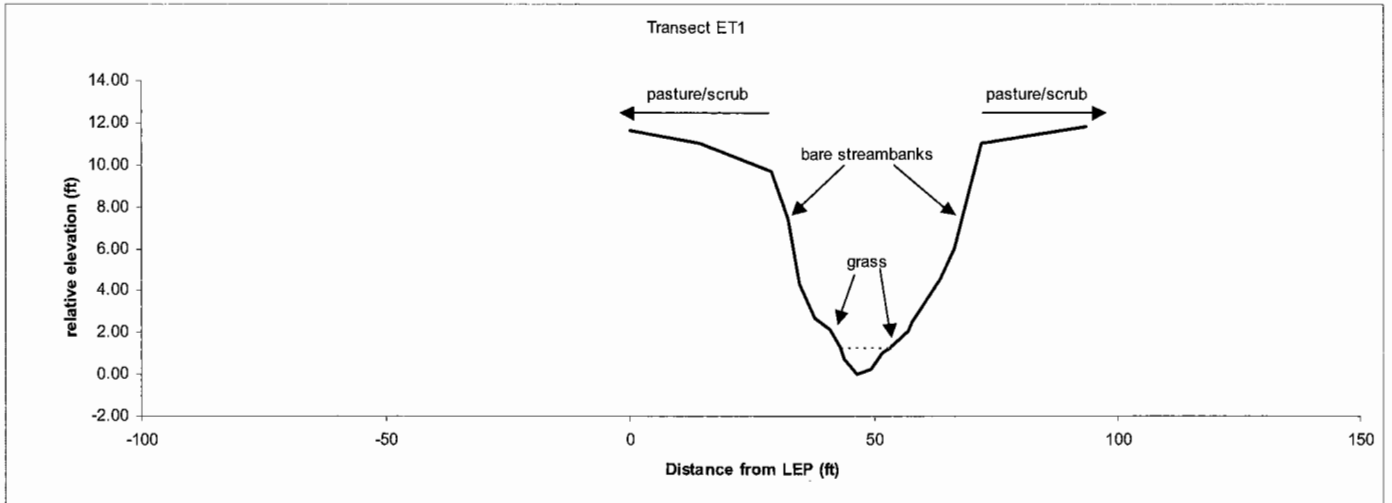
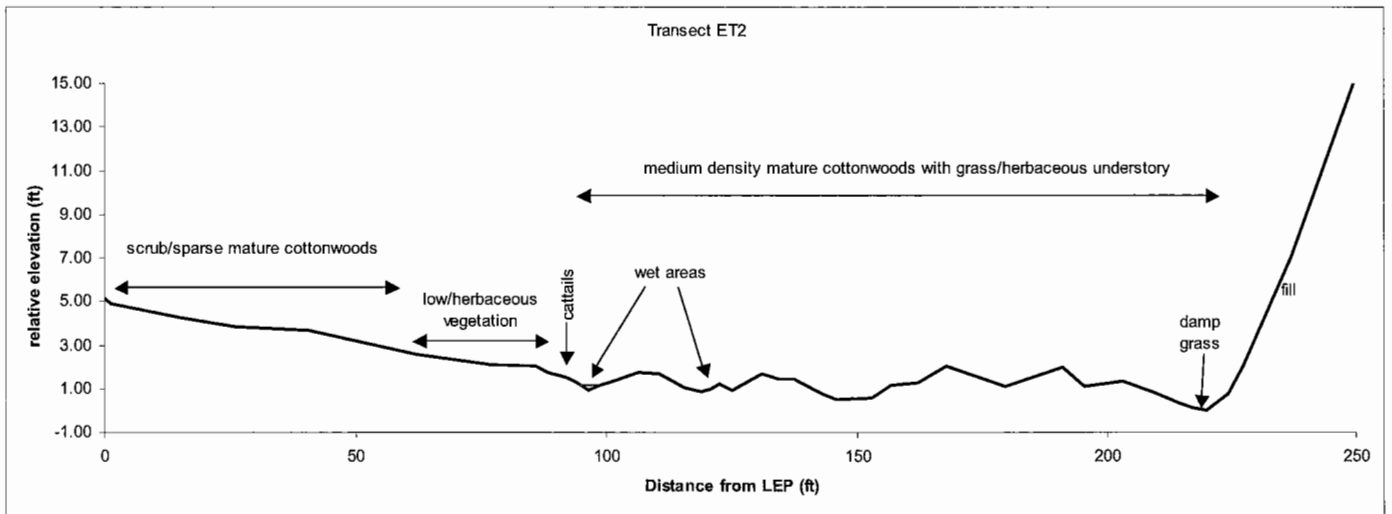
Figure A2. Etna Reach transect plots. Dashed blue line indicates water surface at time of survey.

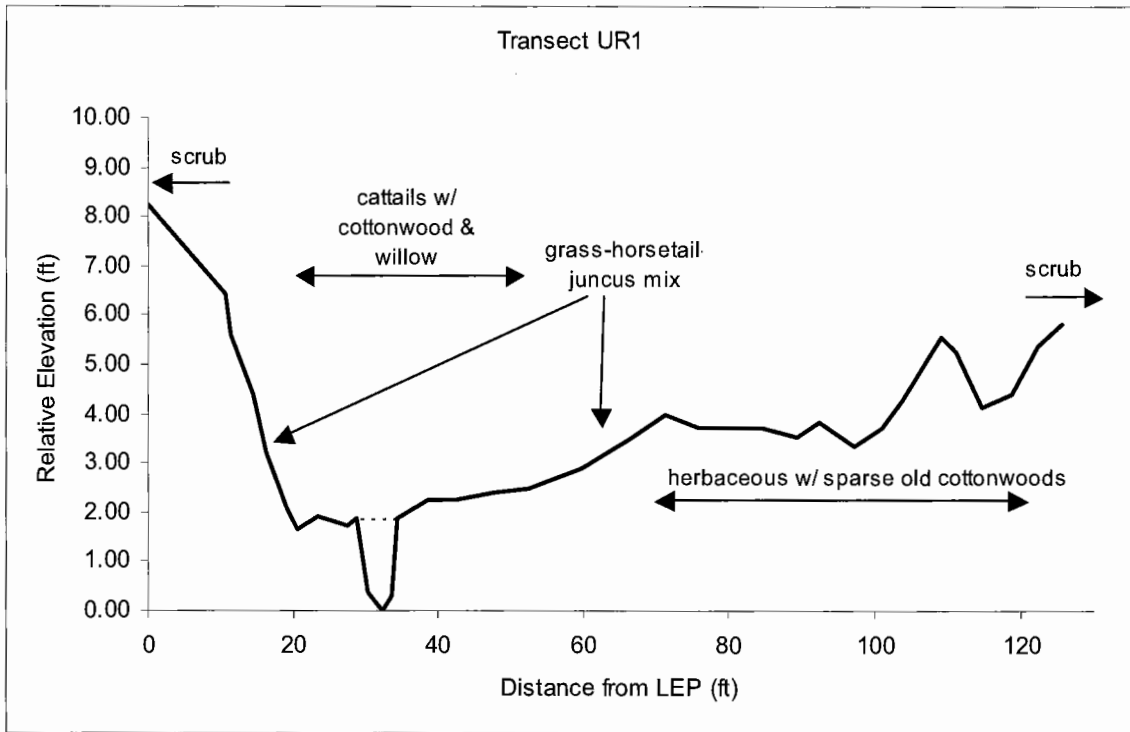
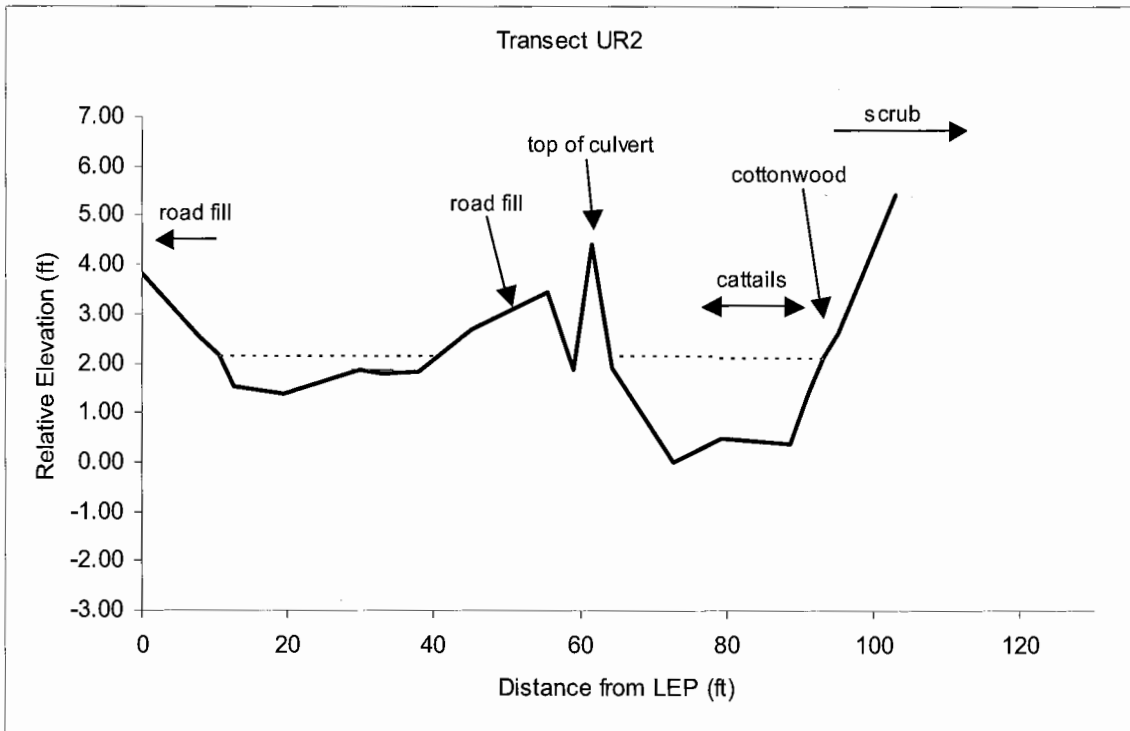
Figure A3. Upper Rainbow Reach transect plots. Dashed blue line indicates water surface at time of survey.

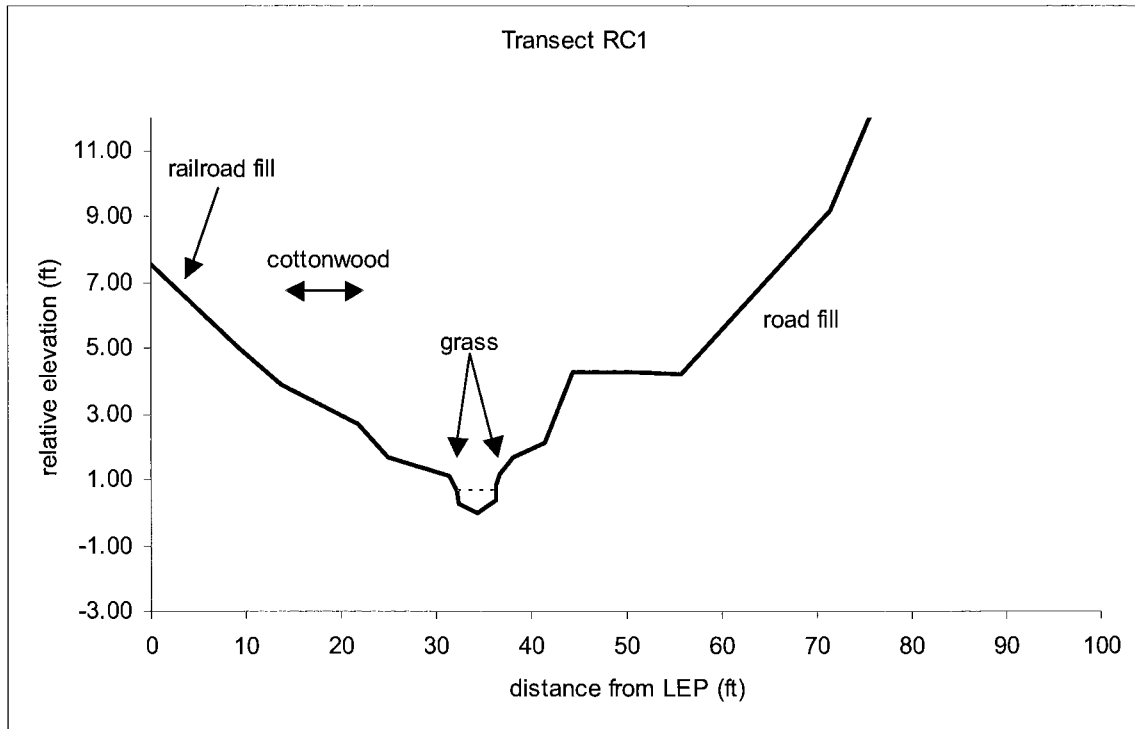
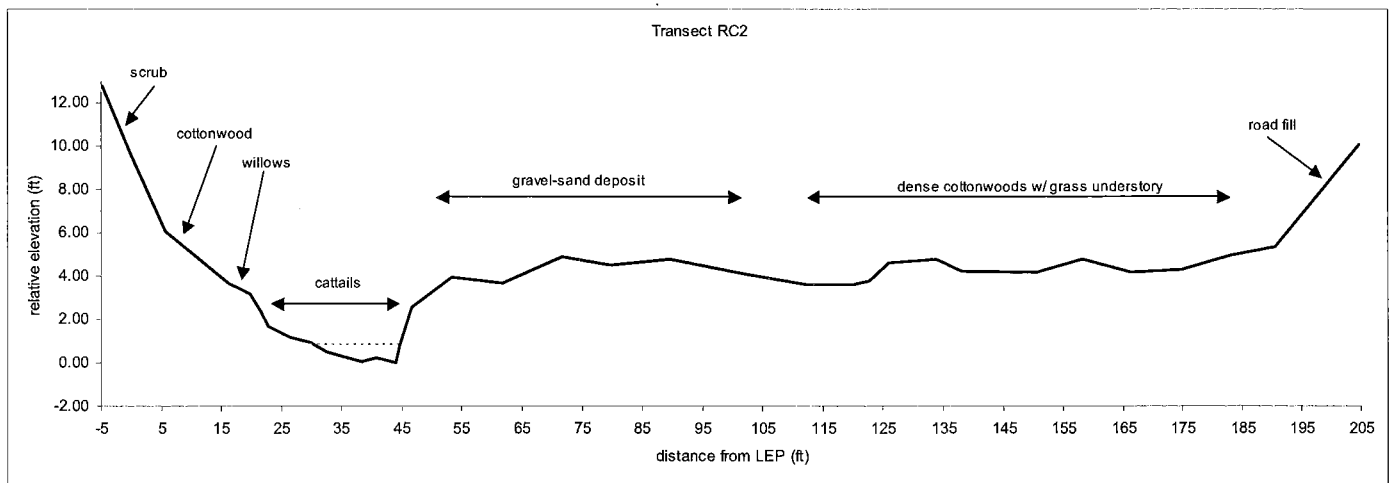
Figure A4. Rainbow Canyon Reach transect plots. Dashed blue line indicates water surface at time of survey.

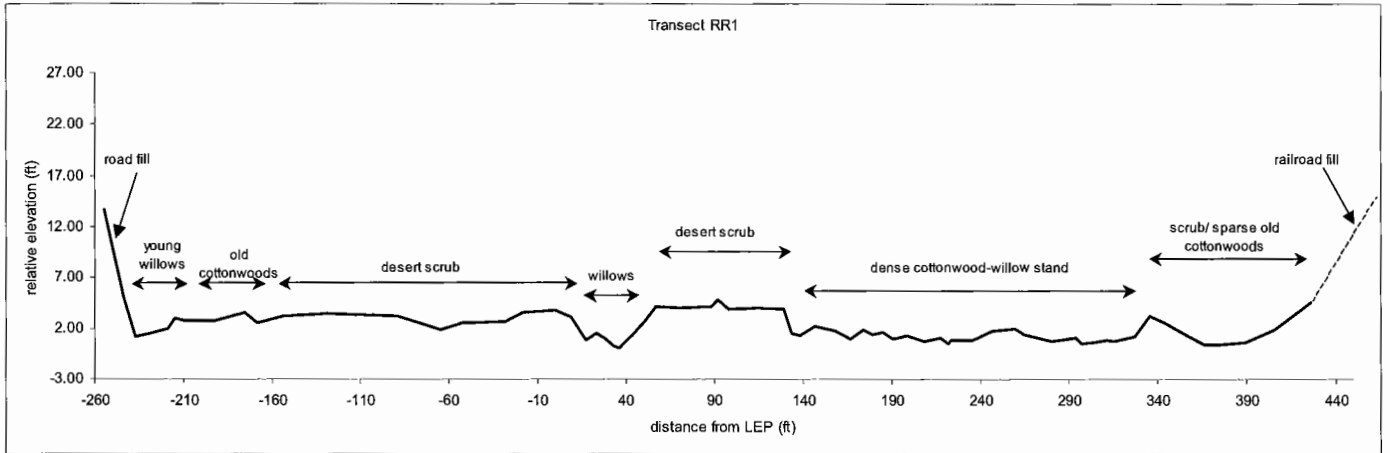
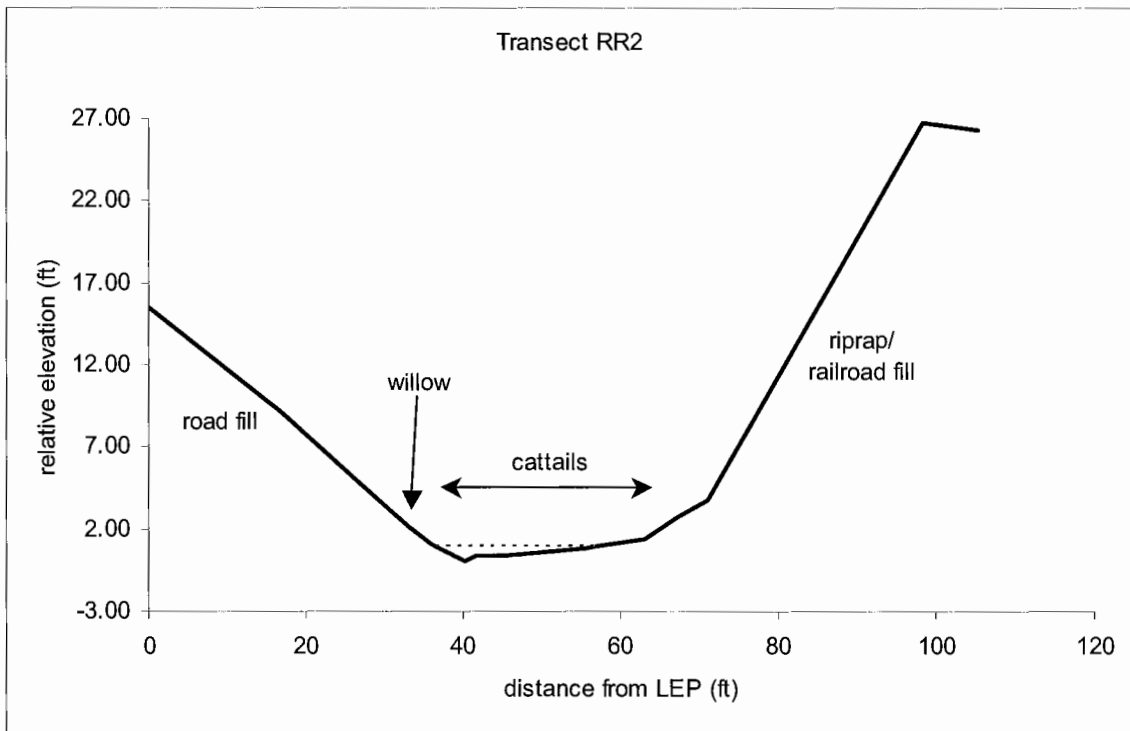
Figure A5. Elgin Reach transect plots. Dashed blue line indicates water surface at time of survey.

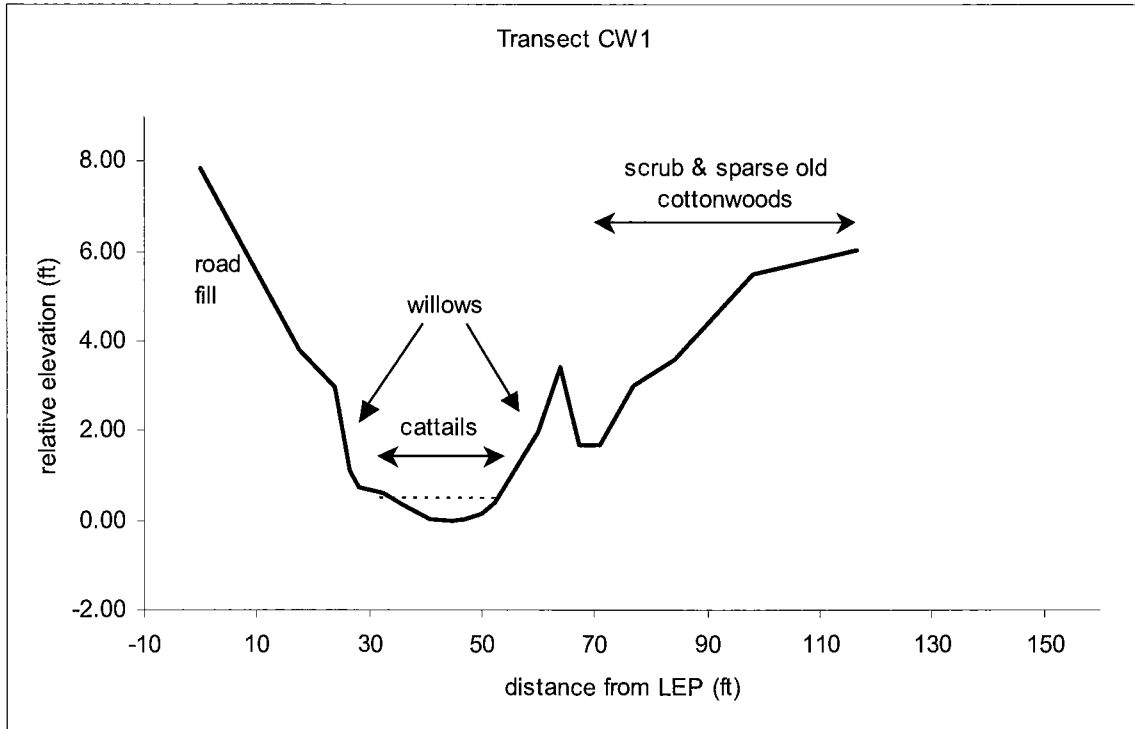
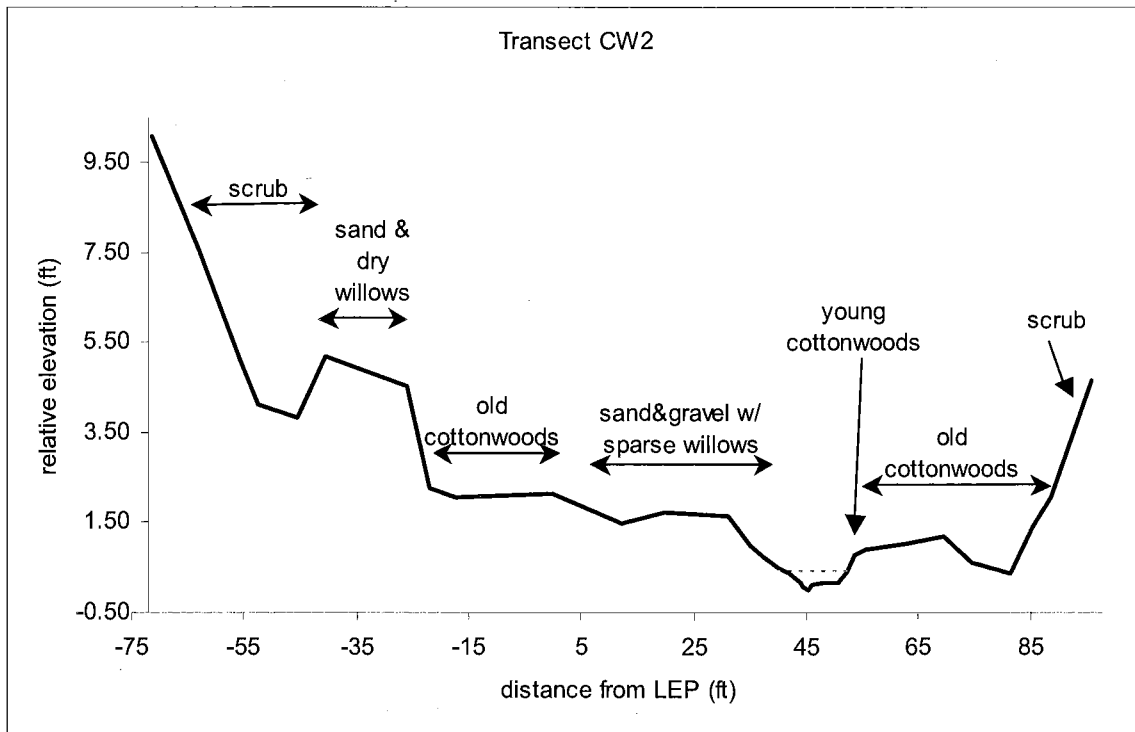
Figure A6. Cottonwood Reach transect plots. Dashed blue line indicates water surface at time of survey.

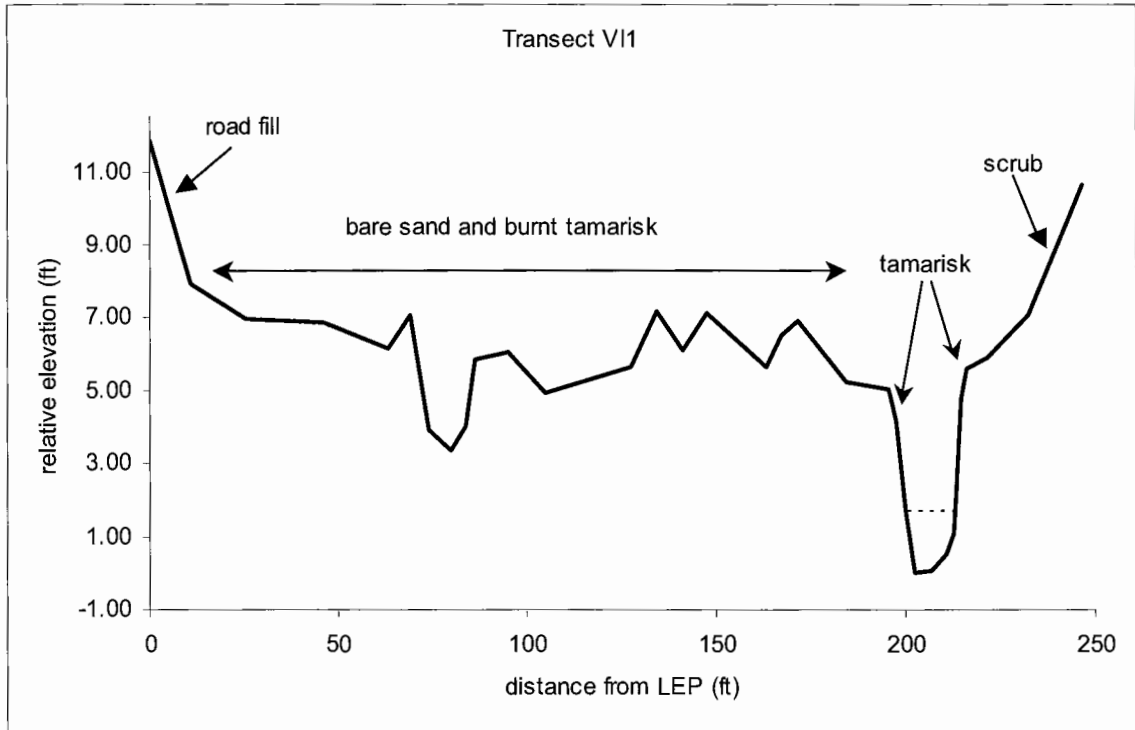
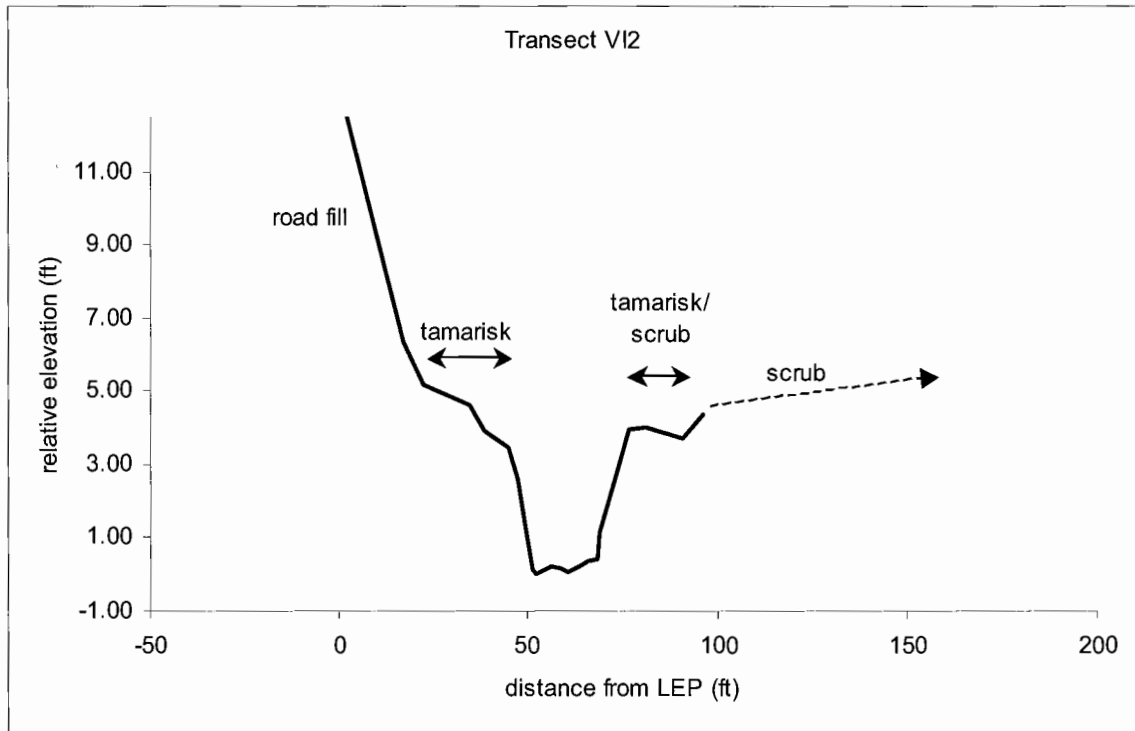
Figure A7. Vigo Reach transect plots. Dashed blue line indicates water surface at time of survey.
