Stream Bank and Bed Stability Assessment Protocol

Joel Sholtes and John Giordanengo
AloTerra Restoration Services, LLC

DRAFT: January 26, 2017

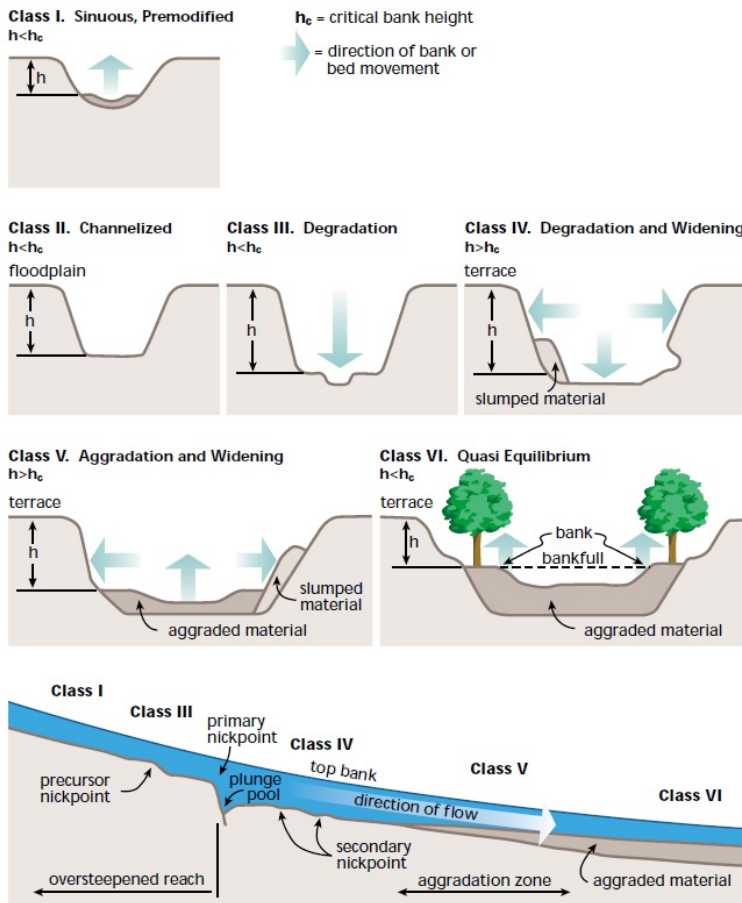
Figure 1. Channel evolution model following a disturbance (FISWRG 1998), modified from Schumm et al. (1984).

Many models of channel evolution in response to a disturbance exist. One intuitive model introduced by Schumm et al. (1984) describes the series of stages a channel may go through in response to a disturbance such as channelization, urbanization, or flooding (Figure 1). Beginning with Stage III, post disturbance, channel incision occurs by degradation (incision) of the channel bed and migration of head cuts (break in slope in erodible material) upstream. This increases the heights of the banks, reduces their stability, and can lead to enhanced scour at the toes of the banks. Bank erosion and failure result and the

channel widens (Stage IV). As the channel widens, the erosive force of the flow dissipates, deposition of sediment results (aggradation), and a new floodplain begins to form within the incised channel (Stage V). Over a period of time (10 to > 100 years depending on the flow regime, vegetation, and bed and bank material) a new stable channel forms (Stage VI). Bank erosion resulting from channel instability may be observed along Stages III to V.

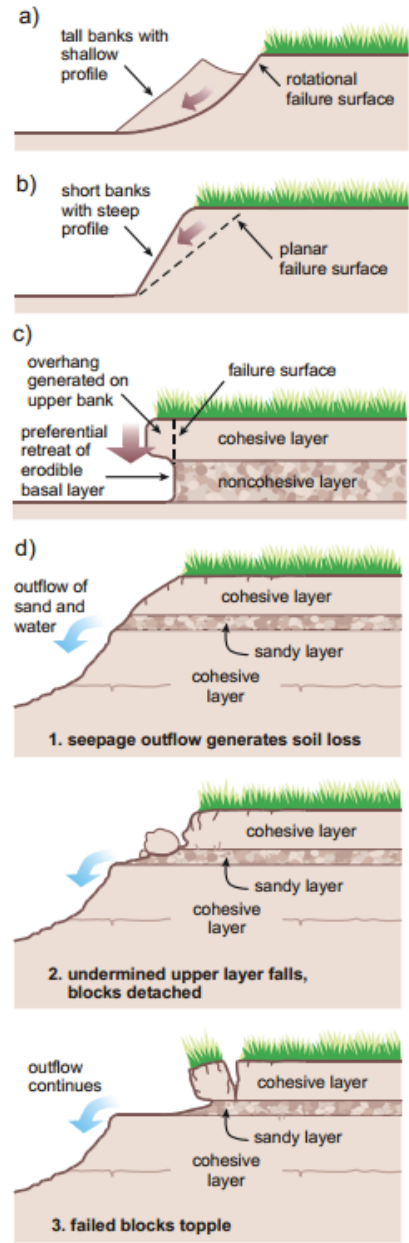
Figure 2. Bank failure mechanisms: a) rotational failure, b) planar failure, c) cantilever failure, d) piping or sapping failure from groundwater. (FISWRG 1998), modified from Hagerty (1991).

Loss of bank material to the channel occurs by two primary processes that work in tandem: slope instability and erosion. Slope stability is a geotechnical property of banks that involves the type of material comprising the banks, the angle of the banks, pressure from groundwater entering the banks, as well as the amount of roots in the bank. All materials have a natural “angle of repose” below which they are stable. Besides bedrock, cohesive bank materials such as silty and clayey soils have the largest stable angle of repose because of the inter-particle cohesion inherent in this material. However, they are susceptible to mass wasting or the loss of large chunks of bank material when they become geotechnically unstable (Haggerty 1991, Simon et al. 1999) (Figure 2a & b).

Scour at the toe of cohesive banks can lead to undercut banks and bank slumping or mass wasting (Figure 2c). Non-cohesive materials such as sand up through cobble material have lower angles of repose, with sand having the lowest. This means that for a sandy bank to be stable it must have a shallow angle. In deeply incised channels and gullies, the groundwater table may intersect the bank. Pressure in the pore space of bank material from this groundwater can reduce the stability of the bank and assist in bank failure (Figure 2d). Finally, roots from vegetation growing on the bank face and on the floodplain just beyond the bank face greatly assist in increasing the tensile strength of the bank. Dense shallow-rooted vegetation such as grasses can prevent erosion of the bank face, but do not contribute greatly to enhancing tensile strength, while deep-rooted woody vegetation (i.e., willows, cottonwoods, and other shrubs and trees) are most effective at increasing the tensile strength of the bank (Figure 3, middle column).

function of the relative percentages of sand, silt, and clay, as well as organic matter. Soils with larger percentages of sands and silts and lower percentages of organic matter tend to be more erodible (Schwab et al. 1981). Banks may have horizontal layers of different types of material each with different degrees of proneness to erosion (soil stratification, Figure 2, 3).

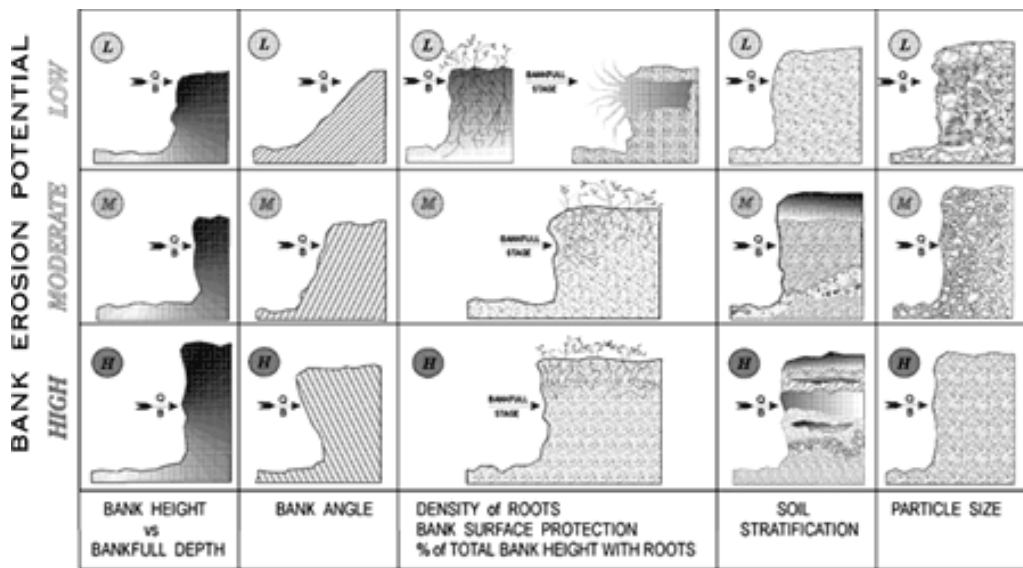
Figure 3. Bank erosion potential diagram as function of various factors. Arrows indicate bankfull height (Rosgen 2006).

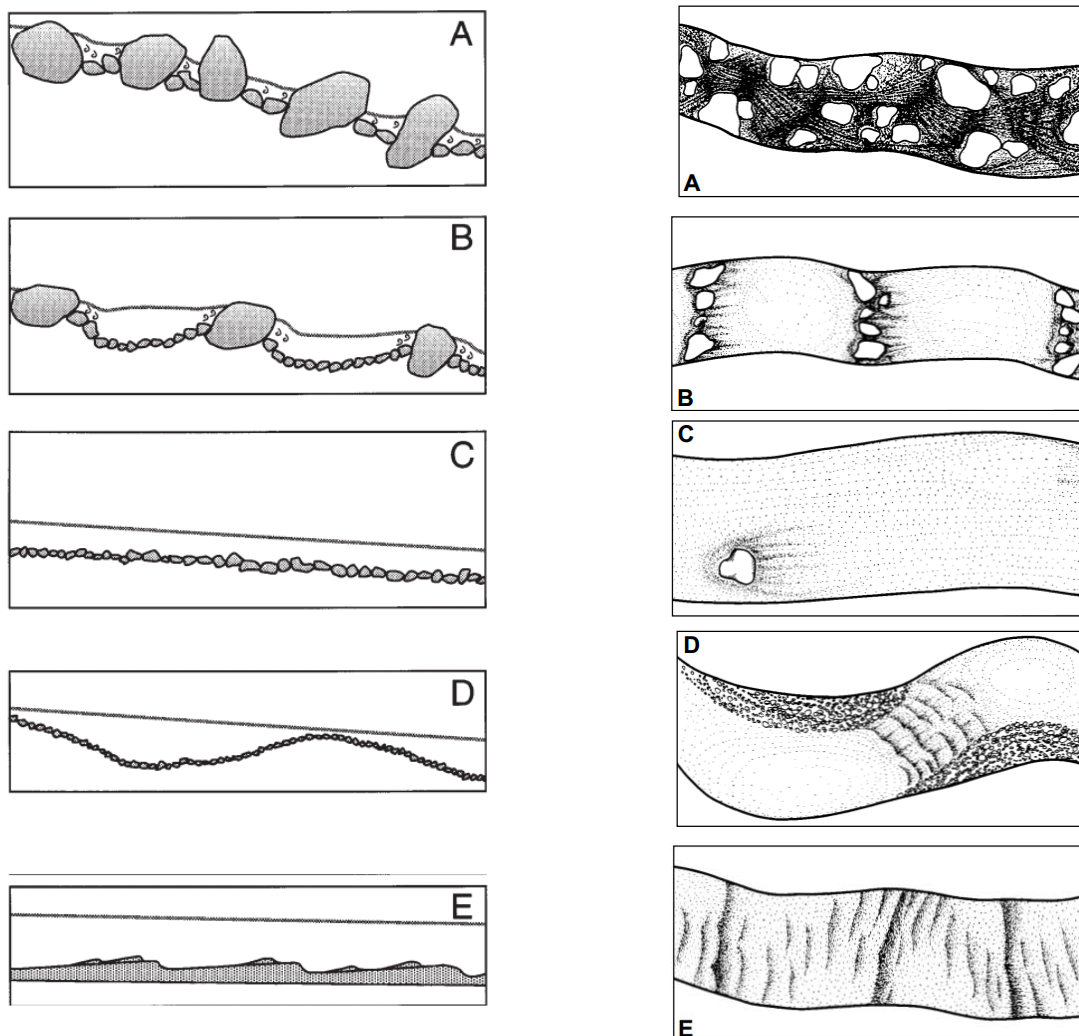
Figure 4. Channel morphologies and bedforms for mountain rivers. Longitudinal profile in left column, and planform view in right. (A) cascade; (B) step pool; (C) plane bed; (D) pool riffle; and (E) dune ripple. (Montgomery and Buffington, 1997). Reprinted under GSA Bulletin’s Fair Use Policy.

While finer bed channels may be more susceptible to vertical incision, streams with fine beds tend to have mild slopes, and less vertical relief to erode. Steeper channels with coarser material are also susceptible to incision, especially where large boulders are lacking to provide grade control. Evidence of active incision often comes in the form of headcuts (or knickpoints), which are steps or discontinuities in the slope of the bed. Headcuts migrate upstream as their faces erode until they encounter a vertical grade control such as boulders or bedrock (Figure 1). They serve to reduce channel slope and erosive energy allowing a channel to adjust to the disturbance that initiated this vertical instability. A range of natural mountain stream types is shown in Figure 4, above.

Equally as important as assessing bank stability is channel bed stability. For the sake of brevity, percent lengths are not included in this portion of the assessment. Rather, the field crew selects the dominant bed sediment type (following Table 1) and dominant morphology type (Figure 4) of the sub-reach. They note whether active or recent incision exists. Clues from positions of roots along the bank and presence of migrating headcuts help inform this. Finally, if recent or active incision exists, the field crew estimates the depth of erosion along the sub-reach. Active incision may occur at or as a result of a stream restoration structure failure. Please note the incision or instability here and document the structure under the “Restoration Treatment Assessment” described below.

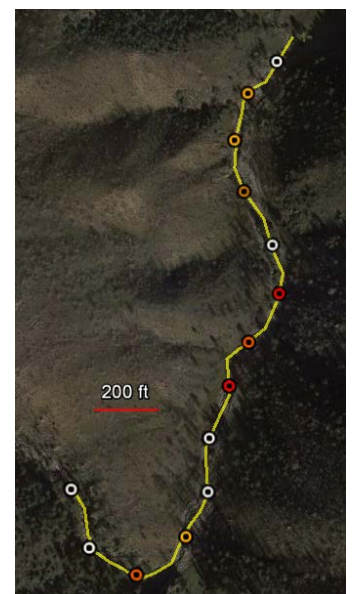
Figure 5. Example of mapped stability scores

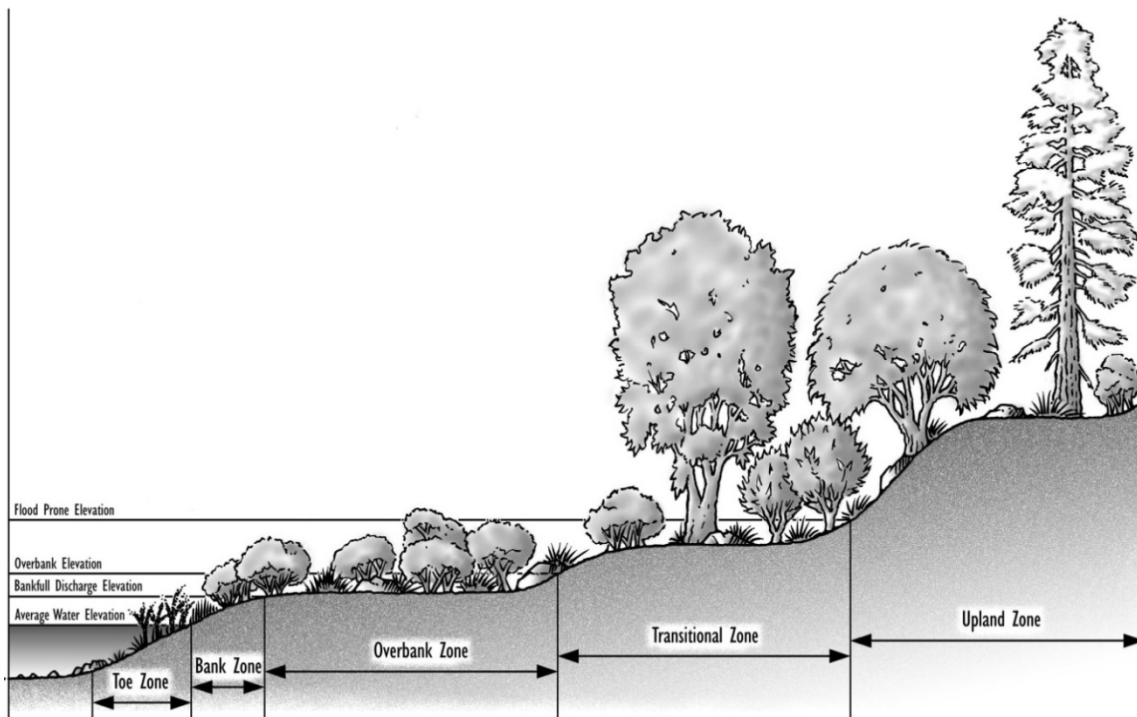
Figure 6. Riparian Planting Zones in Semi-Arid Climates (Hoag and Fripp, 2005)

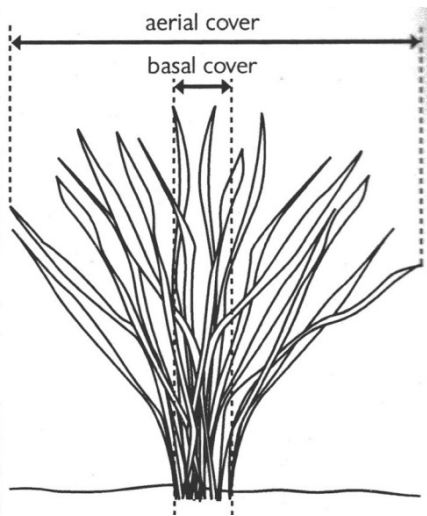
Figure 7: Aerial cover versus Basal cover (Elzinga et. al., 1998)

A plotless cover estimate method (visual estimate of vegetation cover in the entire survey reach) may be used to estimate vegetation cover, by aerial cover (Figure 7). In this cover estimate, the gaps between leaves of a given plant are imagined to be part of the entire canopy of the plant, and it is the canopy cover that is estimated. The plotless cover estimate approach requires some vegetation monitoring experience and/or an effective calibration before beginning the process. To calibrate the observers' eyes, follow a line-intercept procedure (Herrick et al., 2005) over a representative 100-foot section of bank, measuring the cover classes below as first hits (i.e., no ground cover below a leaf will be recorded, and no leaf cover below the first hit leaf will be recorded).
