# Riparian Restoration on Farms and Ranches in Texas

## Introduction

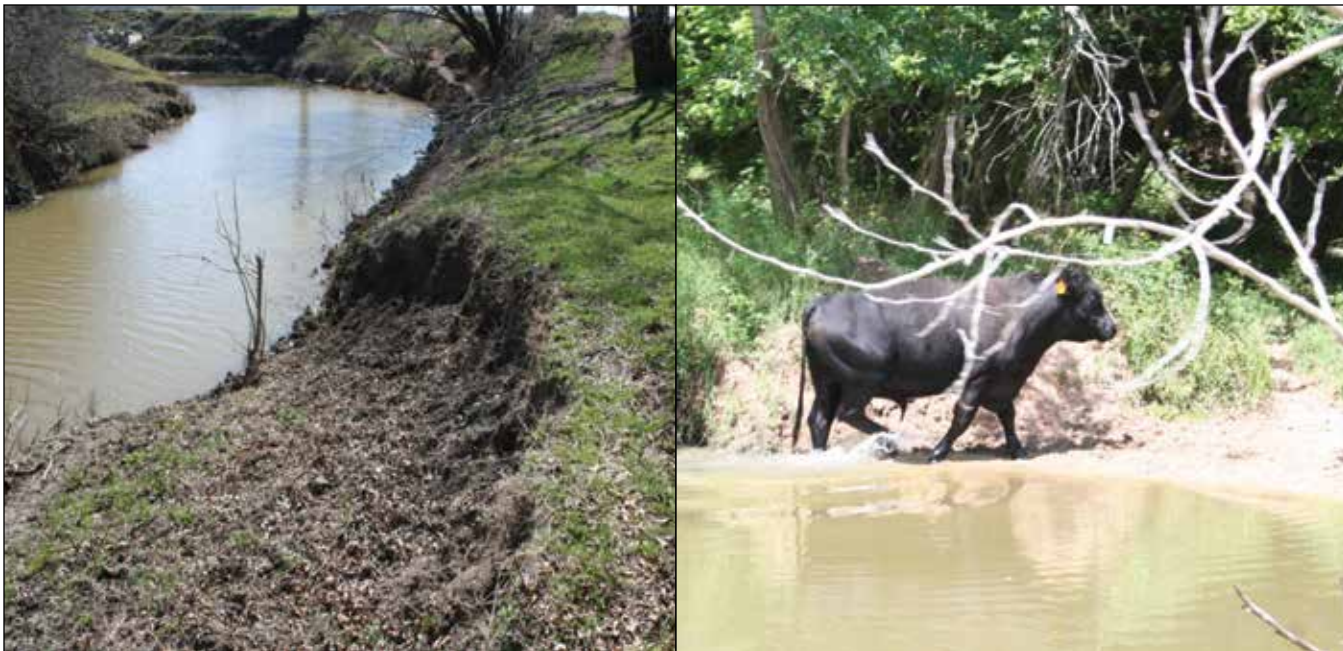
**Figure 1.** If not managed properly, cattle traffic can lead to erosion of streambanks (left) and deposition of fecal matter in waterways (right). Photos by Blake Alldredge and Mark Tyson, Texas A&M AgriLife Extension Service.

- Overgrazing that leads to a reduction in plant cover and vigor, and alteration of species composition and diversity (Kauffman and Krueger, 1984);
- Trampling of banks that results in accelerated stream bank erosion (Figure 1a);
- Soil compaction from livestock traffic that increases runoff and decreases infiltration and water available to plants; and
- Deposition of fecal matter in the stream leading to high levels of bacteria (Figure 1b; Wagner et al. 2013).

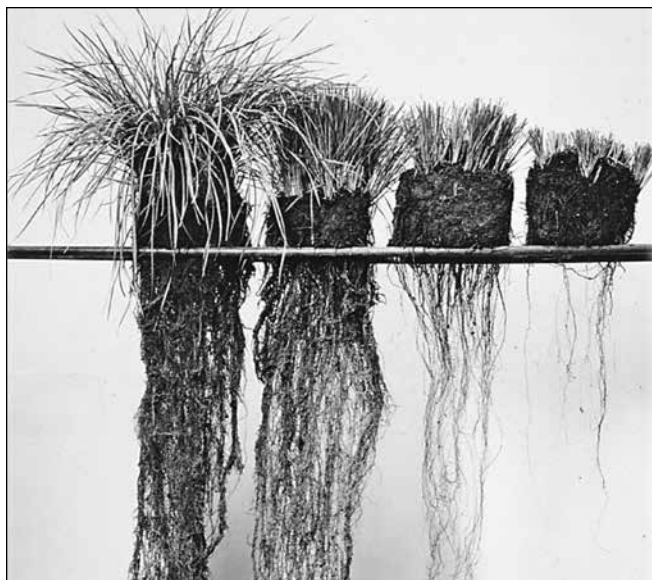
**Figure 2.** As grazing pressure increased, root biomass decreased. The second plant from left has 50% of the top growth removed with little effect on roots. An increase in grazing pressure results in dramatic loss of root development as seen in both plants on the right. From Crider (1955).

Overgrazing of riparian vegetation and plowing too close to the stream can affect bank stability because the removal of above-ground plant growth results in a decrease in root biomass, which physically binds the soil together and makes the soil up to 20,000 times more resistant to erosion (Figure 2; Crider, 1955; Thurow, 1991; Abernethy and Rutherford, 1998). Without the roots to hold soil in place, stream banks become vulnerable to erosion during flooding events. Overgrazing by cattle in the uplands can also impact riparian areas and streams, as decreased infiltration of rainfall into the ground results in greater volumes of runoff in streams and places additional pressure on the stream banks (Figure 3; Thurow, Blackburn, and Taylor, 1986; 1988). Riparian vegetation functions to slow down the overland flow and capture sediment,

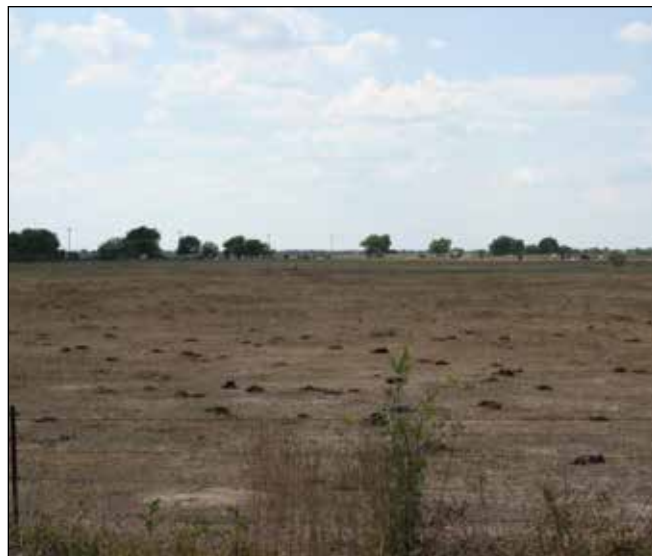
**Figure 3.** Overgrazing in upland areas leads to less infiltration and greater runoff and erosion. Photo by Mark Tyson, Texas A&M AgriLife Extension Service.

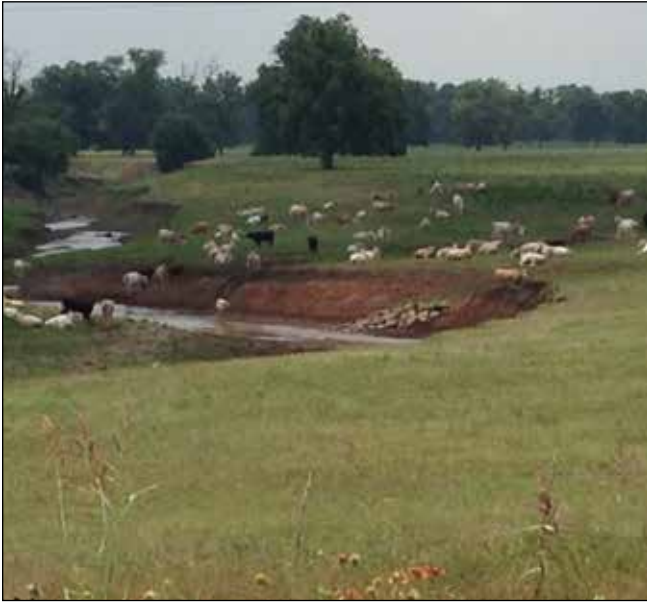
**Figure 4.** Allowing livestock to overgraze riparian areas and trample banks is detrimental to bank stability and water quality. Proper grazing management improves both. Photo by Blake Alldredge, Texas A&M AgriLife Extension Service.

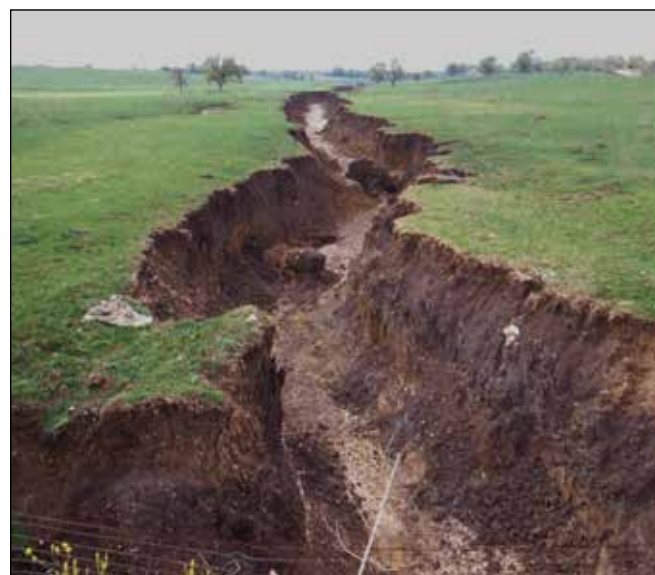
**Figure 5.** Poor riparian management has led to extreme downcutting in this creek. For reference, the block of soil closest to the camera is the size of a refrigerator. Photo by Kenneth Mayben, Natural Resources Conservation Service.

contributed in a watershed (Figure 5; Wynn and Mostaghimi, 2006). The Texas Water Development Board (2009) calculated that the Richland-Chambers Reservoir in Navarro County loses 2,065 acre-feet of water capacity every year for a total loss of 43,361 acre-feet in the 20-year period since 1987, when it was impounded. Consequently, enough sediment has accumulated during that 20-year period to cover the bottom of the 43,384-acre reservoir to an average depth of one foot (Figure 6). Texas A&M University researchers estimate that 84% of the sediment reaching the reservoir every year is from channel and stream bank erosion (Wang et al. 2010).

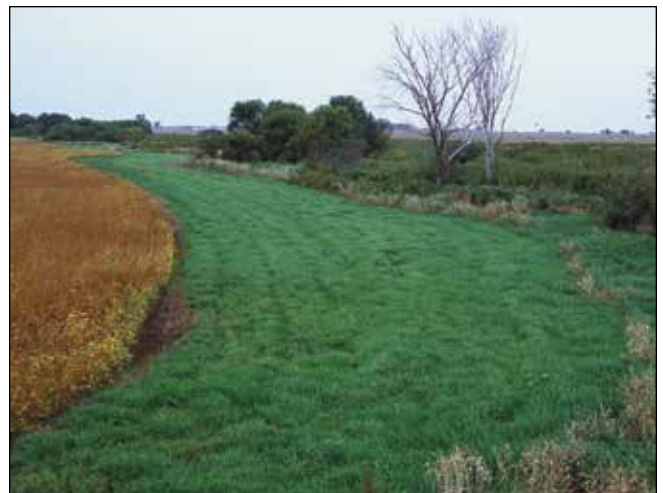
**Figure 7.** Riparian buffers protect creeks by reducing water velocities and capturing sediment from croplands. Photo courtesy of USDA – Natural Resources Conservation Service.

A riparian buffer is defined as a vegetated strip lying between agricultural land and a neighboring watercourse (Figure 7; Collins et al. 2009). Studies indicate that riparian buffers are an effective best management practice (BMP) for reducing nonpoint source pollution (NPS) in agricultural areas. These buffers and other agricultural BMPs can help prevent and/or minimize the effects of NPS by reducing erosion and pollutant loads that would otherwise reach the stream. In some cases, riparian buffers of only 32 feet in width can reduce phosphorus levels up to 95% (Vought et al. 1995), and nitrate levels up to 80% on row crop fields (Schultz et al. 1995). In addition, buffers as narrow as 20 feet can prevent up to 95% of the sediment eroded from uplands from reaching streams (Collins et al. 2009). Likewise, riparian buffers can benefit wildlife populations by providing corridors that connect habitats and allow safe movement between fragmented

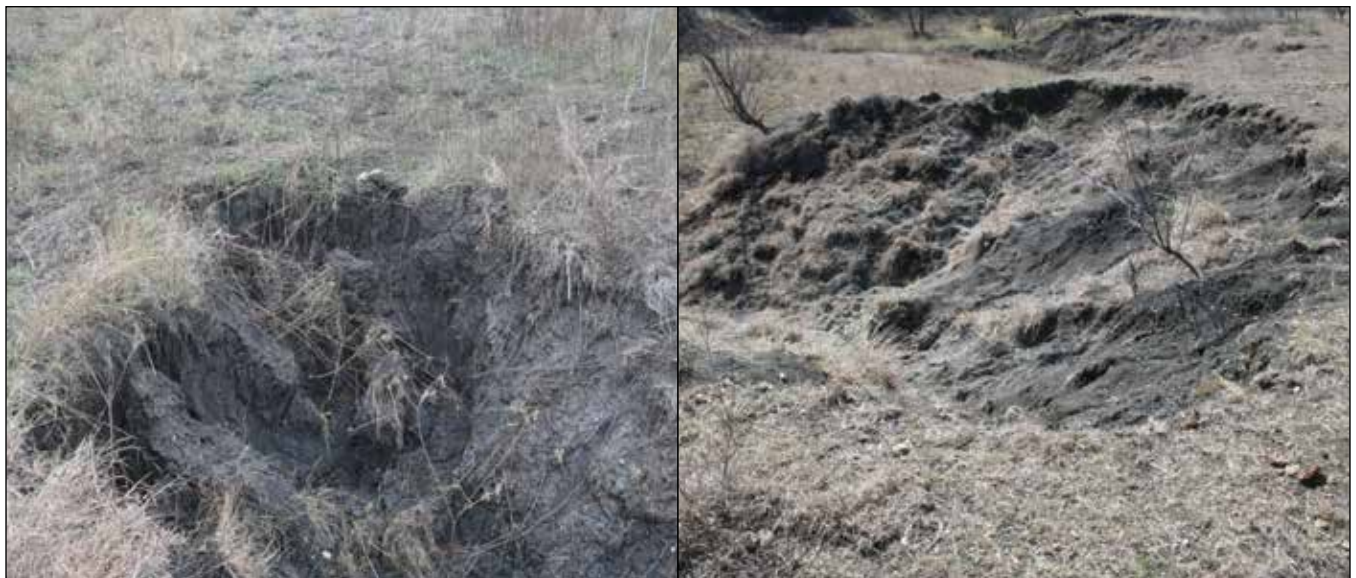
**Figure 8.** Active headcuts (left) and gullies (right) are a sign of active erosion and should be given special attention during planning. Photos by Blake Alldredge, Texas A&M AgriLife Extension Service.

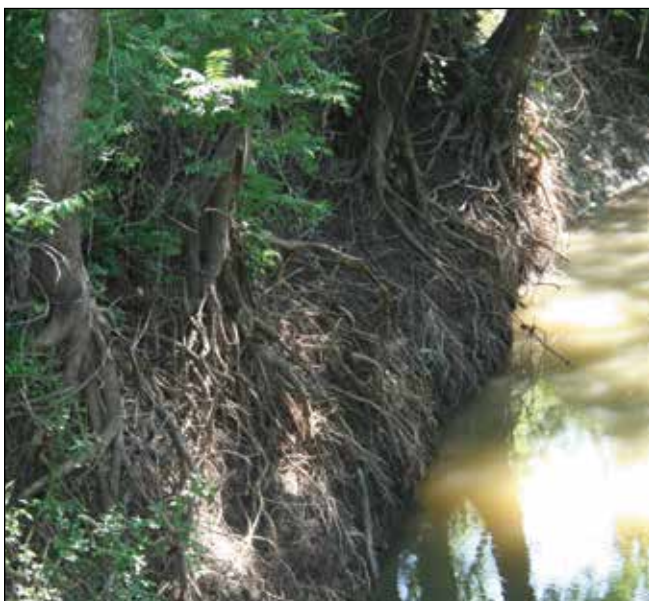
**Figure 9.** Tree roots armor this bank and help to reduce erosion by protecting the soil from water flow. Photo by Blake Alldredge, Texas A&M AgriLife Extension Service.

to increase channel stability in three primary ways: mechanical reinforcement due to tree root tensile strength, decreased moisture content resulting from evapotranspiration of soil moisture through tree leaves, and bank armoring against channel scour by exposed tree roots (Figure 9).

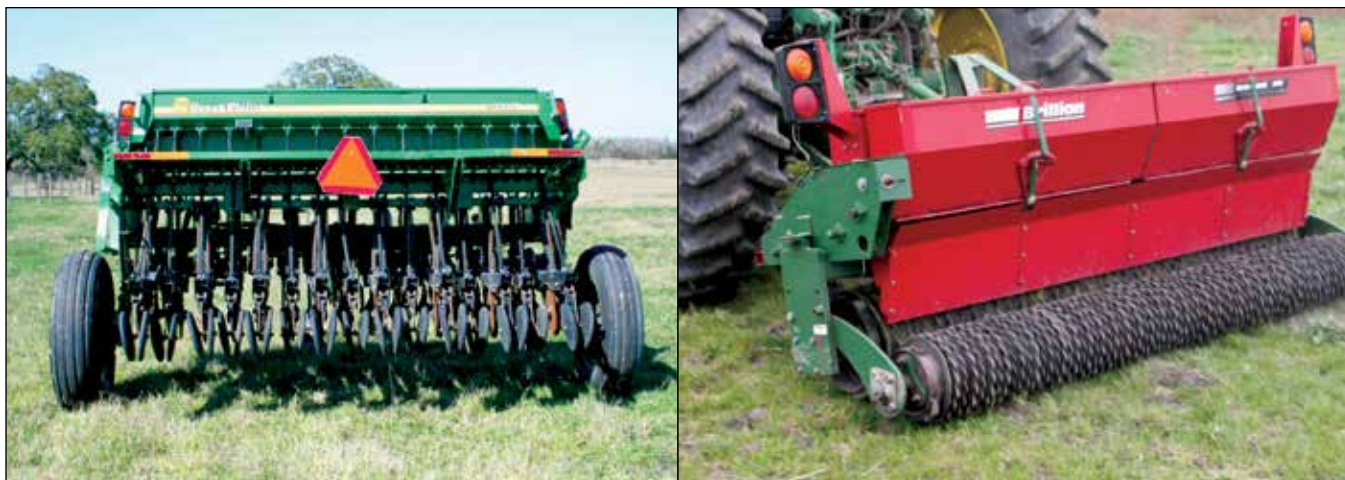
**Figure 11.** No-till seed drills (left) and cultipackers (right) are commonly used for restoring native prairies. Photos by Blake Alldredge, Texas A&M AgriLife Extension Service.

or other implement to firm the seedbed (Figure 11). This method typically costs from \$100 to \$200 per acre, depending mainly on seed prices, which are the greatest expense. Even though this method is more expensive than passive restoration, given the right conditions, a productive stand of native prairie plants can be established within two to three years. In contrast, if it is determined after two years of passive restoration that the native seedbank is not sufficient, then active restoration techniques would need to be used to establish a native prairie plant community which may take an additional two to three years.

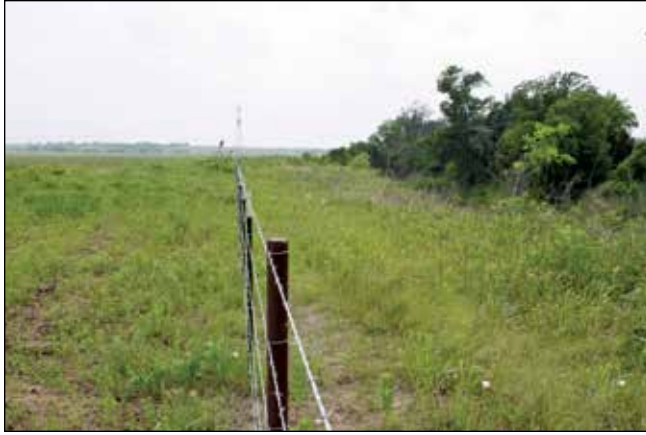
**Figure 12.** This riparian fence could be moved back 200 to 300 yards to create a riparian pasture. Photo by Blake Alldredge, Texas A&M AgriLife Extension Service.

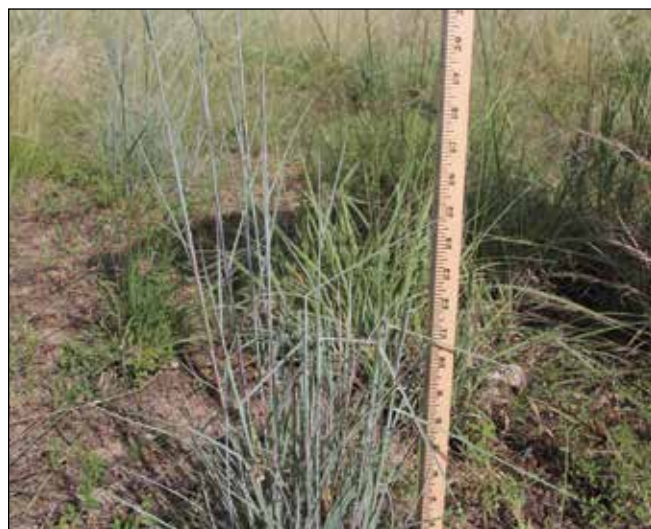
**Figure 15.** Measuring plant stubble height is easily done with a grazing stick or yard stick. Measure the height of standing vegetation in several locations within the same area. Photo by Blake Alldredge, Texas A&M AgriLife Extension Service.

Riparian areas should be frequently monitored, especially when using the area to graze cattle. The easiest way to ensure that there is adequate plant material covering the ground is to measure plant stubble height (Figure 15; Clary and Leininger, 2000). The best way to do this is by using a grazing or yard stick to measure the height of the vegetation in several locations, within the same area, to obtain an average height. It is important to evaluate the grasses that cattle will graze. For bermudagrass and other introduced shortgrasses, the minimum average height should be 3 to 4 inches; 12 to 14 inches for native tallgrasses; and 6 to 8 inches for native midgrasses. Maintaining these minimum heights will ensure continued plant vigor in addition to erosion and stream bank stabilization. For a complete discussion of this technique and others with data recording

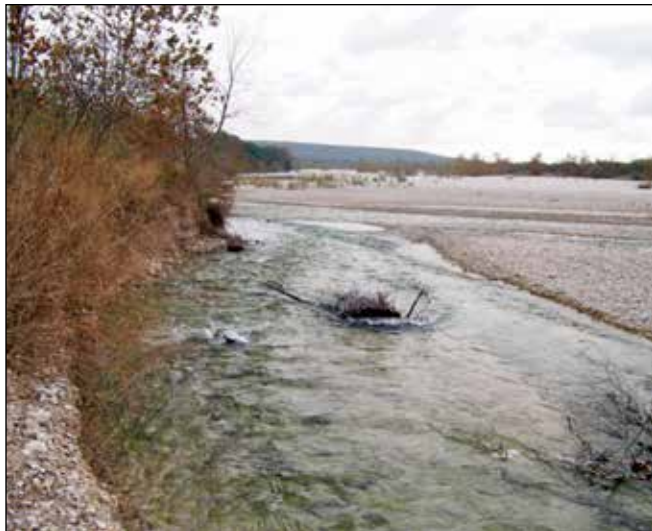
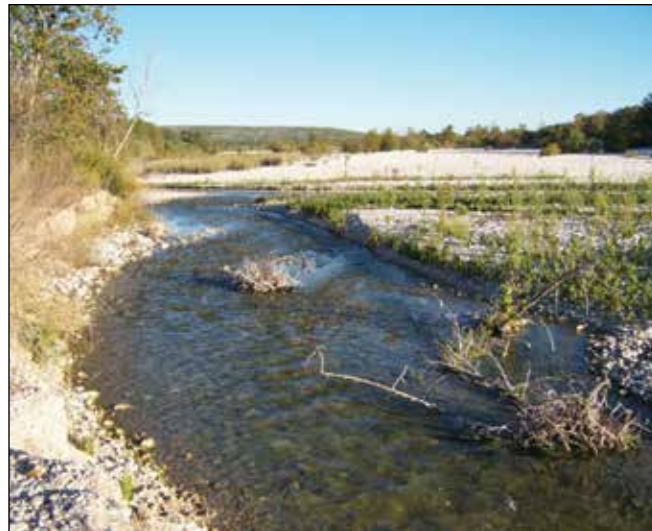
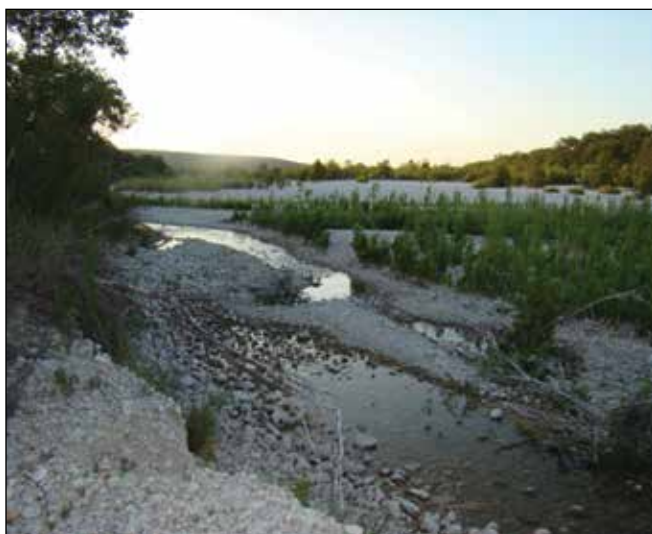
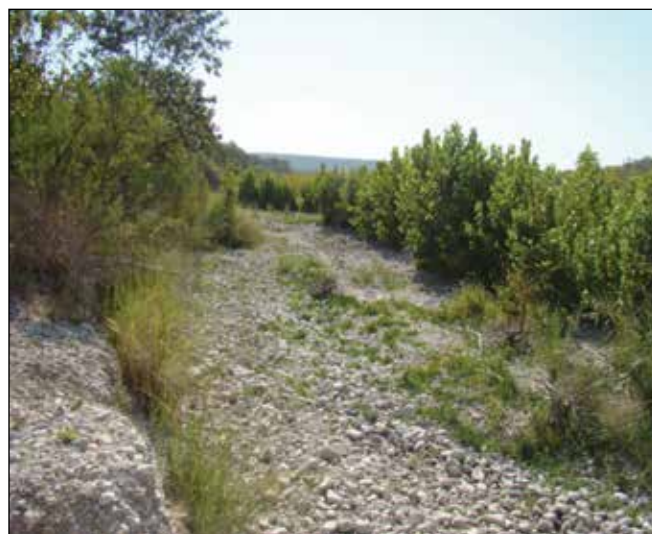
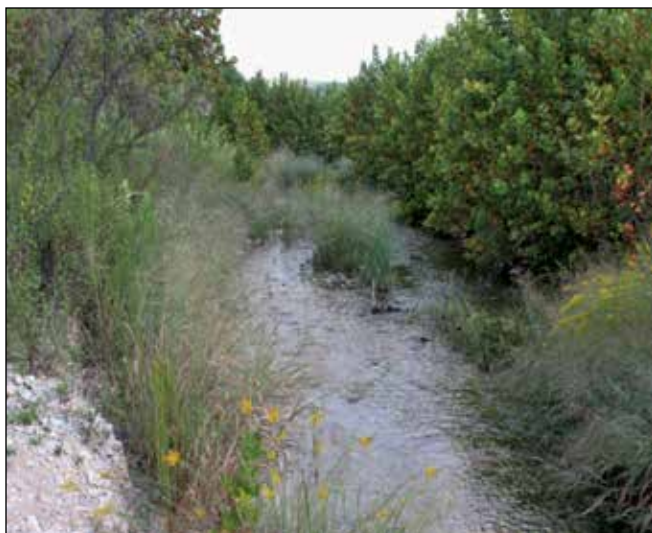
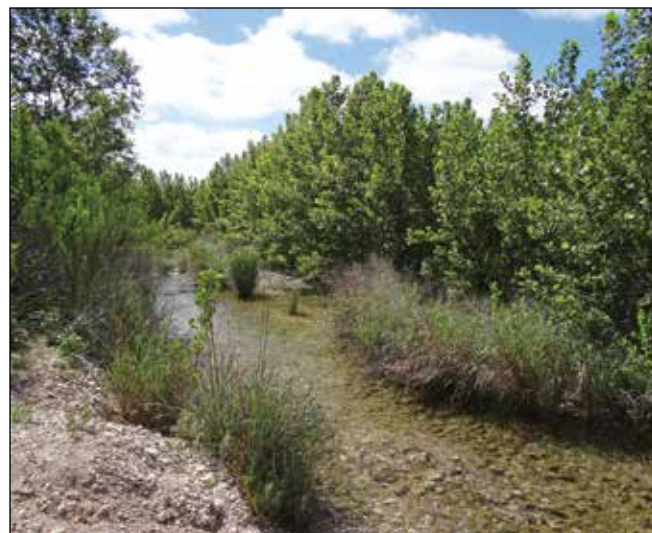
**Appendix B.** Example of photo point monitoring along the Nueces River after the prohibition of off-road vehicles in the riverbed. Photos by Sky Lewey, Nueces River Authority.
