The Vanishing Santa Cruz River

Background

The Issue

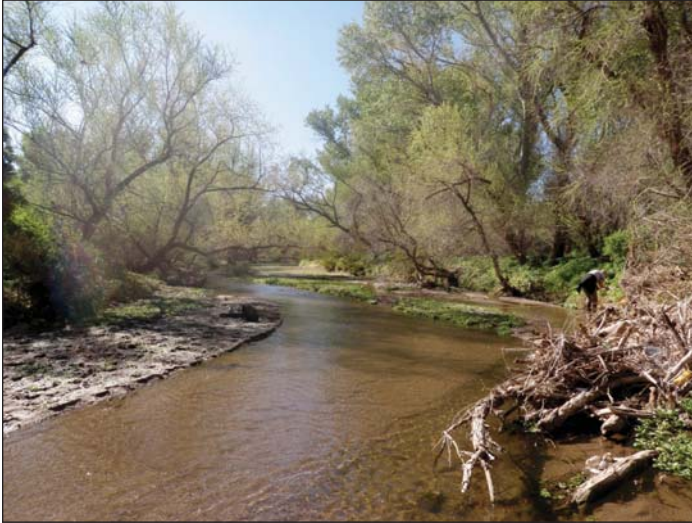
Santa Cruz River upstream of Santa Gertrudis Lane in 2012, flowing at approximately 12 cubic feet per second.

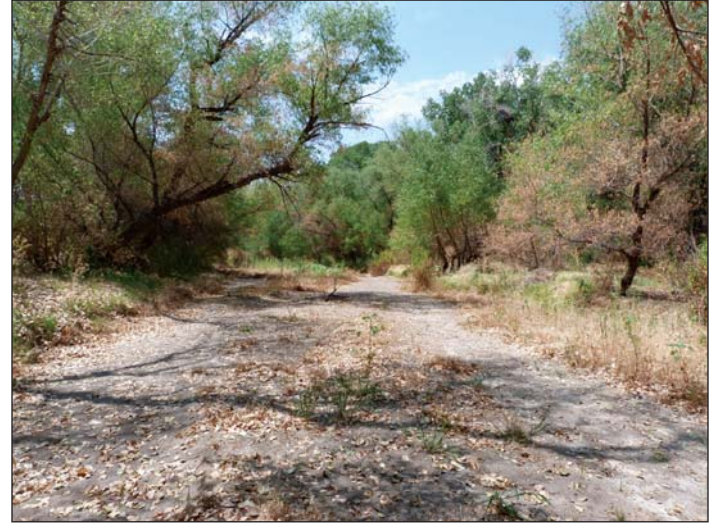
Santa Cruz River north of Santa Gertrudis Lane, July 3, 2013.

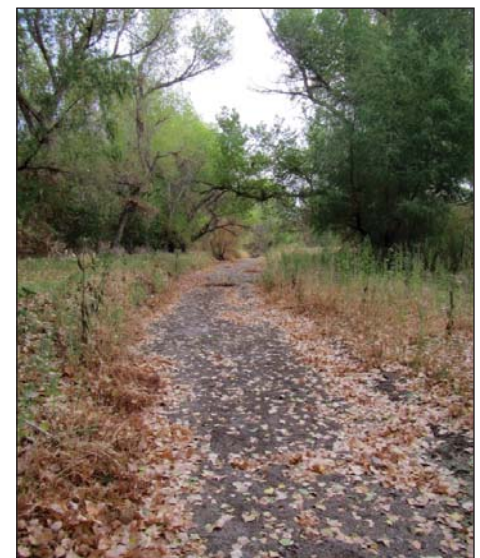
Figure 1. Cottonwood leaf drop at Tumacácori NHP along the dry bed of the Santa Cruz River, July 1, 2013.

The reduction of water levels in the river and its adjoining soils has put stress on riparian trees and plants. The cottonwood–willow forest managed by Tumacácori NHP represents one of the last vestiges of this plant association in the western U.S. In order to thrive, the dominant trees of the park’s riparian gallery forest, Fremont cottonwoods (*Populus fremontii*), need groundwater to remain at a level around 2 meters below the surface (Stromberg et al. 1996). If groundwater falls below the roots of the cottonwoods and other vegetation, then the plants begin to get stressed and, in response, drop their leaves to conserve water (Figure 1). If the plants continue to have limited access to groundwater, extensive vegetation mortality can result.

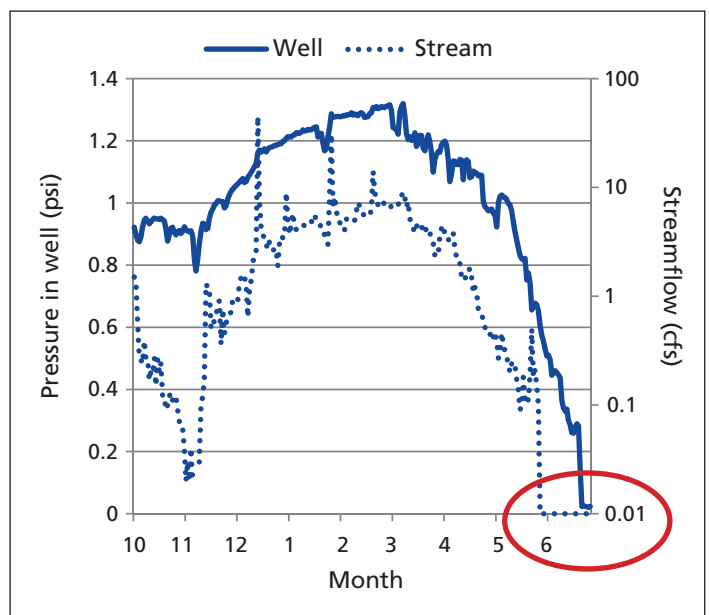
Figure 2. Water year 2013 flow rate (cfs) measured at the Tubac USGS gage and the pressure (psi) detected by the transducer in a groundwater monitoring well at Tumacácori NHP. Near-zero pressure indicates the well is dry.

At Tumacácori NHP, streamflow has ceased and groundwater levels are dropping as a result of the overall reduction in flow. Maintaining and replenishing the groundwater adjacent to the river requires a constant flow of river water; without it, evaporation, transpiration (both of which increase in extreme summer temperatures), and loss to surrounding deeper groundwater all combine to lower the surface-water level below the roots of riparian vegetation (Figure 2).
